## Application for Planning

### *S.57 Land Use Planning and Approvals Act 1993*

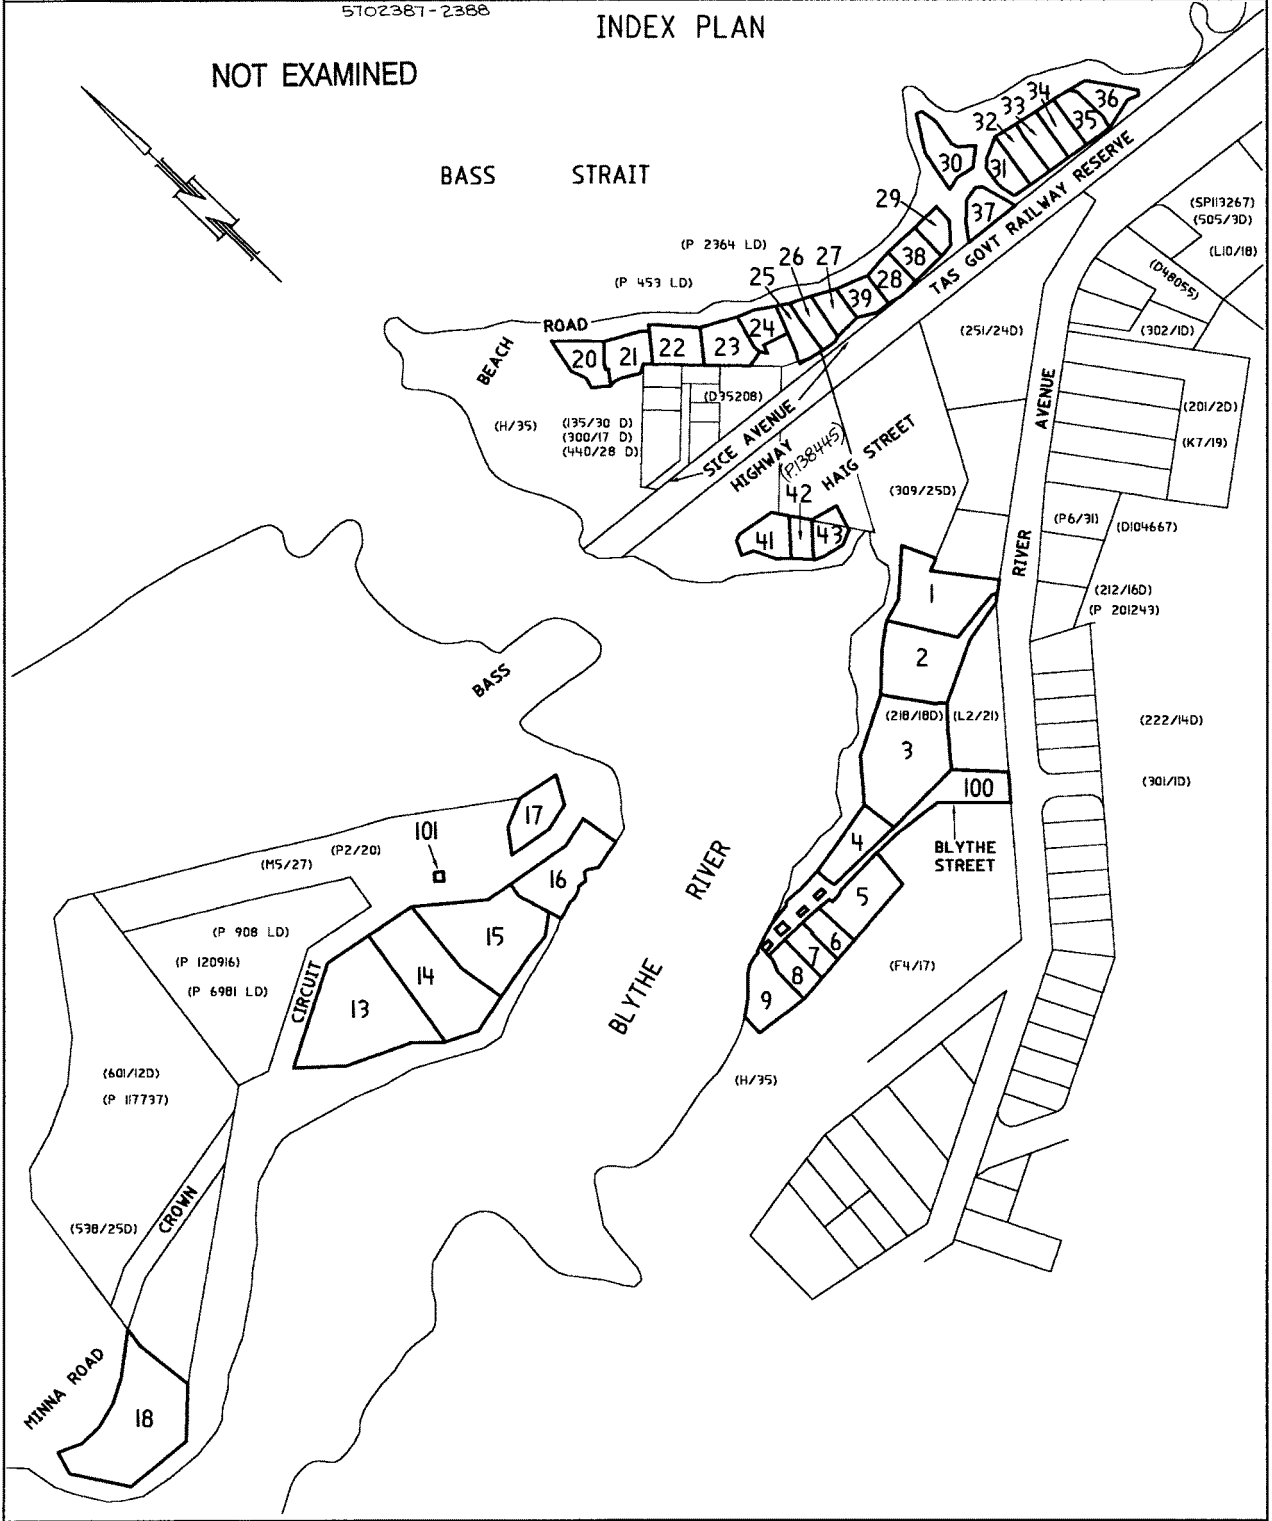
<p>OWNER THE CROWN</p> <p>FOLIO REFERENCE SECTION 27A C.373988</p> <p>F.R.224562/1 &amp; F.R.234758/1</p> <p>GRANTEE</p> <p>WHOLE OF LOTS 1-9, 13-18, 20-39, 41-43, 100 &amp; 101 THE CROWN.</p>	<p><b>PLAN OF SURVEY</b></p> <p>BY SURVEYOR CRAIG B ROGERSON FIRST FLOOR No 11 BAYFIELD STREET ROSNY PARK PH 6244-6256 FAX 6244-6221 MOB 0418-120-796</p> <p>LOCATION</p> <p><b>(TOWN OF HEYBRIDGE)</b> <b>CITY OF BURNIE &amp; DEVON-STOWPORT</b></p> <p>SCALE 1:3000 LENGTHS IN METRES</p>	<p>REGISTERED NUMBER</p> <p><b>P 138382</b></p> <p>APPROVED <b>08 OCT 2002</b> EFFECTIVE FROM</p> <p><i>Alice Kawa</i> Recorder of Titles</p>	
<p>MAPSHEET MUNICIPAL CODE No 103,104 (4045-44,54)</p>	<p>LAST UPI No 4203630, 4201331, 4201334-1345, 5102806, 5102189, 5102387-2388</p>	<p>LAST PLAN No</p>	<p>ALL EXISTING SURVEY NUMBERS TO BE CROSS REFERENCED ON THIS PLAN</p>

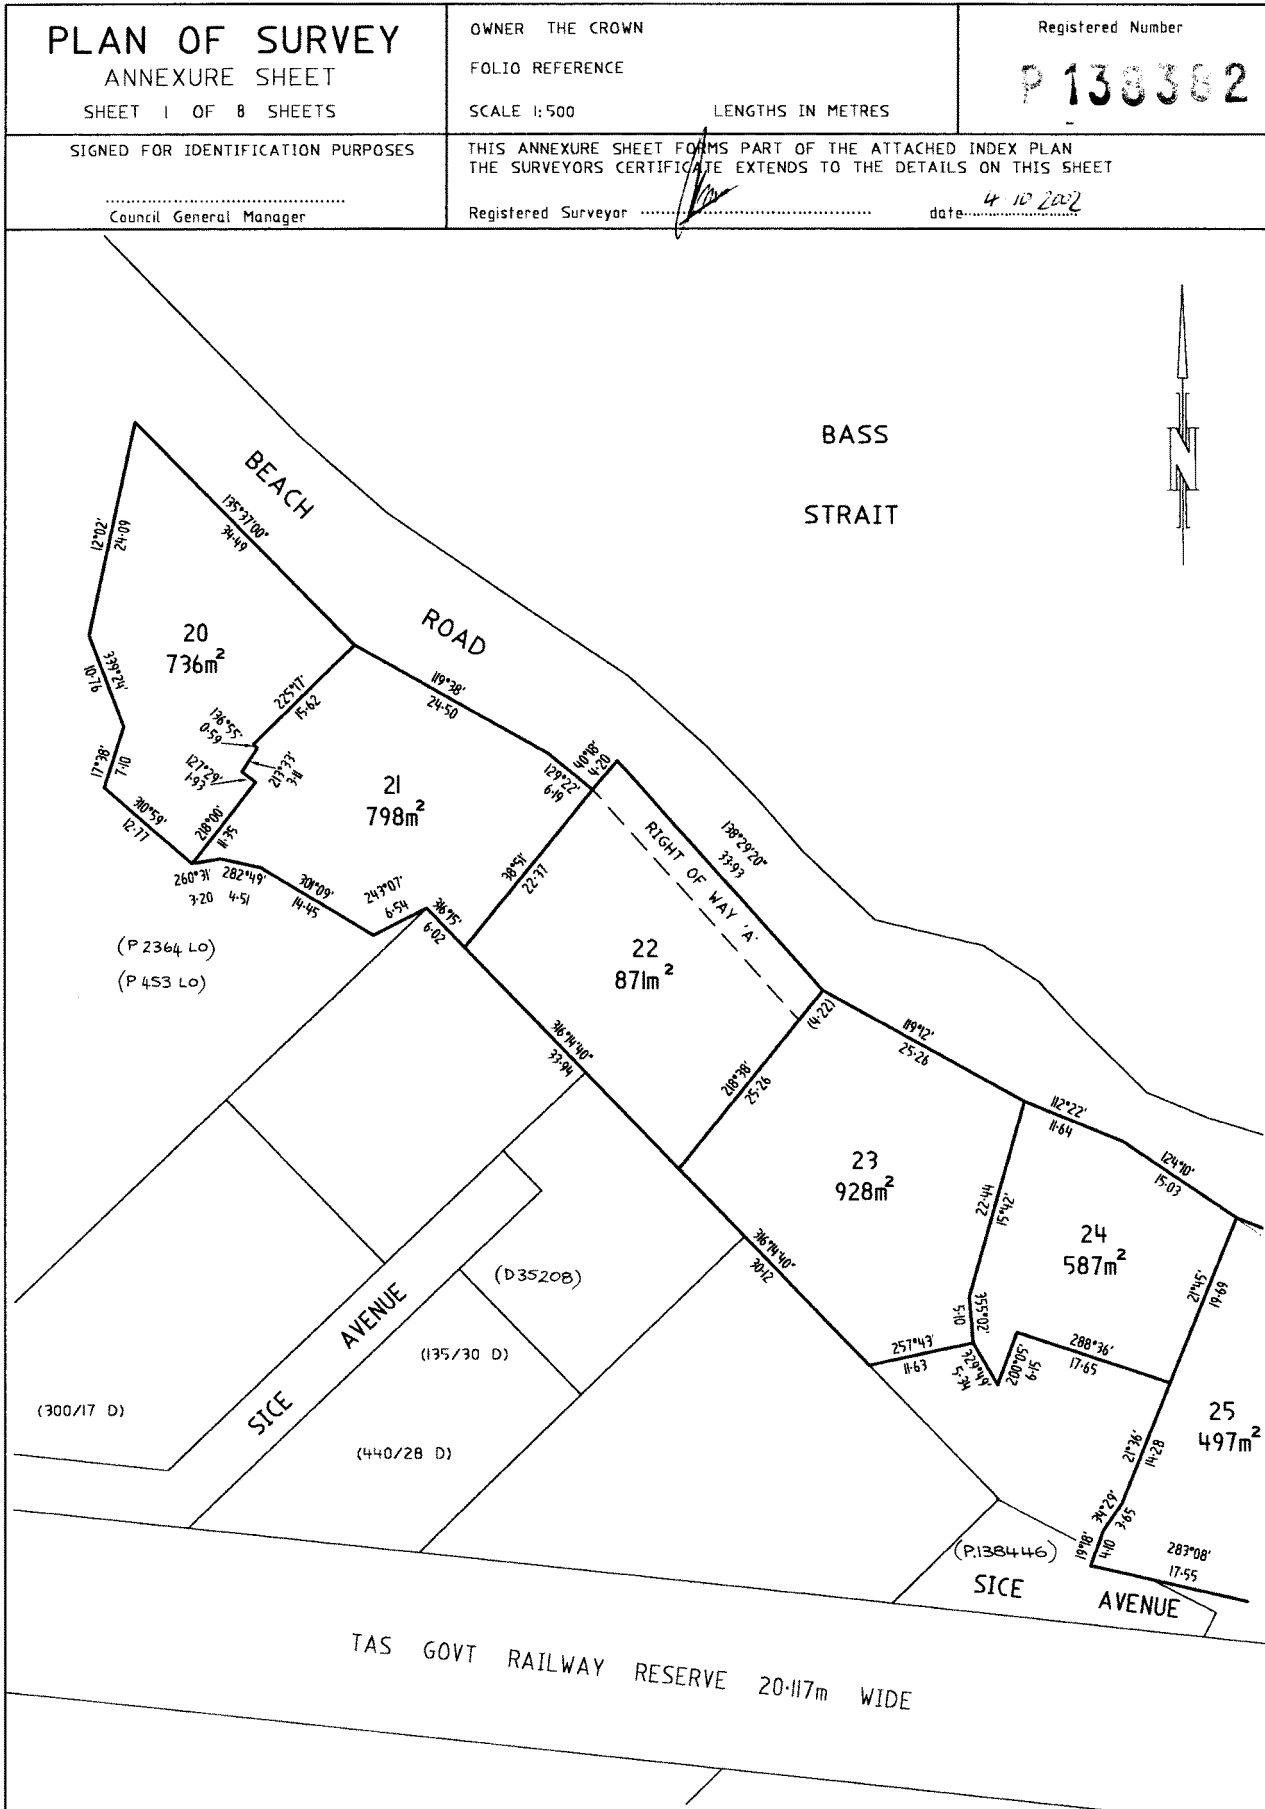
<p><b>PLAN OF SURVEY</b> ANNEXURE SHEET SHEET 2 OF 8 SHEETS</p>	OWNER THE CROWN	<p>Registered Number <b>P138382</b></p>
	FOLIO REFERENCE	
	SCALE 1:500	LENGTHS IN METRES

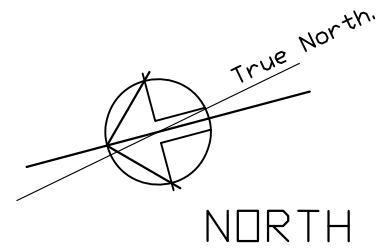
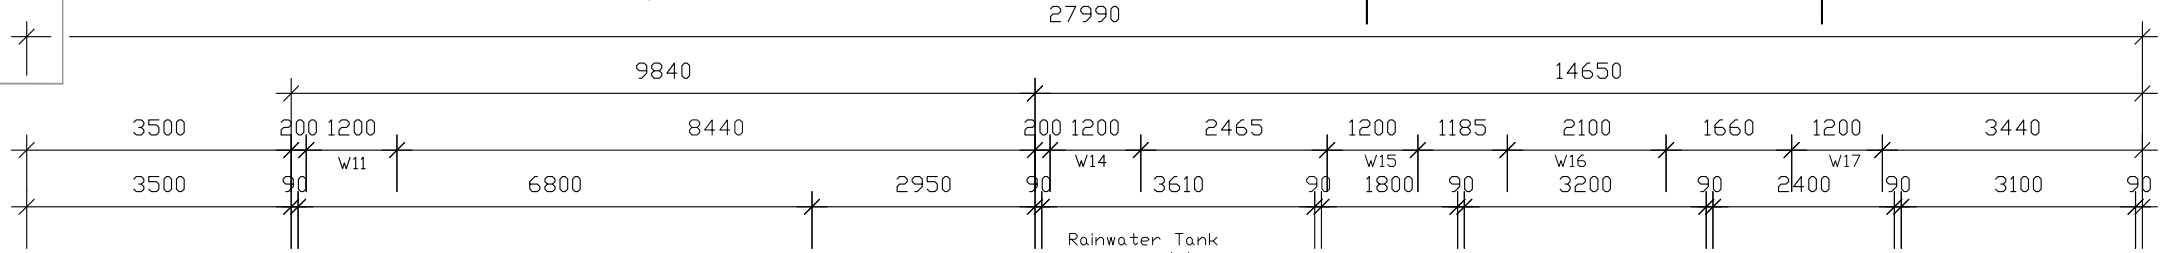
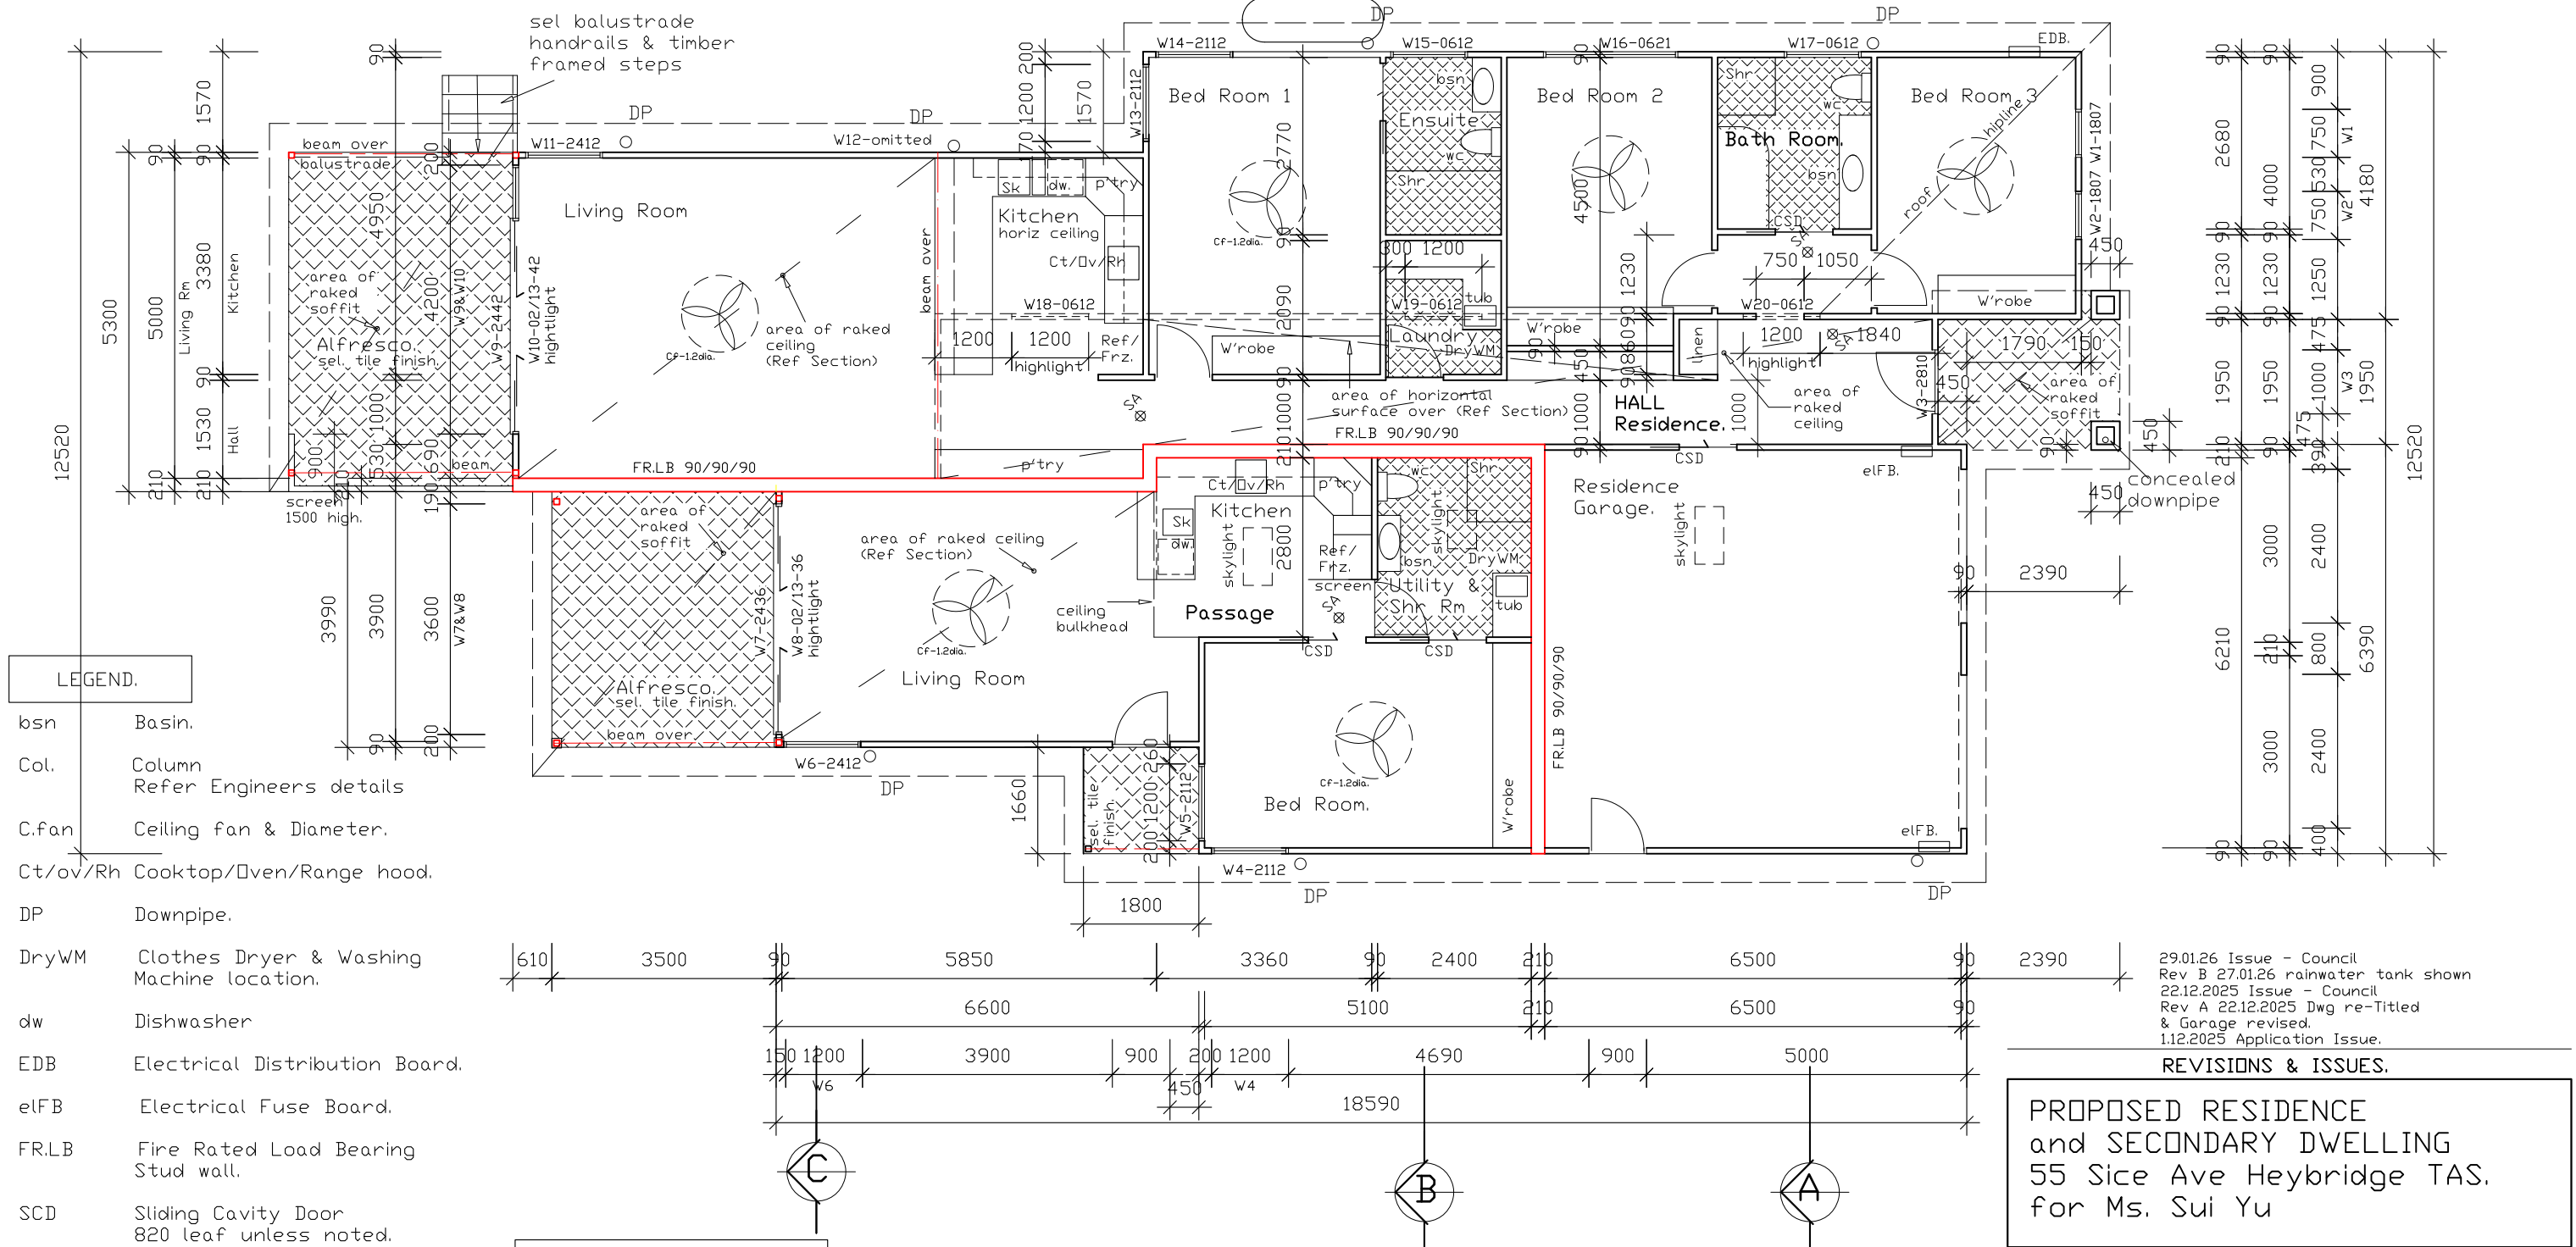
- LEGEND.**
- bsn Basin.
  - Col. Column Refer Engineers details
  - C.fan Ceiling fan & Diameter.
  - Ct/ov/Rh Cooktop/Oven/Range hood.
  - DP Downpipe.
  - DryWM Clothes Dryer & Washing Machine location.
  - dw Dishwasher
  - EDB Electrical Distribution Board.
  - eIFB Electrical Fuse Board.
  - FR.LB Fire Rated Load Bearing Stud wall.
  - SCD Sliding Cavity Door 820 leaf unless noted.
  - sk Sink configuration as shown
  - T.B.C To Be Confirmed.
  - SA Smoke Alarm.
  - W.9 Window Number. Height / width.

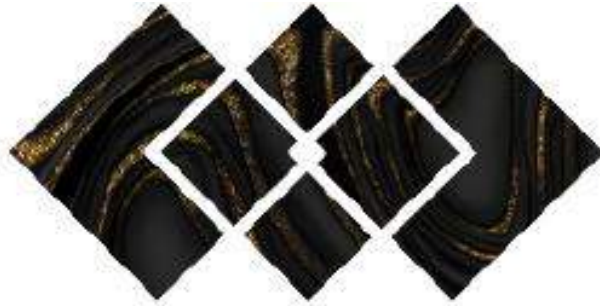
**ENERGY EFFICIENT HOMES**  
Architects - Cobbity  
Tel. 0412 536 353 Date: Oct 2025  
Ref: 25 67 590 Dwg No: **A3-05.A**

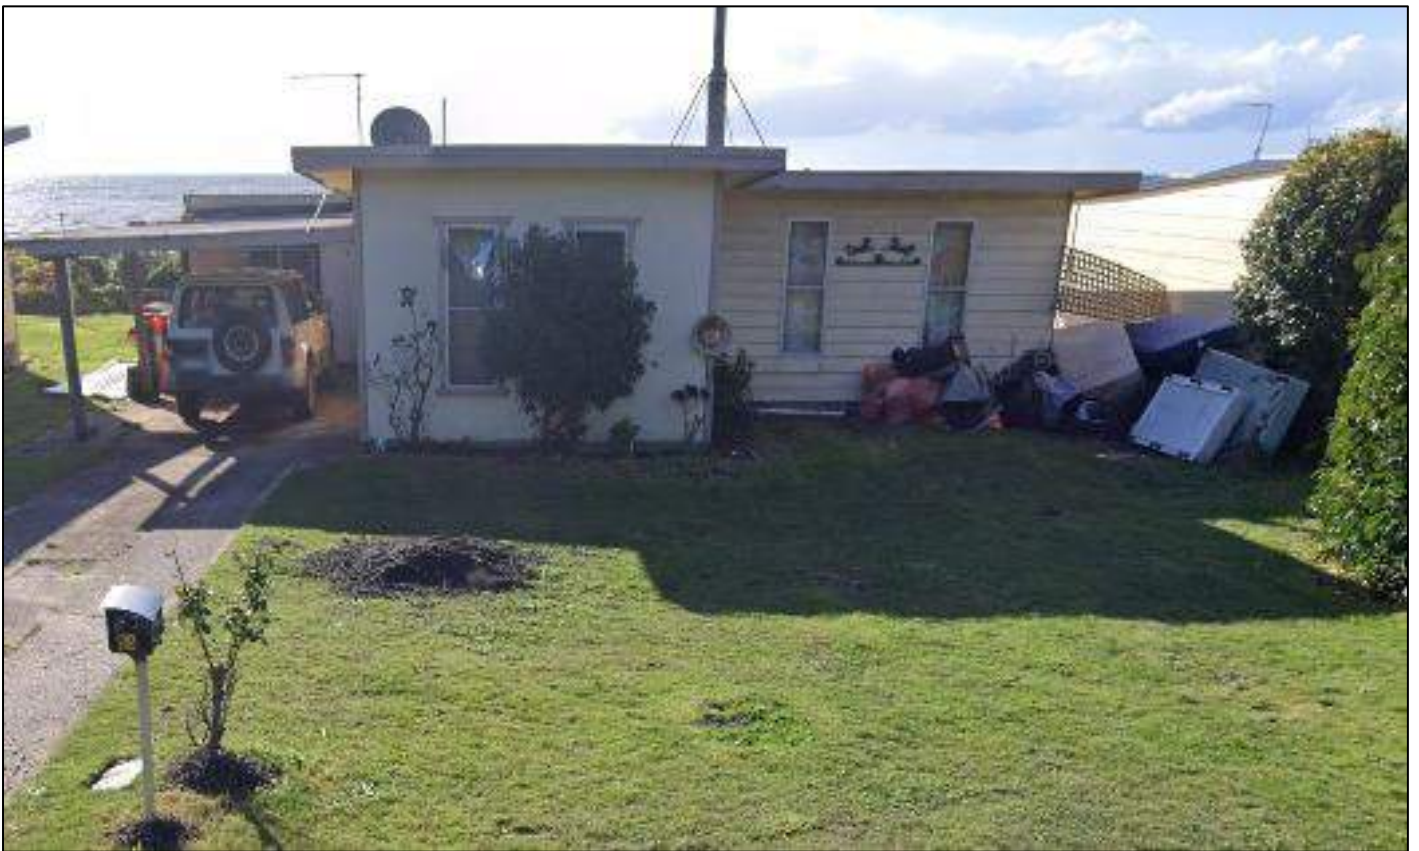
55 Sice Avenue, Heybridge, 7316, 3<sup>rd</sup> June 2025

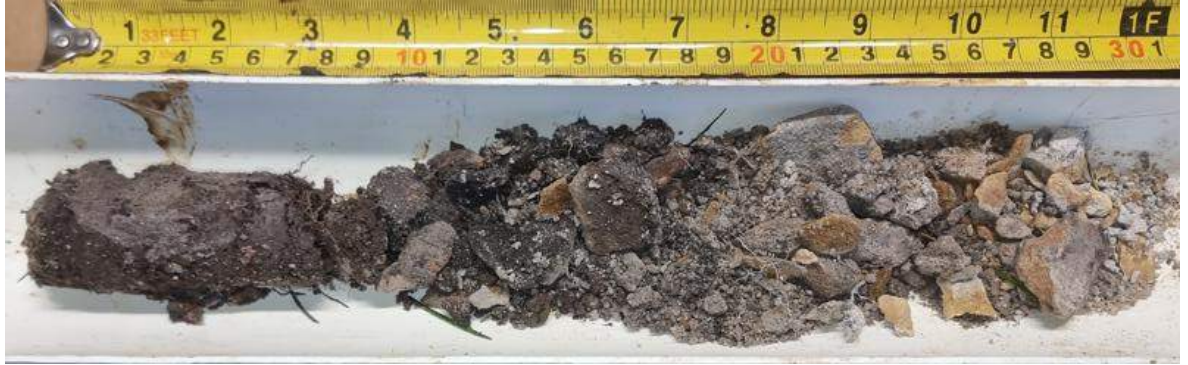
TH1 Depth (m)	Horizon	Description and field texture grade	Observed soil class	Lab derived USCS Class
0.0 – 0.15m	A	Very Dark Grey 2.5YR 3/1, inorganic silts, silty sands, sandy loam, Strong structure, slightly moist. Fine texture. Very Soft. Roots throughout. Refusal at 0.3m.	SM	CL-ML
0.15 – 0.3m	A2 / B	Grey 2.5YR 5/1, inorganic silts, very fine clayey sands, Dry, loose. Very Soft.	SM	ML

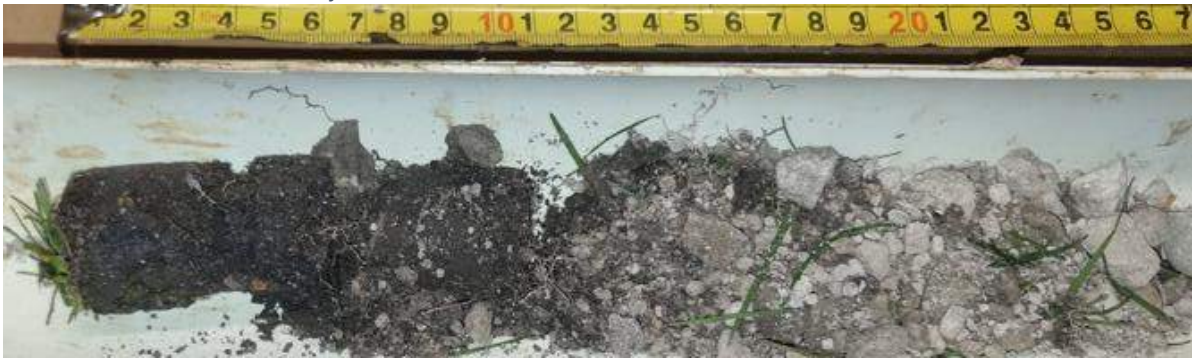
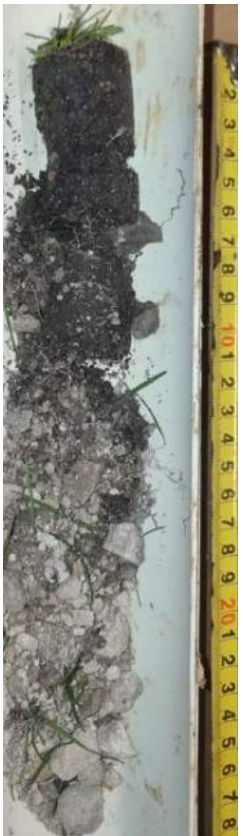
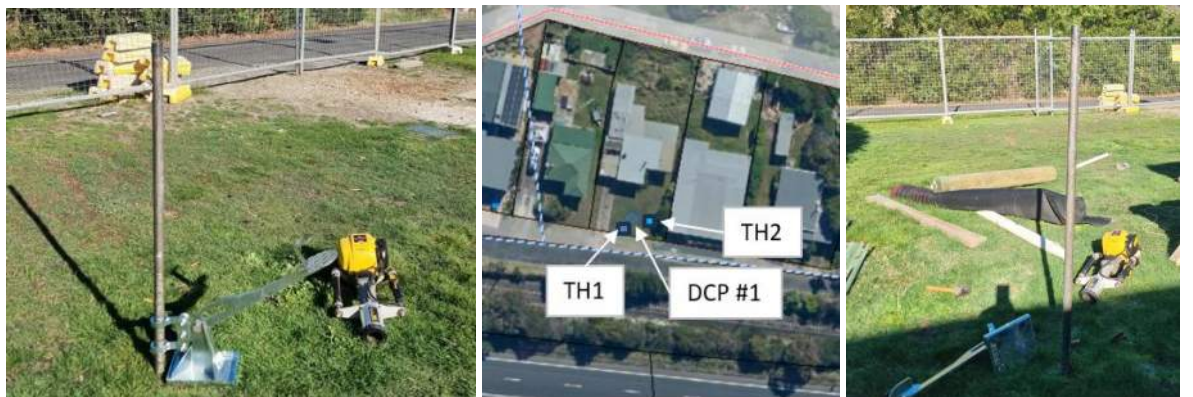
**HOTMANN SERVICES PTY LTD**  
**SOIL PROFILES 55 Sice Avenue, Heybridge**

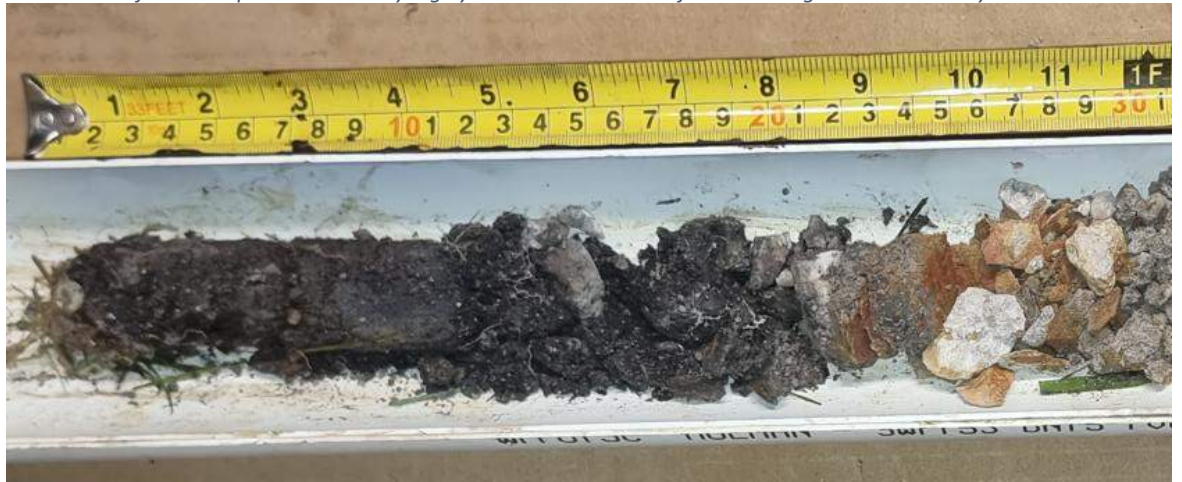
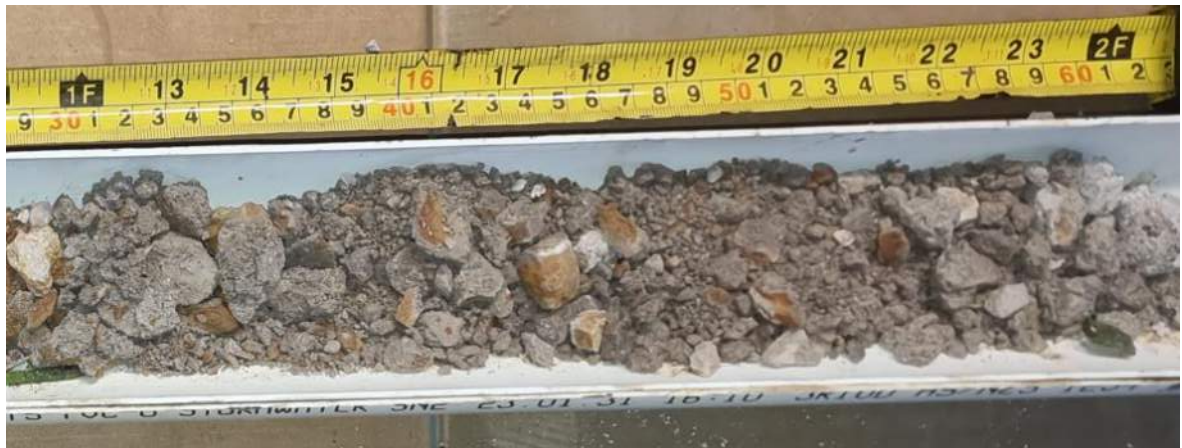
TH3 Depth (m)	Horizon	Description and field texture grade	Observed soil class	Lab derived USCS Class
0.0 – 0.2m	A	Very Dark Grey 2.5YR 3/1, inorganic silts, silty sands, sandy loam & peds, Strong structure, slightly moist. Fine texture. Very Soft. Roots throughout.	SM	CL-ML
0.2 – 0.3m	A2 / B	Light Olive Brown 2.5YR 5/3, inorganic silts, very fine clayey sands, Dry, loose. Very hard.	SM	CL-ML
0.3 – 0.65m	B / B2	Light Olive Brown 2.5YR 5/3, inorganic silts / sands, very fine clayey sands, Dry, loose. Hard. Decaying sediments. Gritty / Friable.	SM	ML

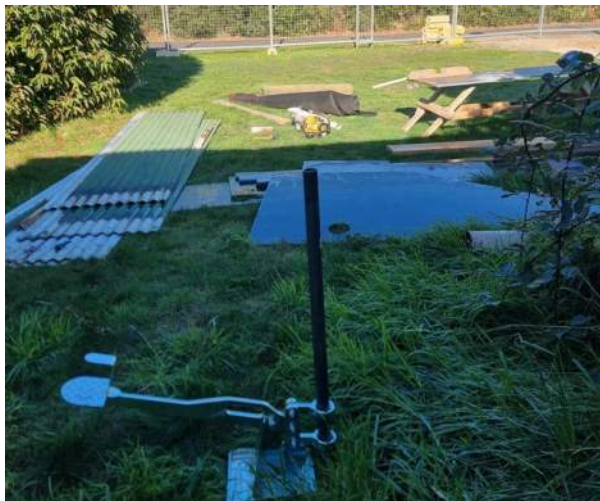
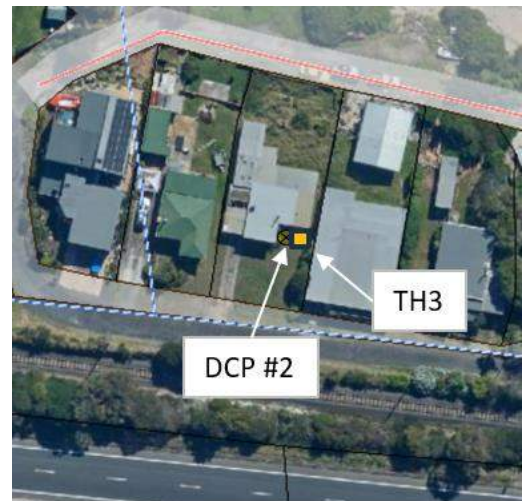
**HOTMANN SERVICES PTY LTD**  
**SOIL PROFILES 55 Sice Avenue, Heybridge**

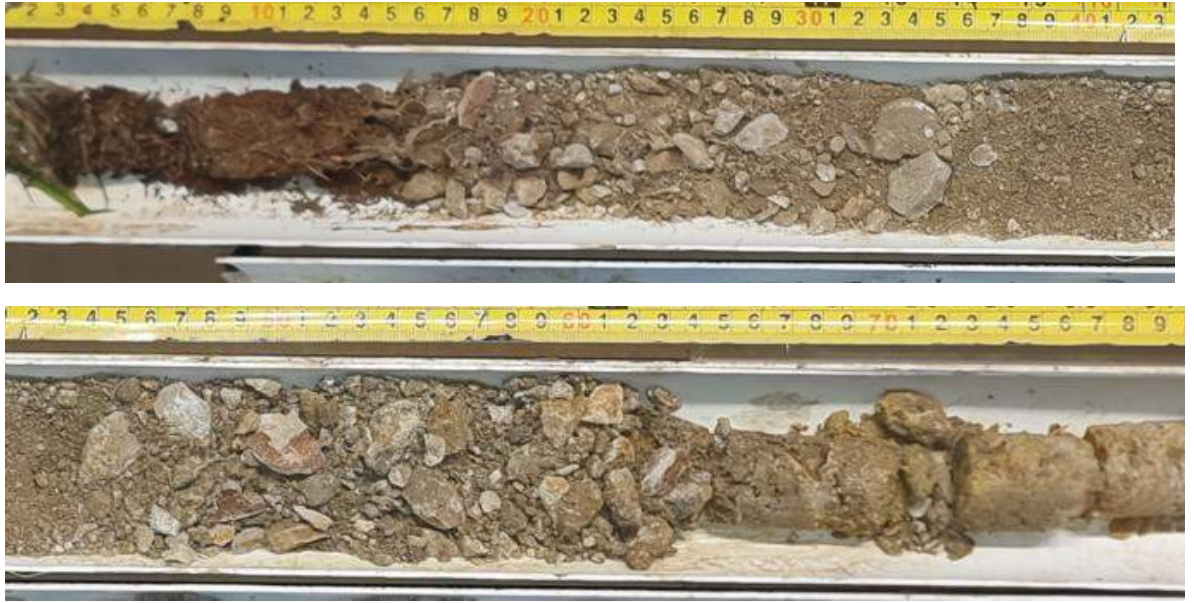
TH4 Depth (m)	Horizon	Description and field texture grade	Observed soil class	Lab derived USCS Class
0.0 – 0.15m	A	Very Dark Grey 2.5YR 3/1, inorganic silts, silty sands, sandy loam & peds, Strong structure, slightly moist. Fine texture. Very Soft. Roots throughout.	SM	CL-ML
0.15 – 0.65m	B	Light Olive Brown 2.5YR 5/3, inorganic silts, very fine, clayey sands, Dry, loose. Very hard.	SM	CL-ML
0.65 – 0.69m	B / B2	Light Olive Brown 2.5YR 5/3, inorganic silts / sands & minor clay, very fine clayey sands, Dry, loose. Decaying sediments. Gritty / Friable, weathered sediments. Hard clayey texture.	SM	ML

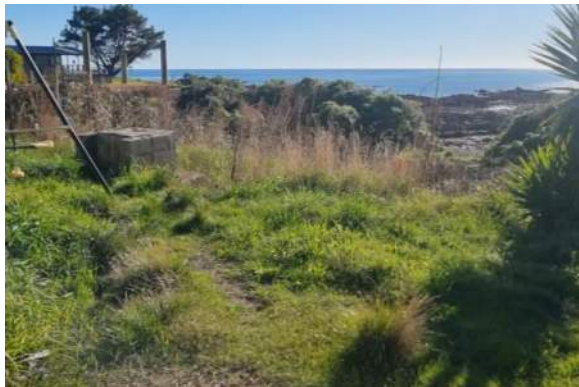
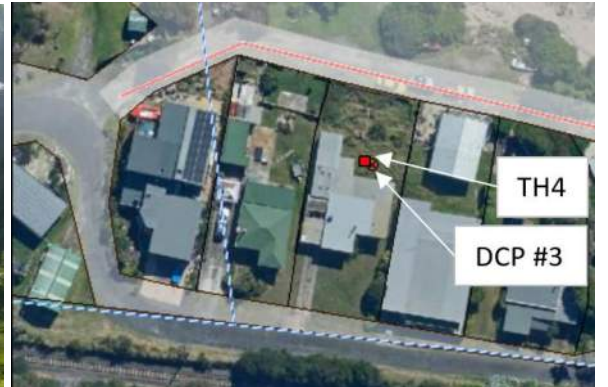
**HOTMANN SERVICES PTY LTD**  
**SOIL PROFILES 55 Sice Avenue, Heybridge**

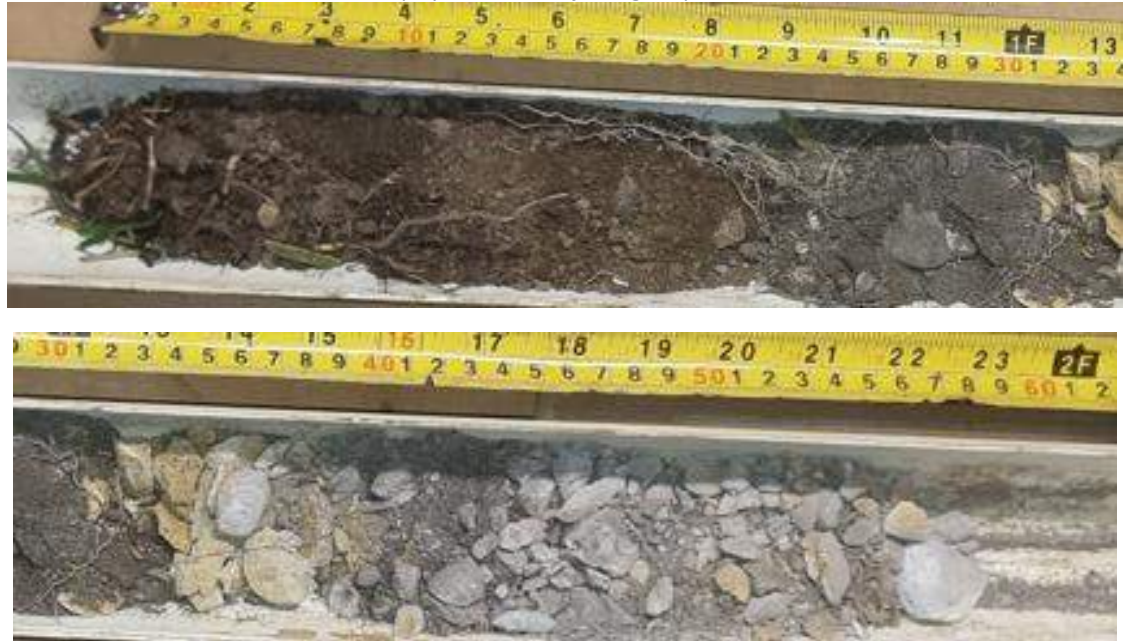
TH5 Depth (m)	Horizon	Description and field texture grade	Observed soil class	Lab derived USCS Class
0.0 – 0.2m	A	Black 2.5YR 2.5/1, inorganic silts, silty sands, fine, weak structure, slightly moist. Very Soft. Roots throughout.	SM	CL-ML

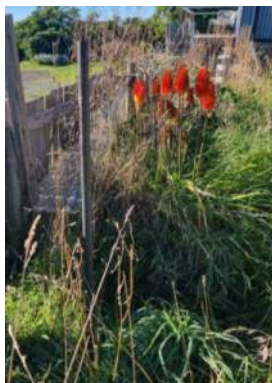
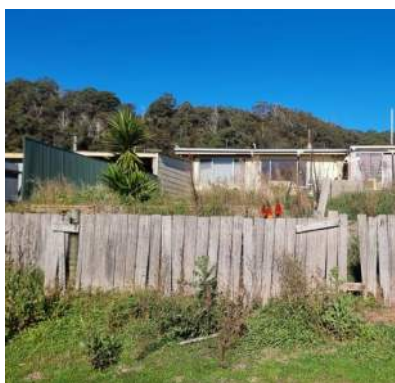
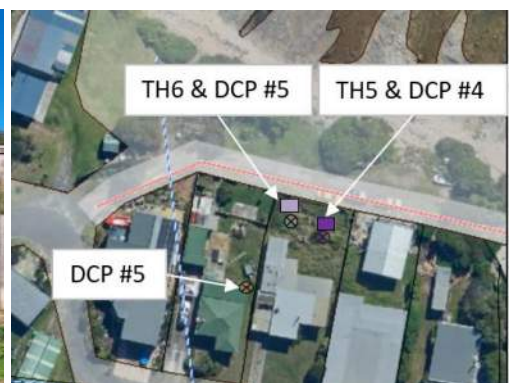
**HOTMANN SERVICES PTY LTD**

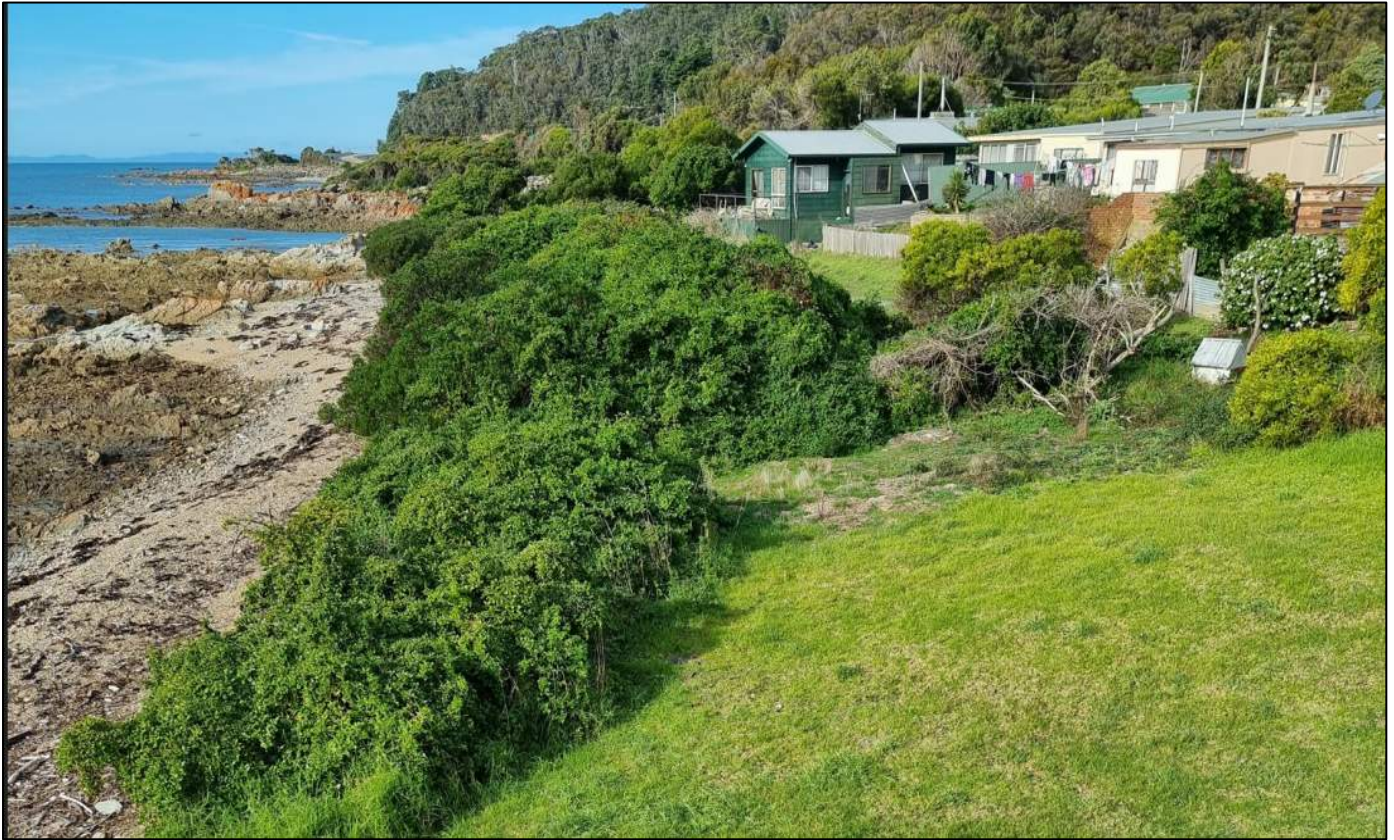
*Figure 10b. (Below) View from balcony of #45 Sice Avenue looking eastward (2025).*

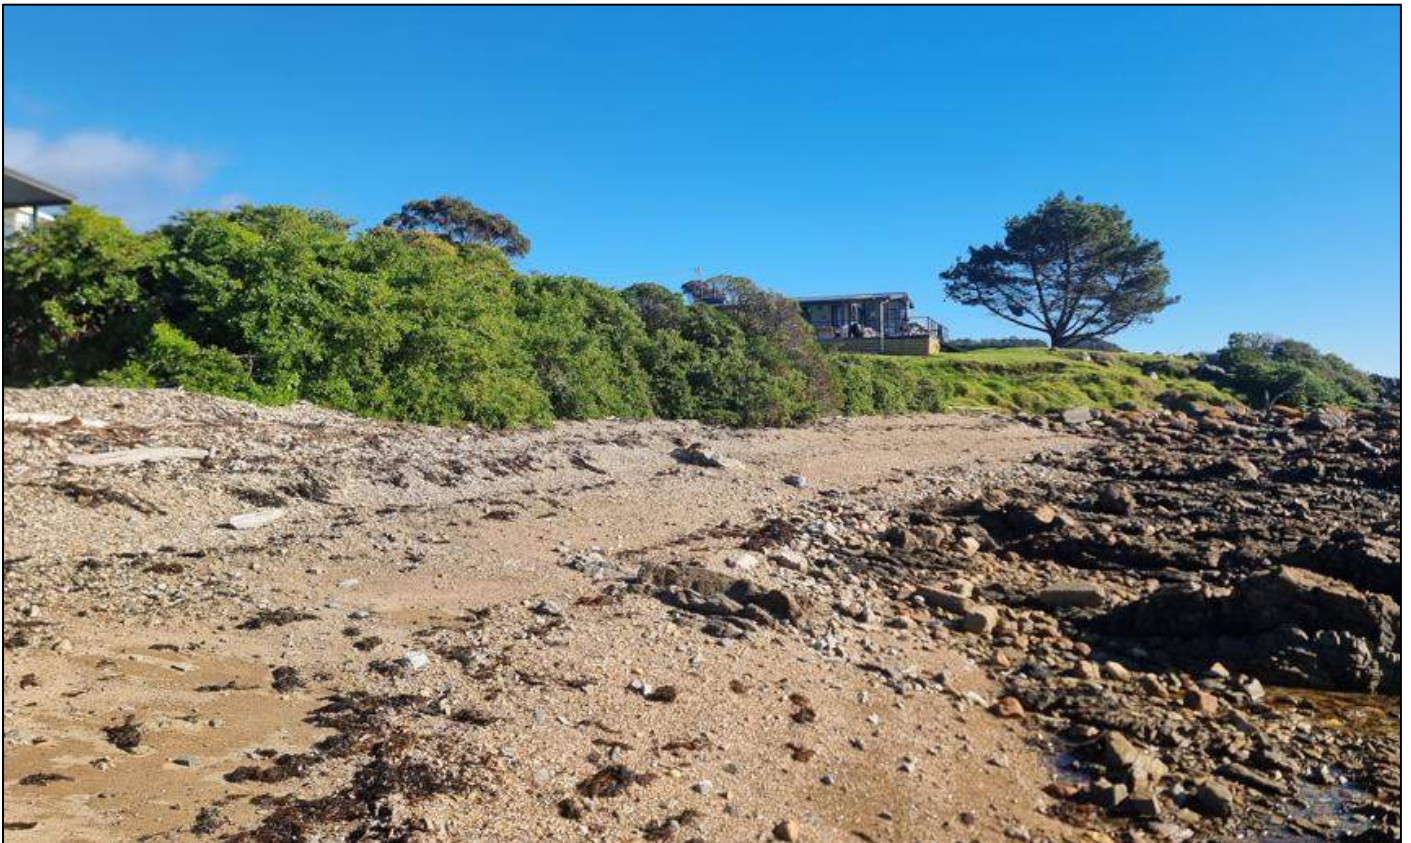
**HOTMANN SERVICES PTY LTD**  
**DCP TESTS AND ESTIMATED BEARING CAPACITY**

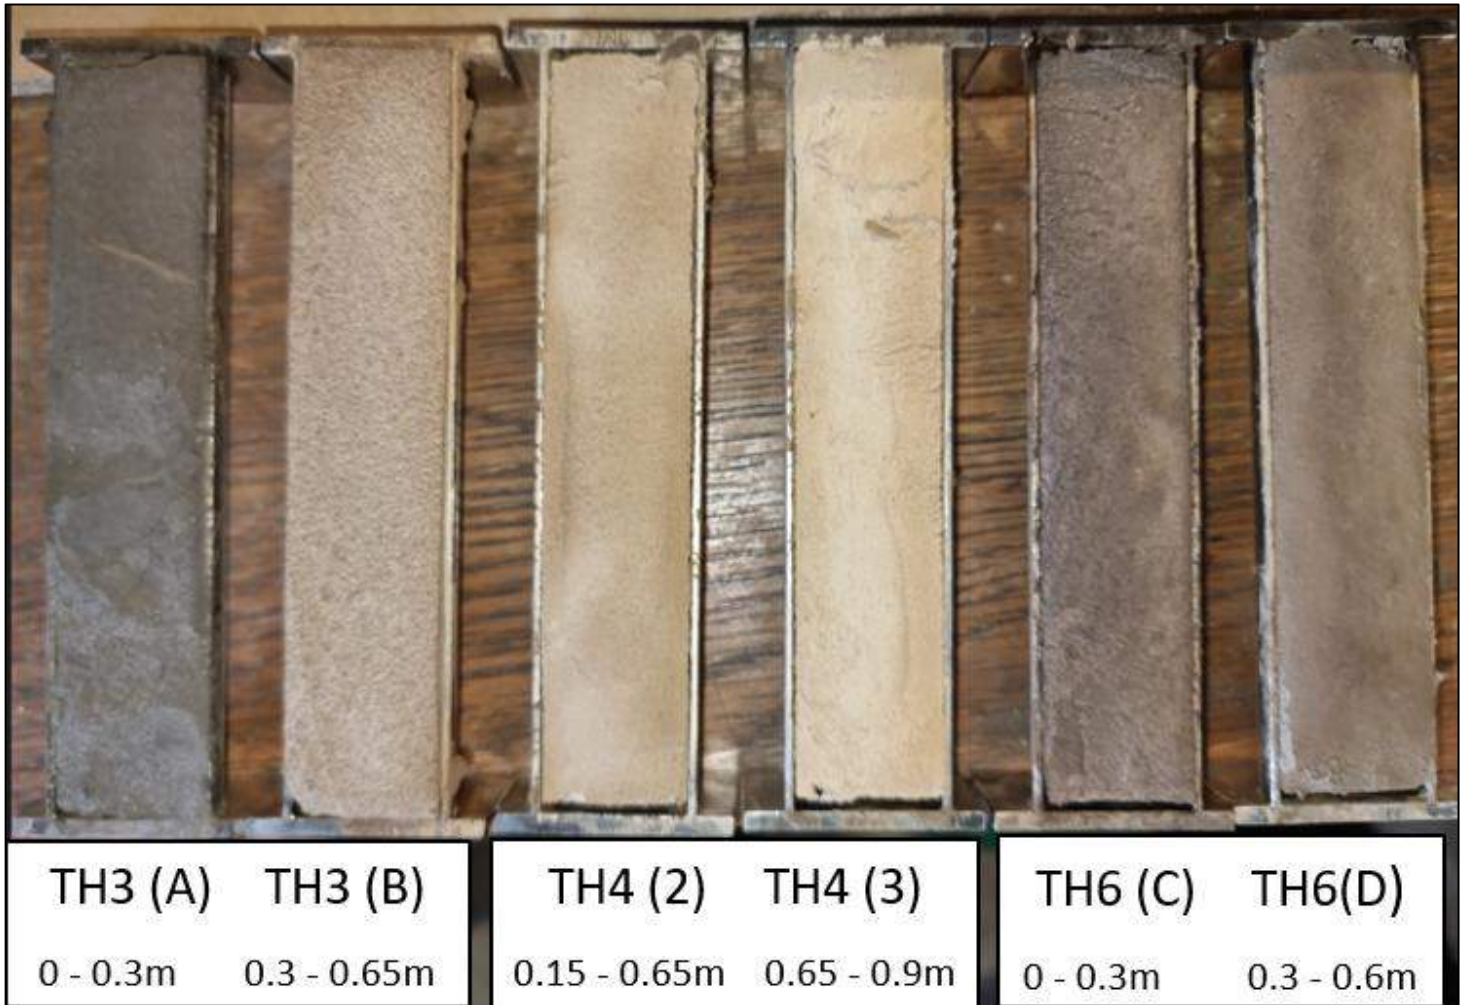
#### PLASTICITY TESTING:

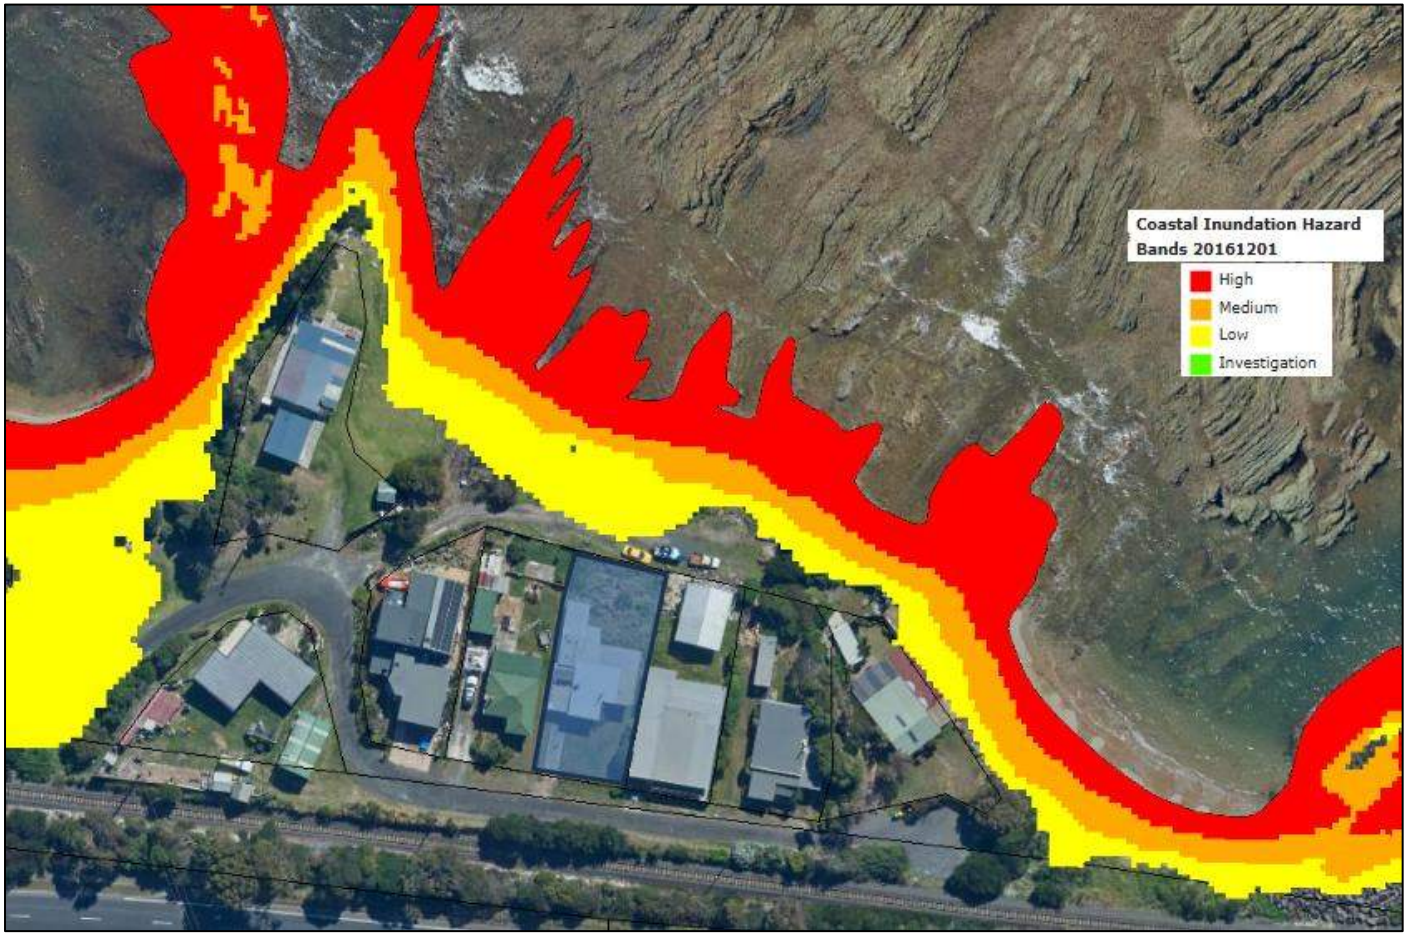
Figure 23. (Below) Coastal Projected Storm Tide overlay near site.

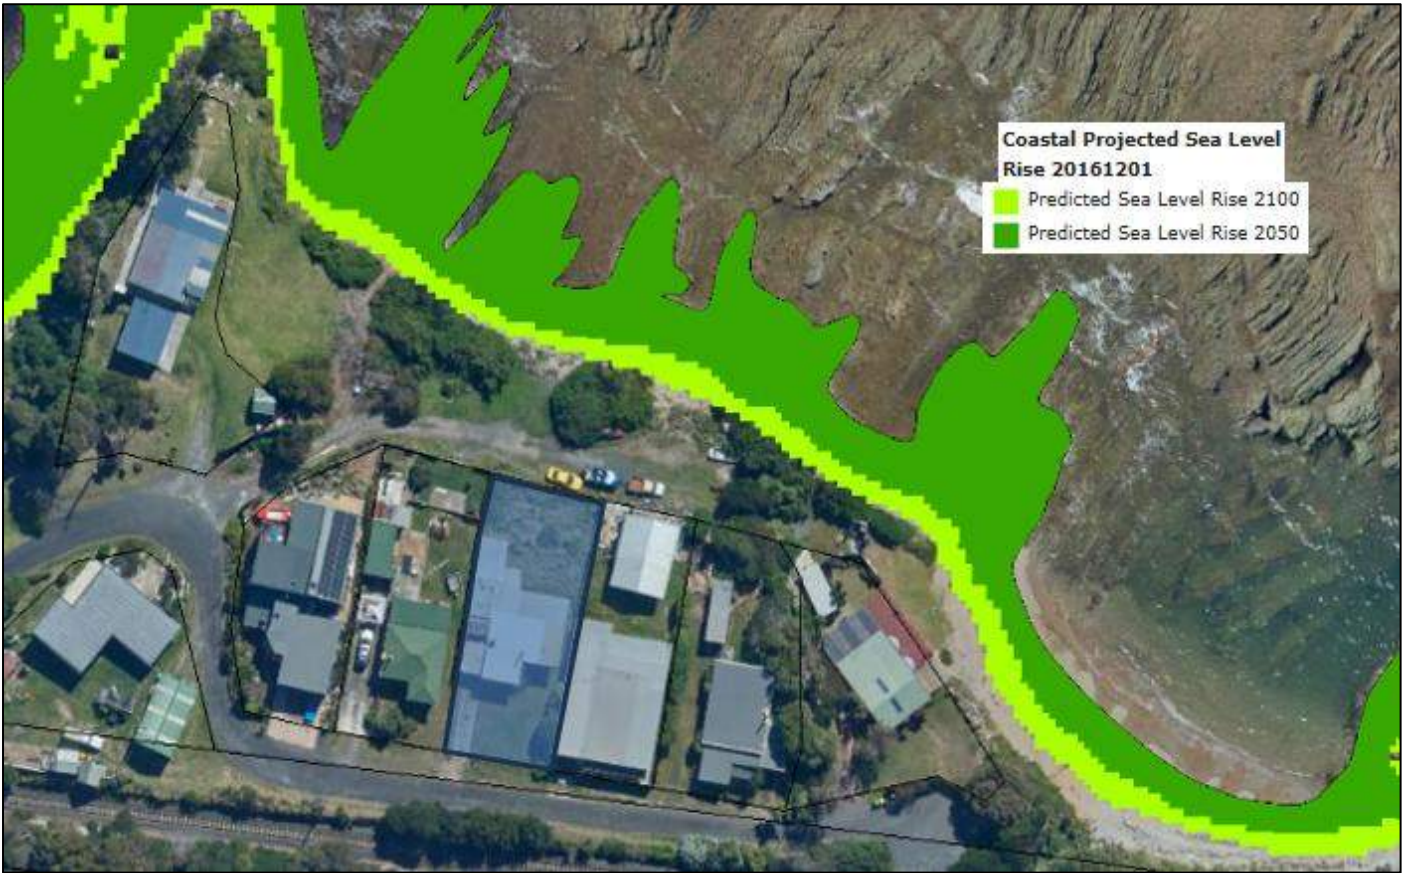
Figure 25. (Below) Storm bite High hazard zone apparent within footprint of proposed decking expansion.
