## Application for Planning

### *S.57 Land Use Planning and Approvals Act 1993*

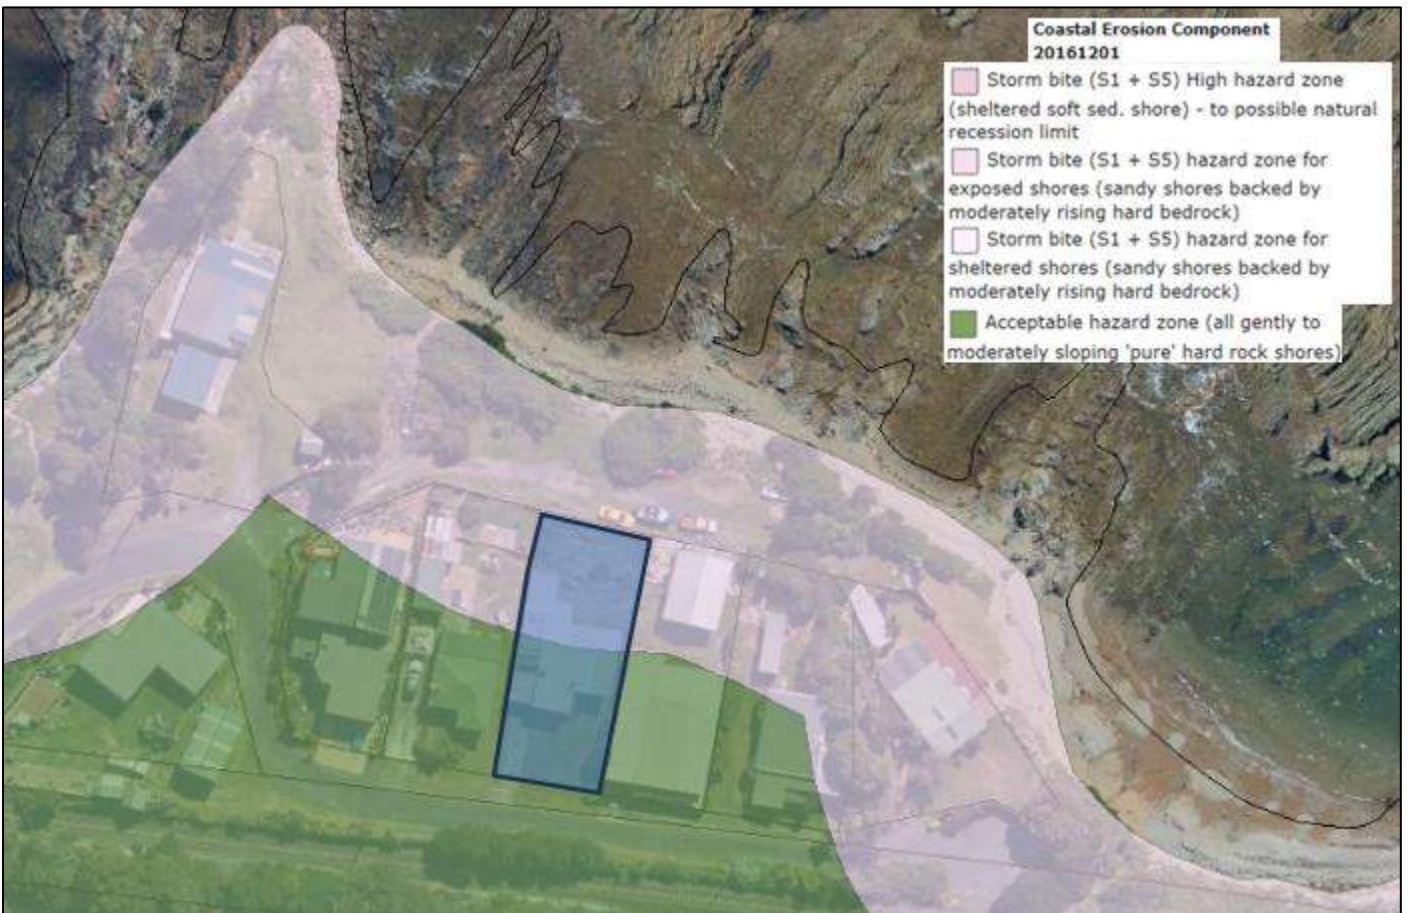
## HOTMANN SERVICES PTY LTD

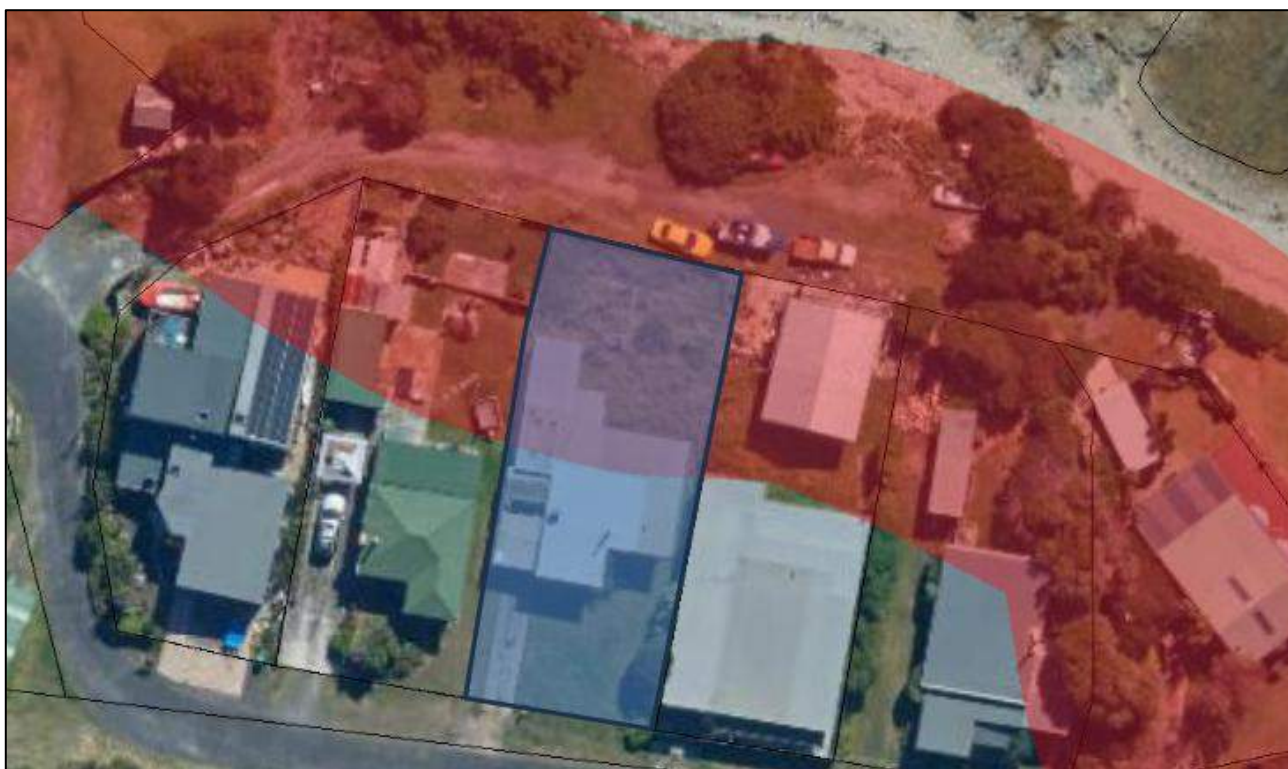
Figure 27. Excerpt from "APPLYING THE TASMANIAN COASTAL EROSION HAZARD CODE TO DEVELOPMENT APPLICATIONS"

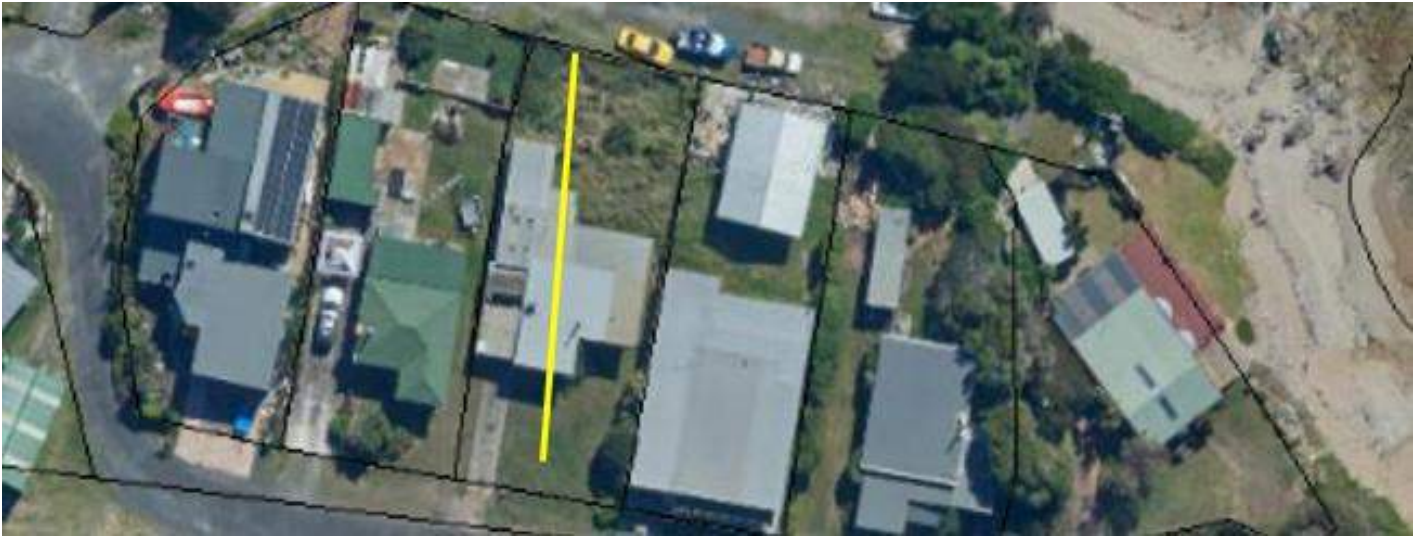
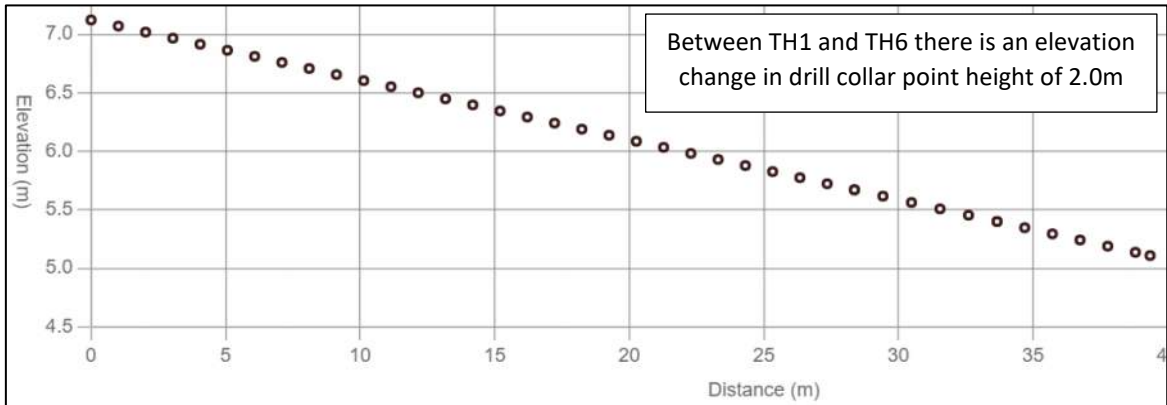
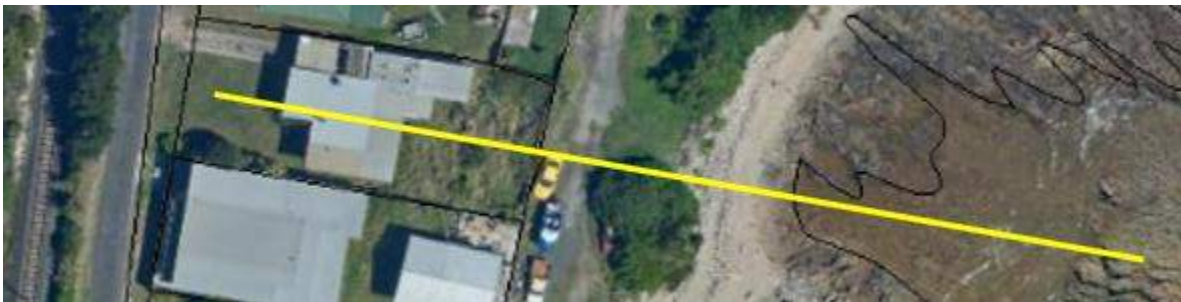
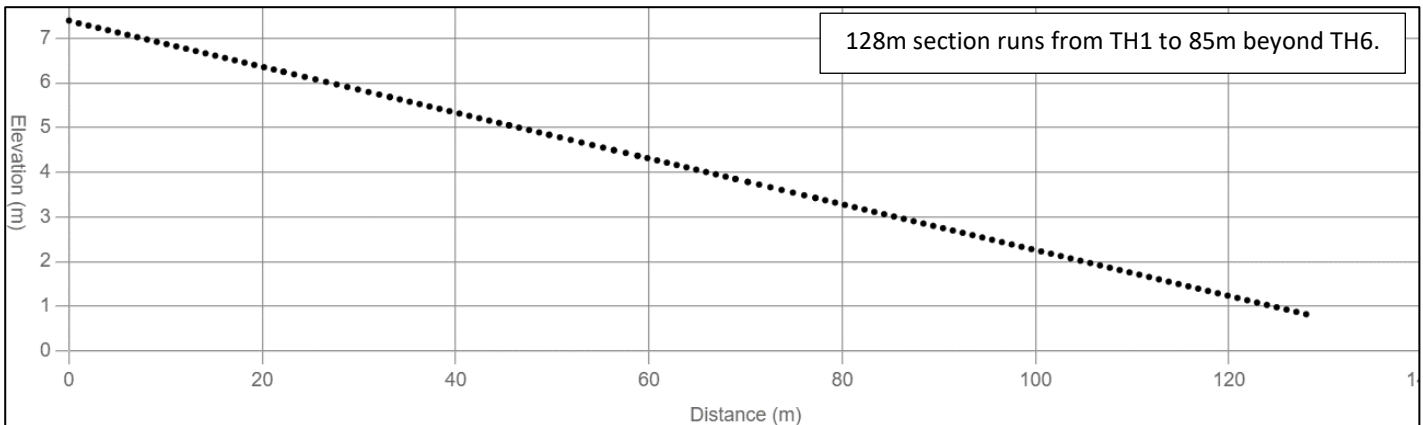
### Essential performance criteria

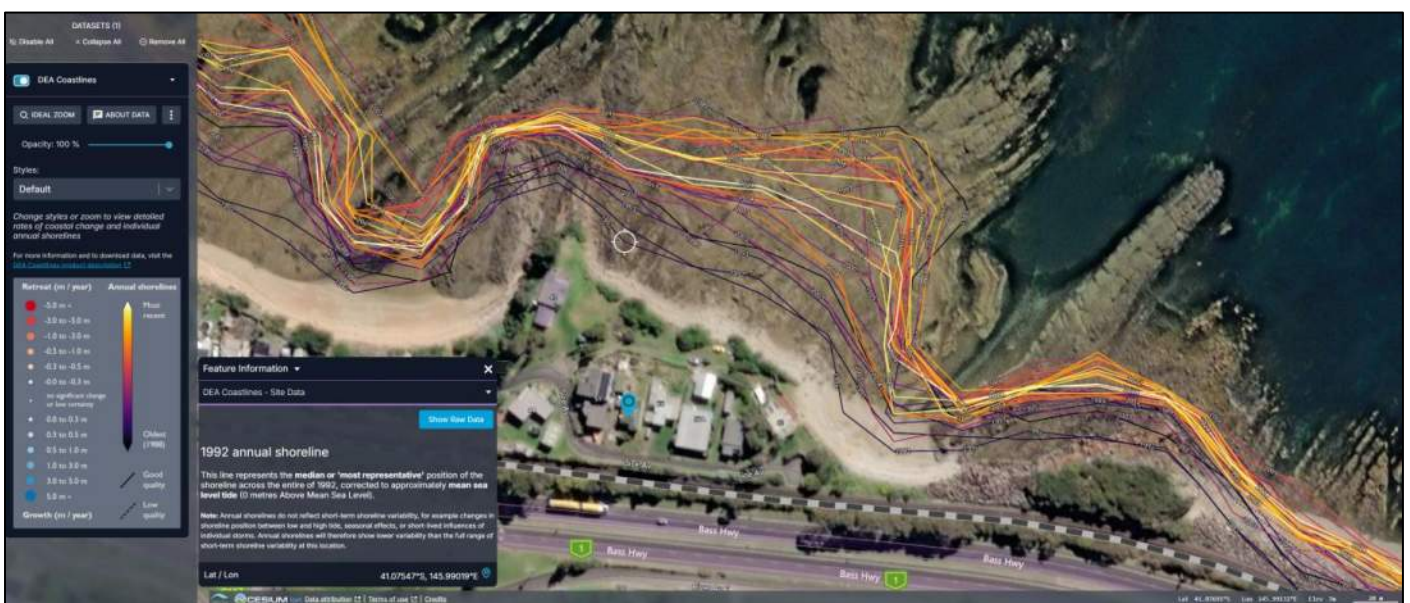
## HOTMANN SERVICES PTY LTD

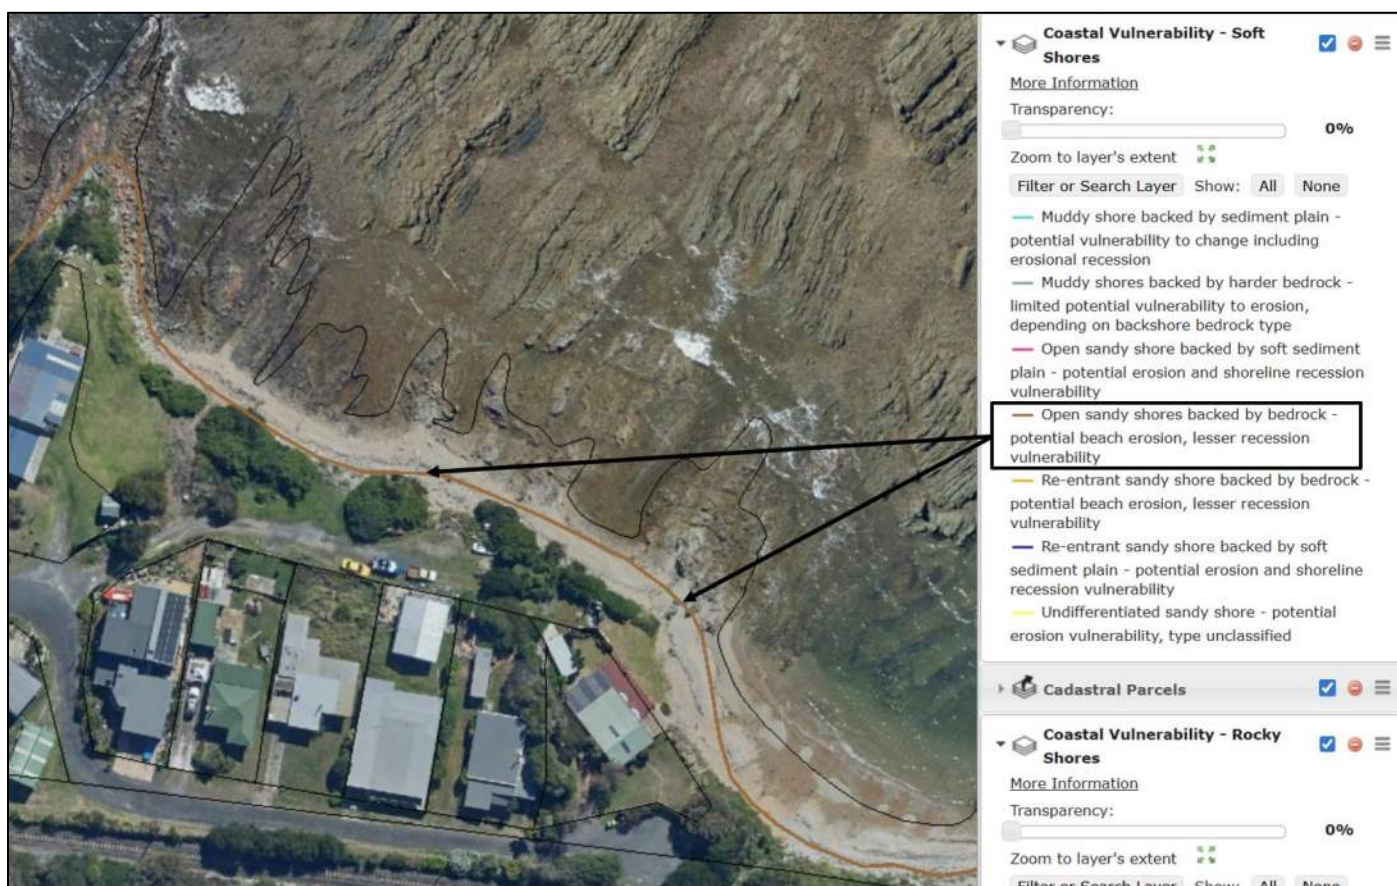
A methodology for defining susceptibility of shores to erosion is outlined in "Coastal erosion susceptibility zone mapping for hazard band definition in Tasmania" report for the DPAC (Sharples et al., 2013). In this report Sharples et al describe in detail that among the most fundamental characteristics that define erosion susceptibility is the inherent "erodibility" of the geology, with a categorisation between soft sediment, soft-rock, and hard-rock shorelines defined. Sharples (2013) refines these 3 categories are further by four erosion susceptibility zones as follows:

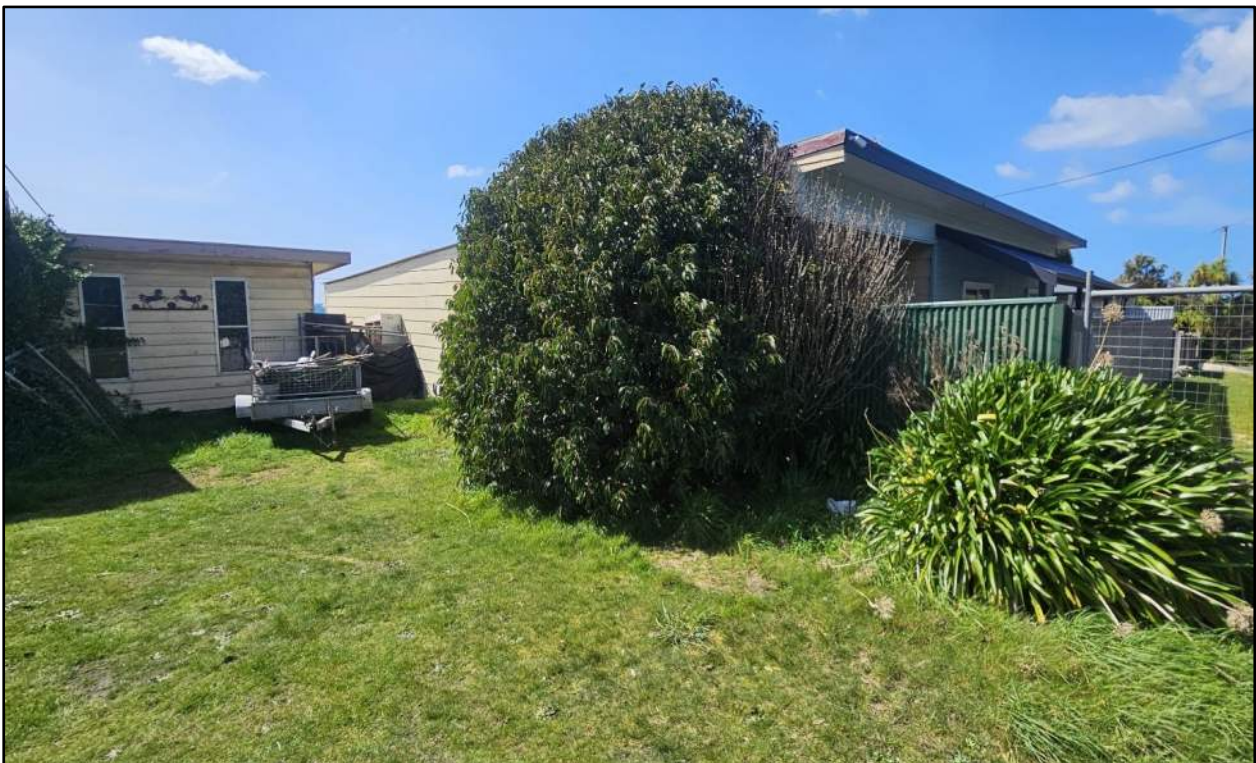
**Photo 2:** The introduced ornamental vegetation growing in the front yard. Facing NE, M.Rose, 24/09/25.

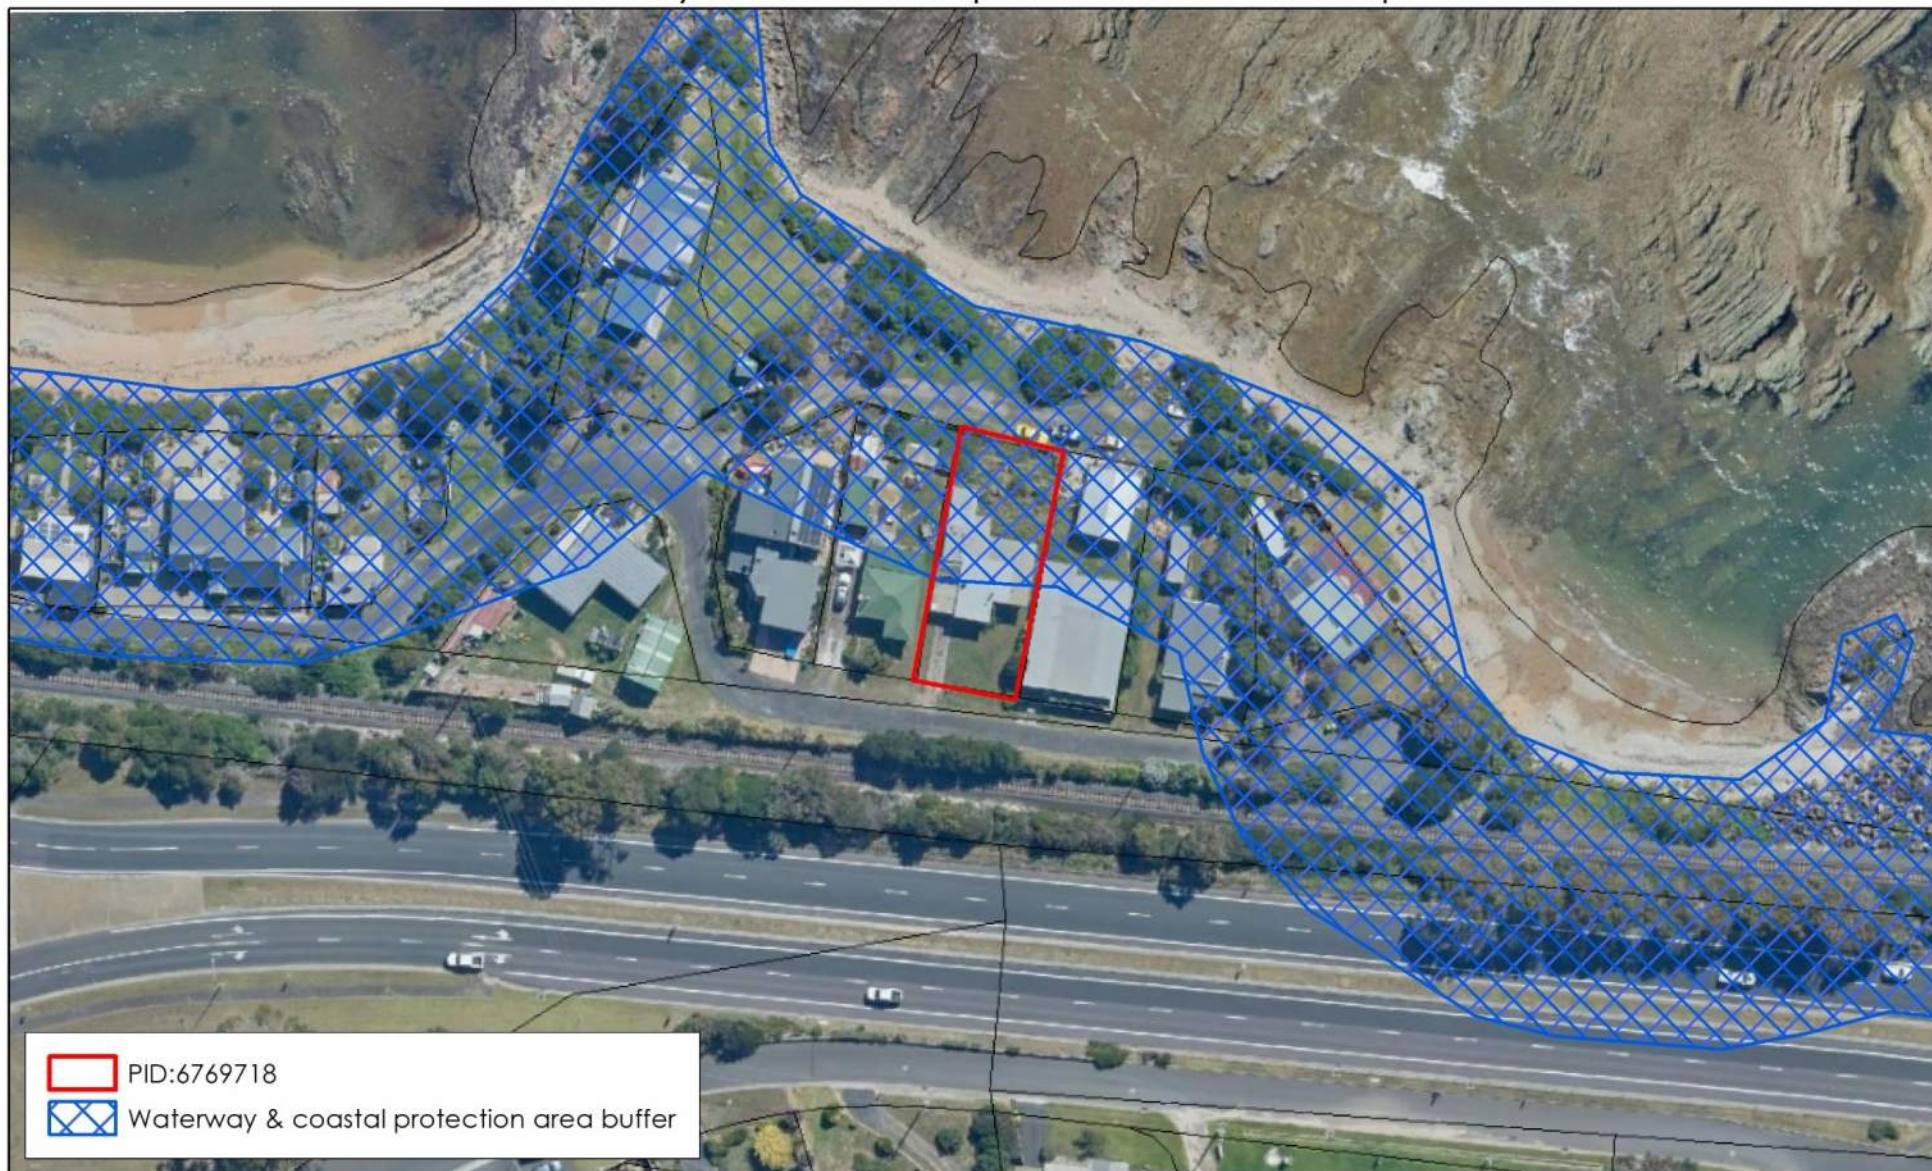
Project: Natural assets code assessment	Drawn by: Matt Rose	  <p>NATURAL STATE PO Box 139, Ulverstone TAS 7315 Mobile: 0437 971 144 E: matt@naturalstate.com.au www.naturalstate.com.au</p>	<p>Acknowledgements: Raster Data : Base image Copyright State of Tasmania. Vector Data : Copyright State of Tasmania &amp; Natural State.</p>   <p>Scale 1:1,000</p>	 
Client: Sui Yu	Date: 25/09/2025

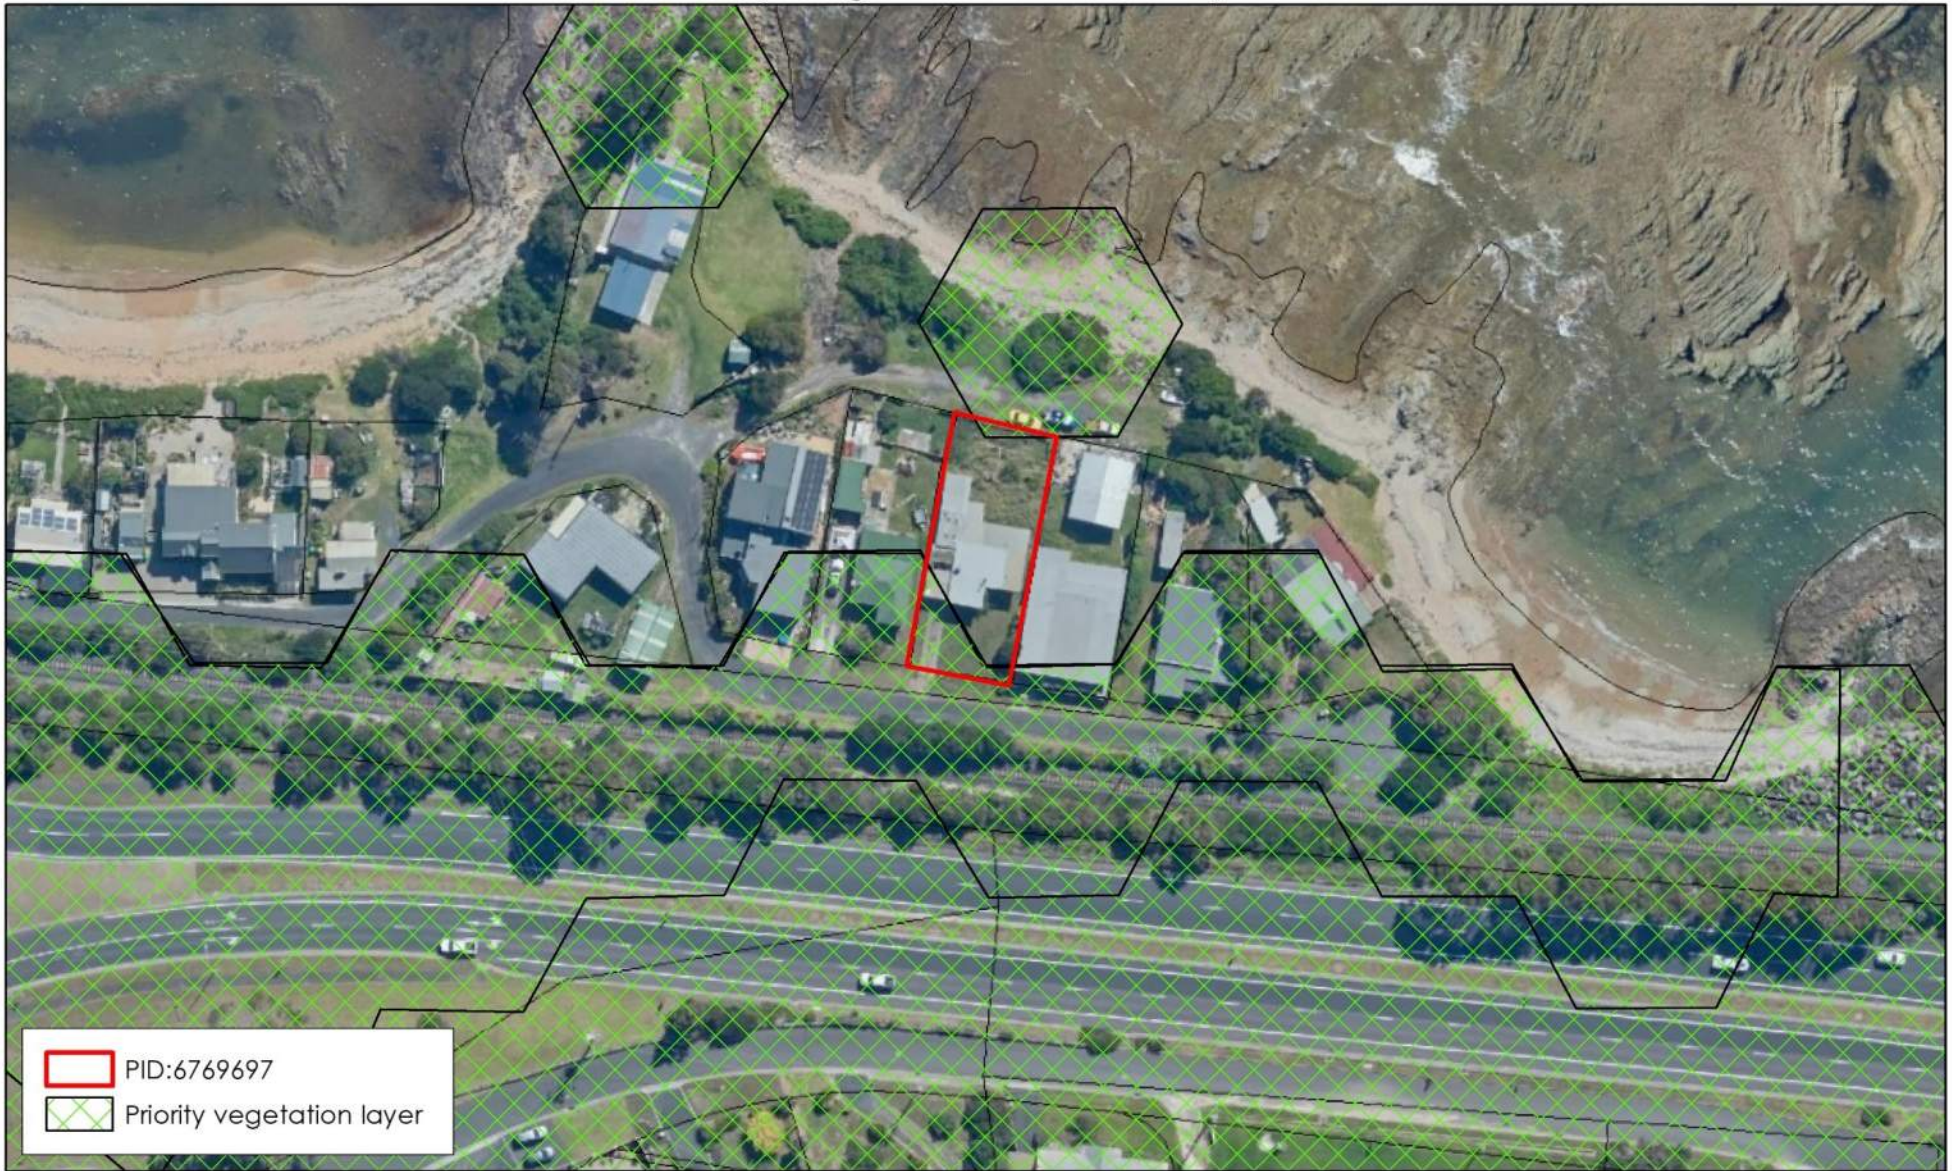
Project: Natural assets code assessment	Drawn by: Matt Rose	 	NATURAL STATE PO Box 139, Ulverstone TAS 7315 Mobile: 0437 971 144 E: matt@naturalstate.com.au www.naturalstate.com.au	Acknowledgements: Raster Data : Base image Copyright State of Tasmania. Vector Data : Copyright State of Tasmania & Natural State.	 
Client: Sui Yu	Date: 25/09/2025
