APPLICATION FOR PLANNING PERMIT

Application Number:	PA2025.0188
Proposed Use or Development:	Educational and Occasional Care – construction of a new early learning and childcare building, including demolition of the existing building.
Address of the Land:	19-21 Thomas Street, East Devonport
Date of Notice:	10/01/2026

GEOTECHNICAL INVESTIGATION

'East Devonport Primary School' 19-21
Thomas Street, East Devonport

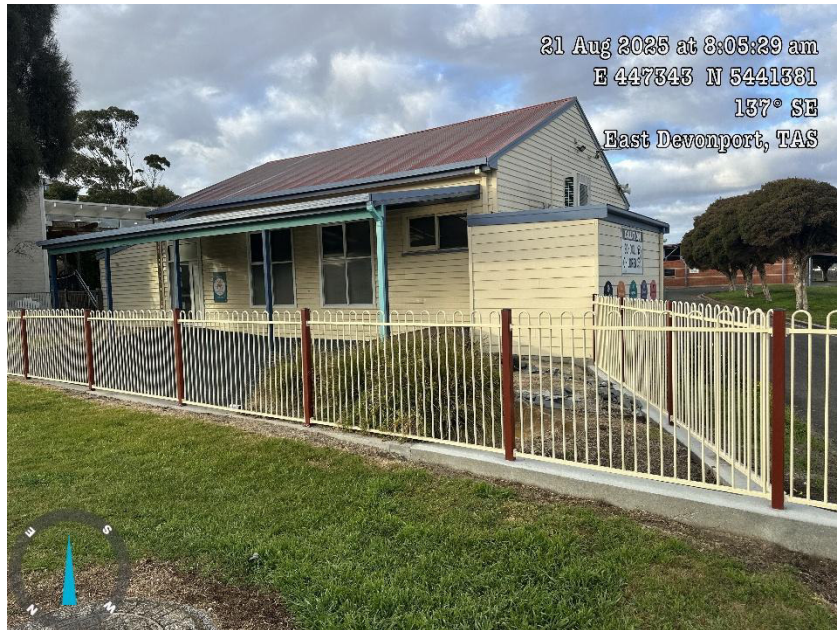
Plate 1 – View of the Early Learning Facility looking towards the southeast, 21.08.2025

The site is currently developed with school buildings and facilities. The proposed development area is situated in the northeastern portion of the site and is currently developed with an early learning facility.

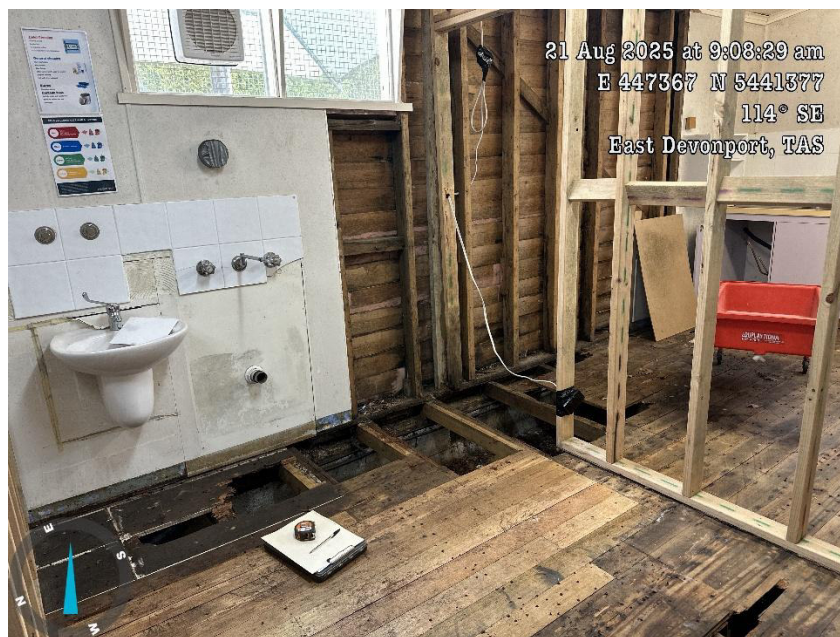
Plate 2 – View of Borehole BH2 location inside the early learning building, 21.08.2025

Boreholes BH1 and BH2 encountered a mix fill of sand, clayey silt and silty gravel to the depths of 0.8m to 0.9m, underlain by high plasticity silty clay to the investigated or refusal depths of 1.3m to 1.8m.

Borehole BH1 did not encounter any signs of groundwater seepage over the investigated depth. However, Borehole BH2 encountered surface water ponding over very low permeable, high-plasticity clay at 0.4m.

Auger refusal within Borehole BH2 was inferred to be due to backfill cobbles falling into the borehole.

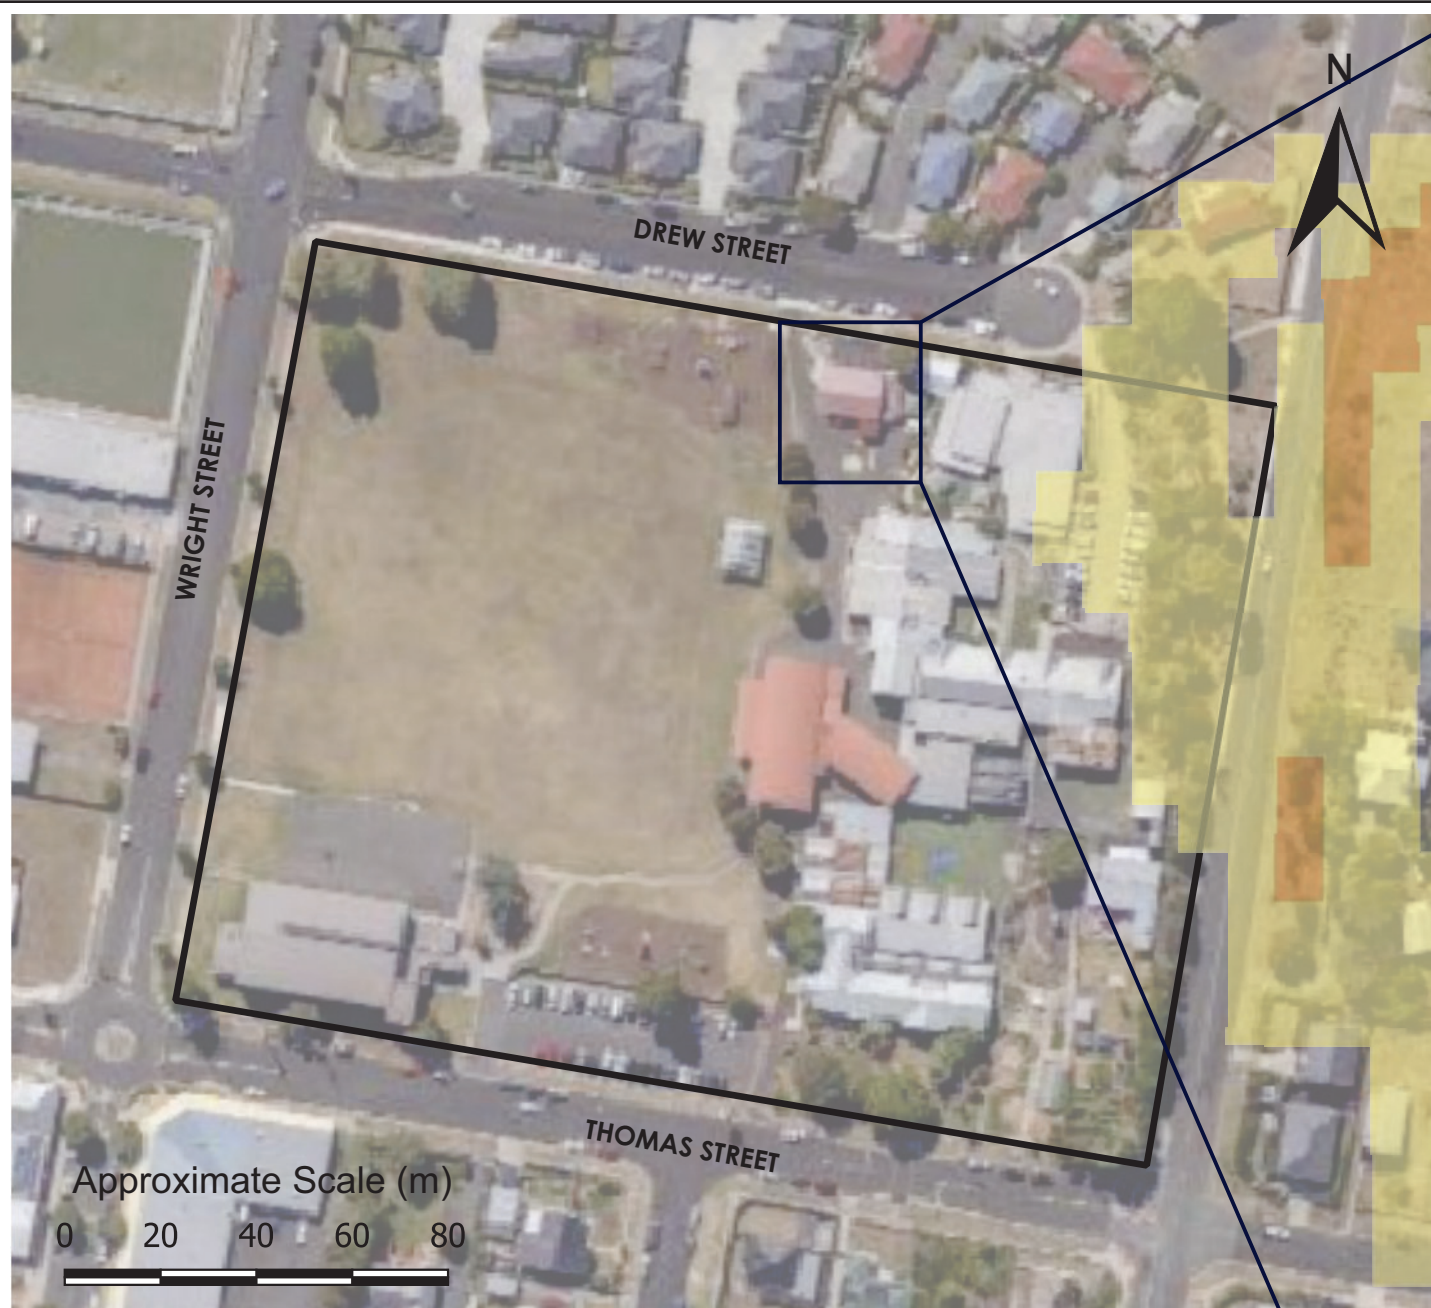
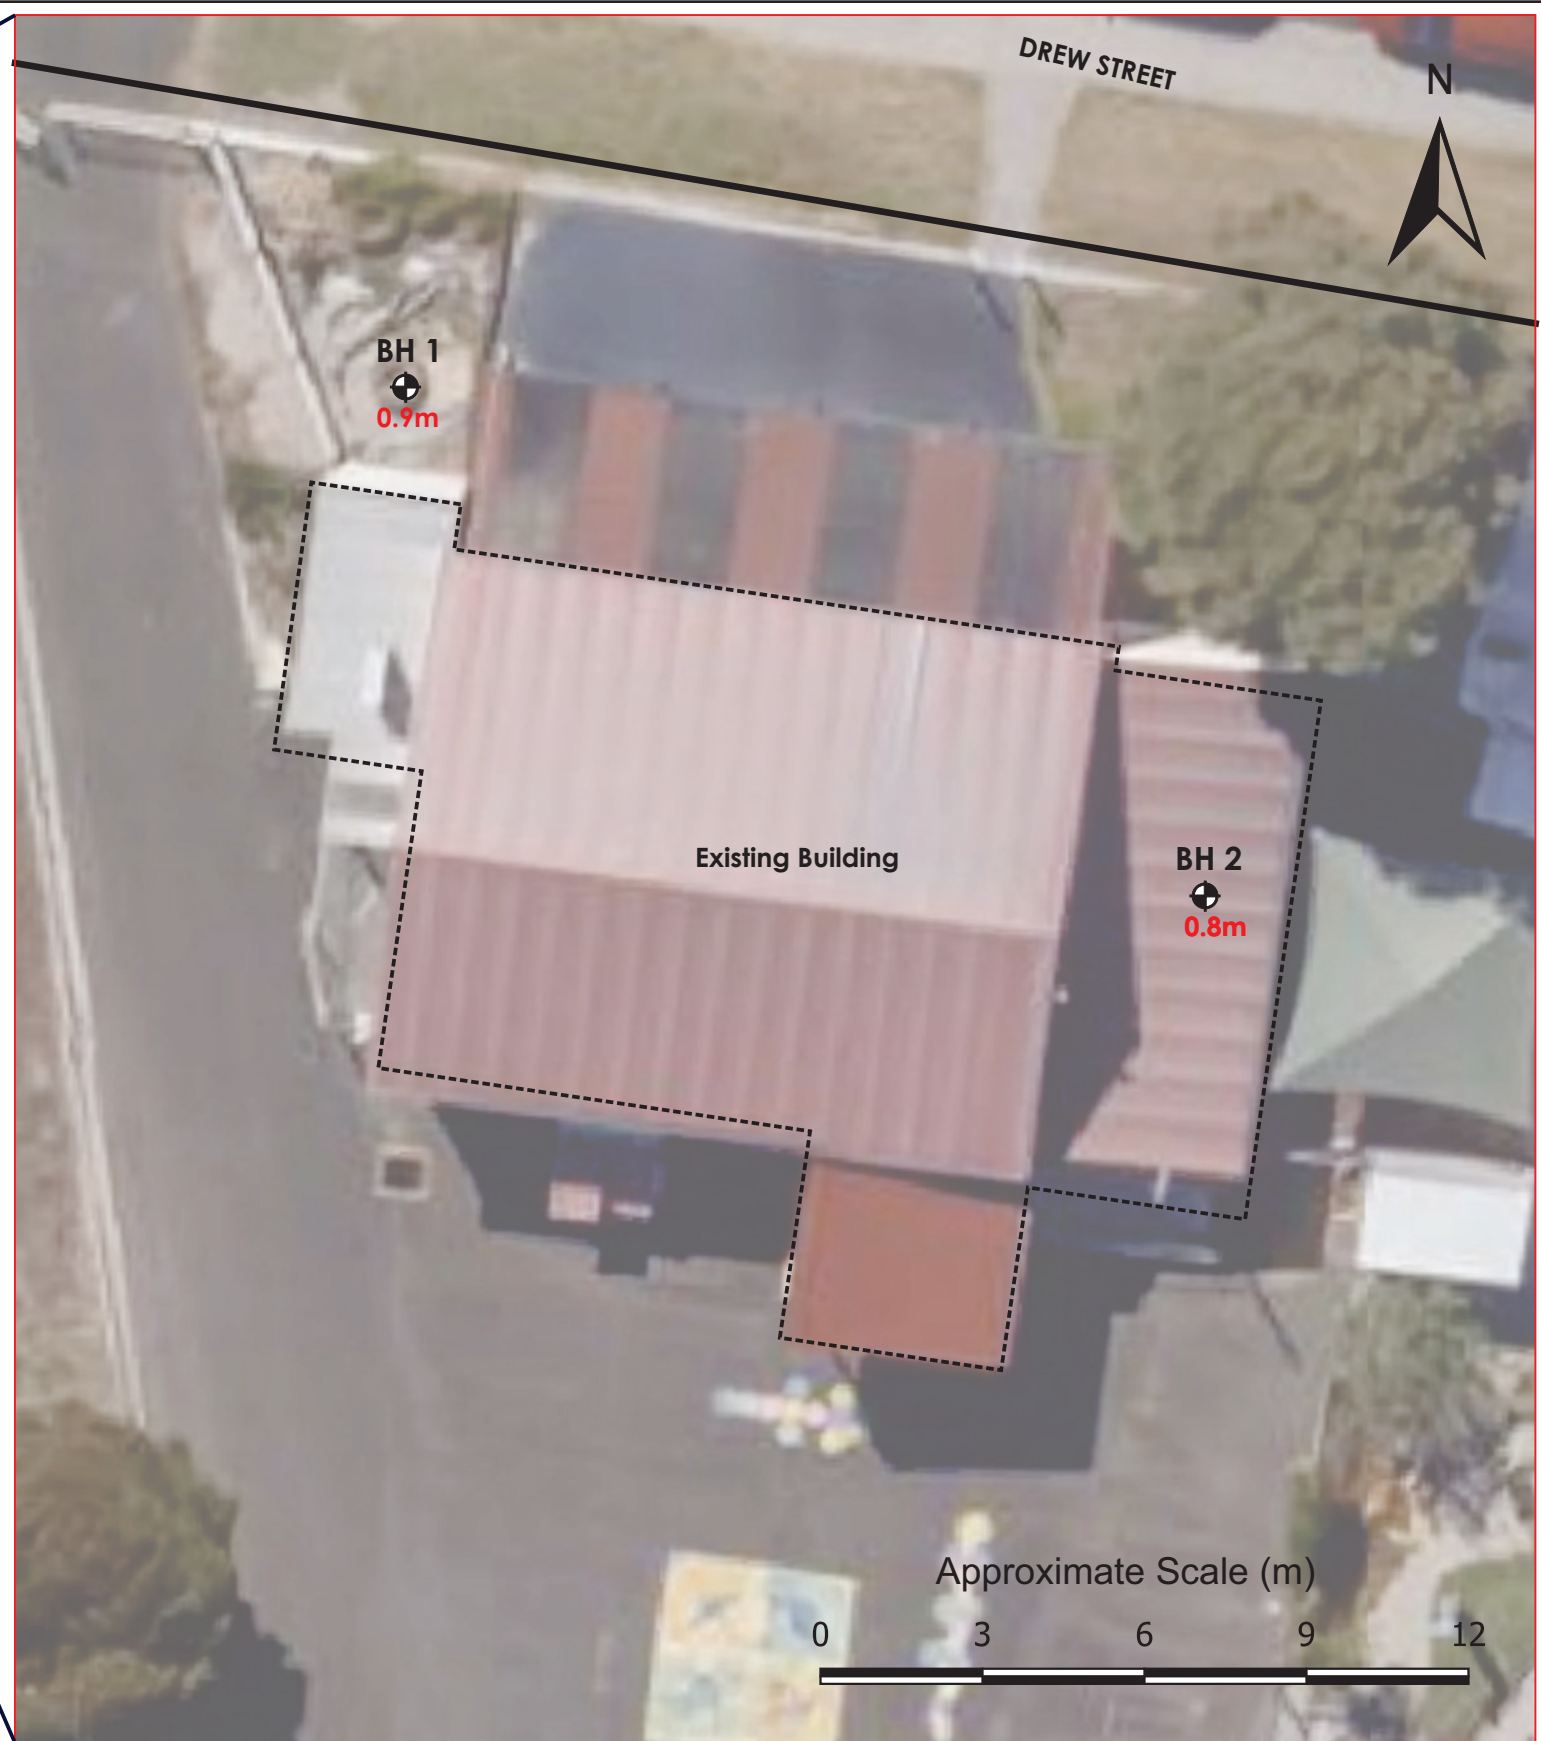
Drawing 1: Site Plan

Examination of the LIST Landslide Planning Map – Hazard Bands Overlay indicates that the proposed development area is not within a mapped landslide hazard area. However, a small portion of the site is mapped as low landslide hazard band. (see Drawing 1 – Site Plan)

The logs of the boreholes are included in Appendix A and their locations are shown on Drawing 1 attached.

We understand that the proposed development involves replacing a section of damaged floorboards in the Early Learning Facility, located in the northeast corner of the site (see Drawing 1 – Site Plan).

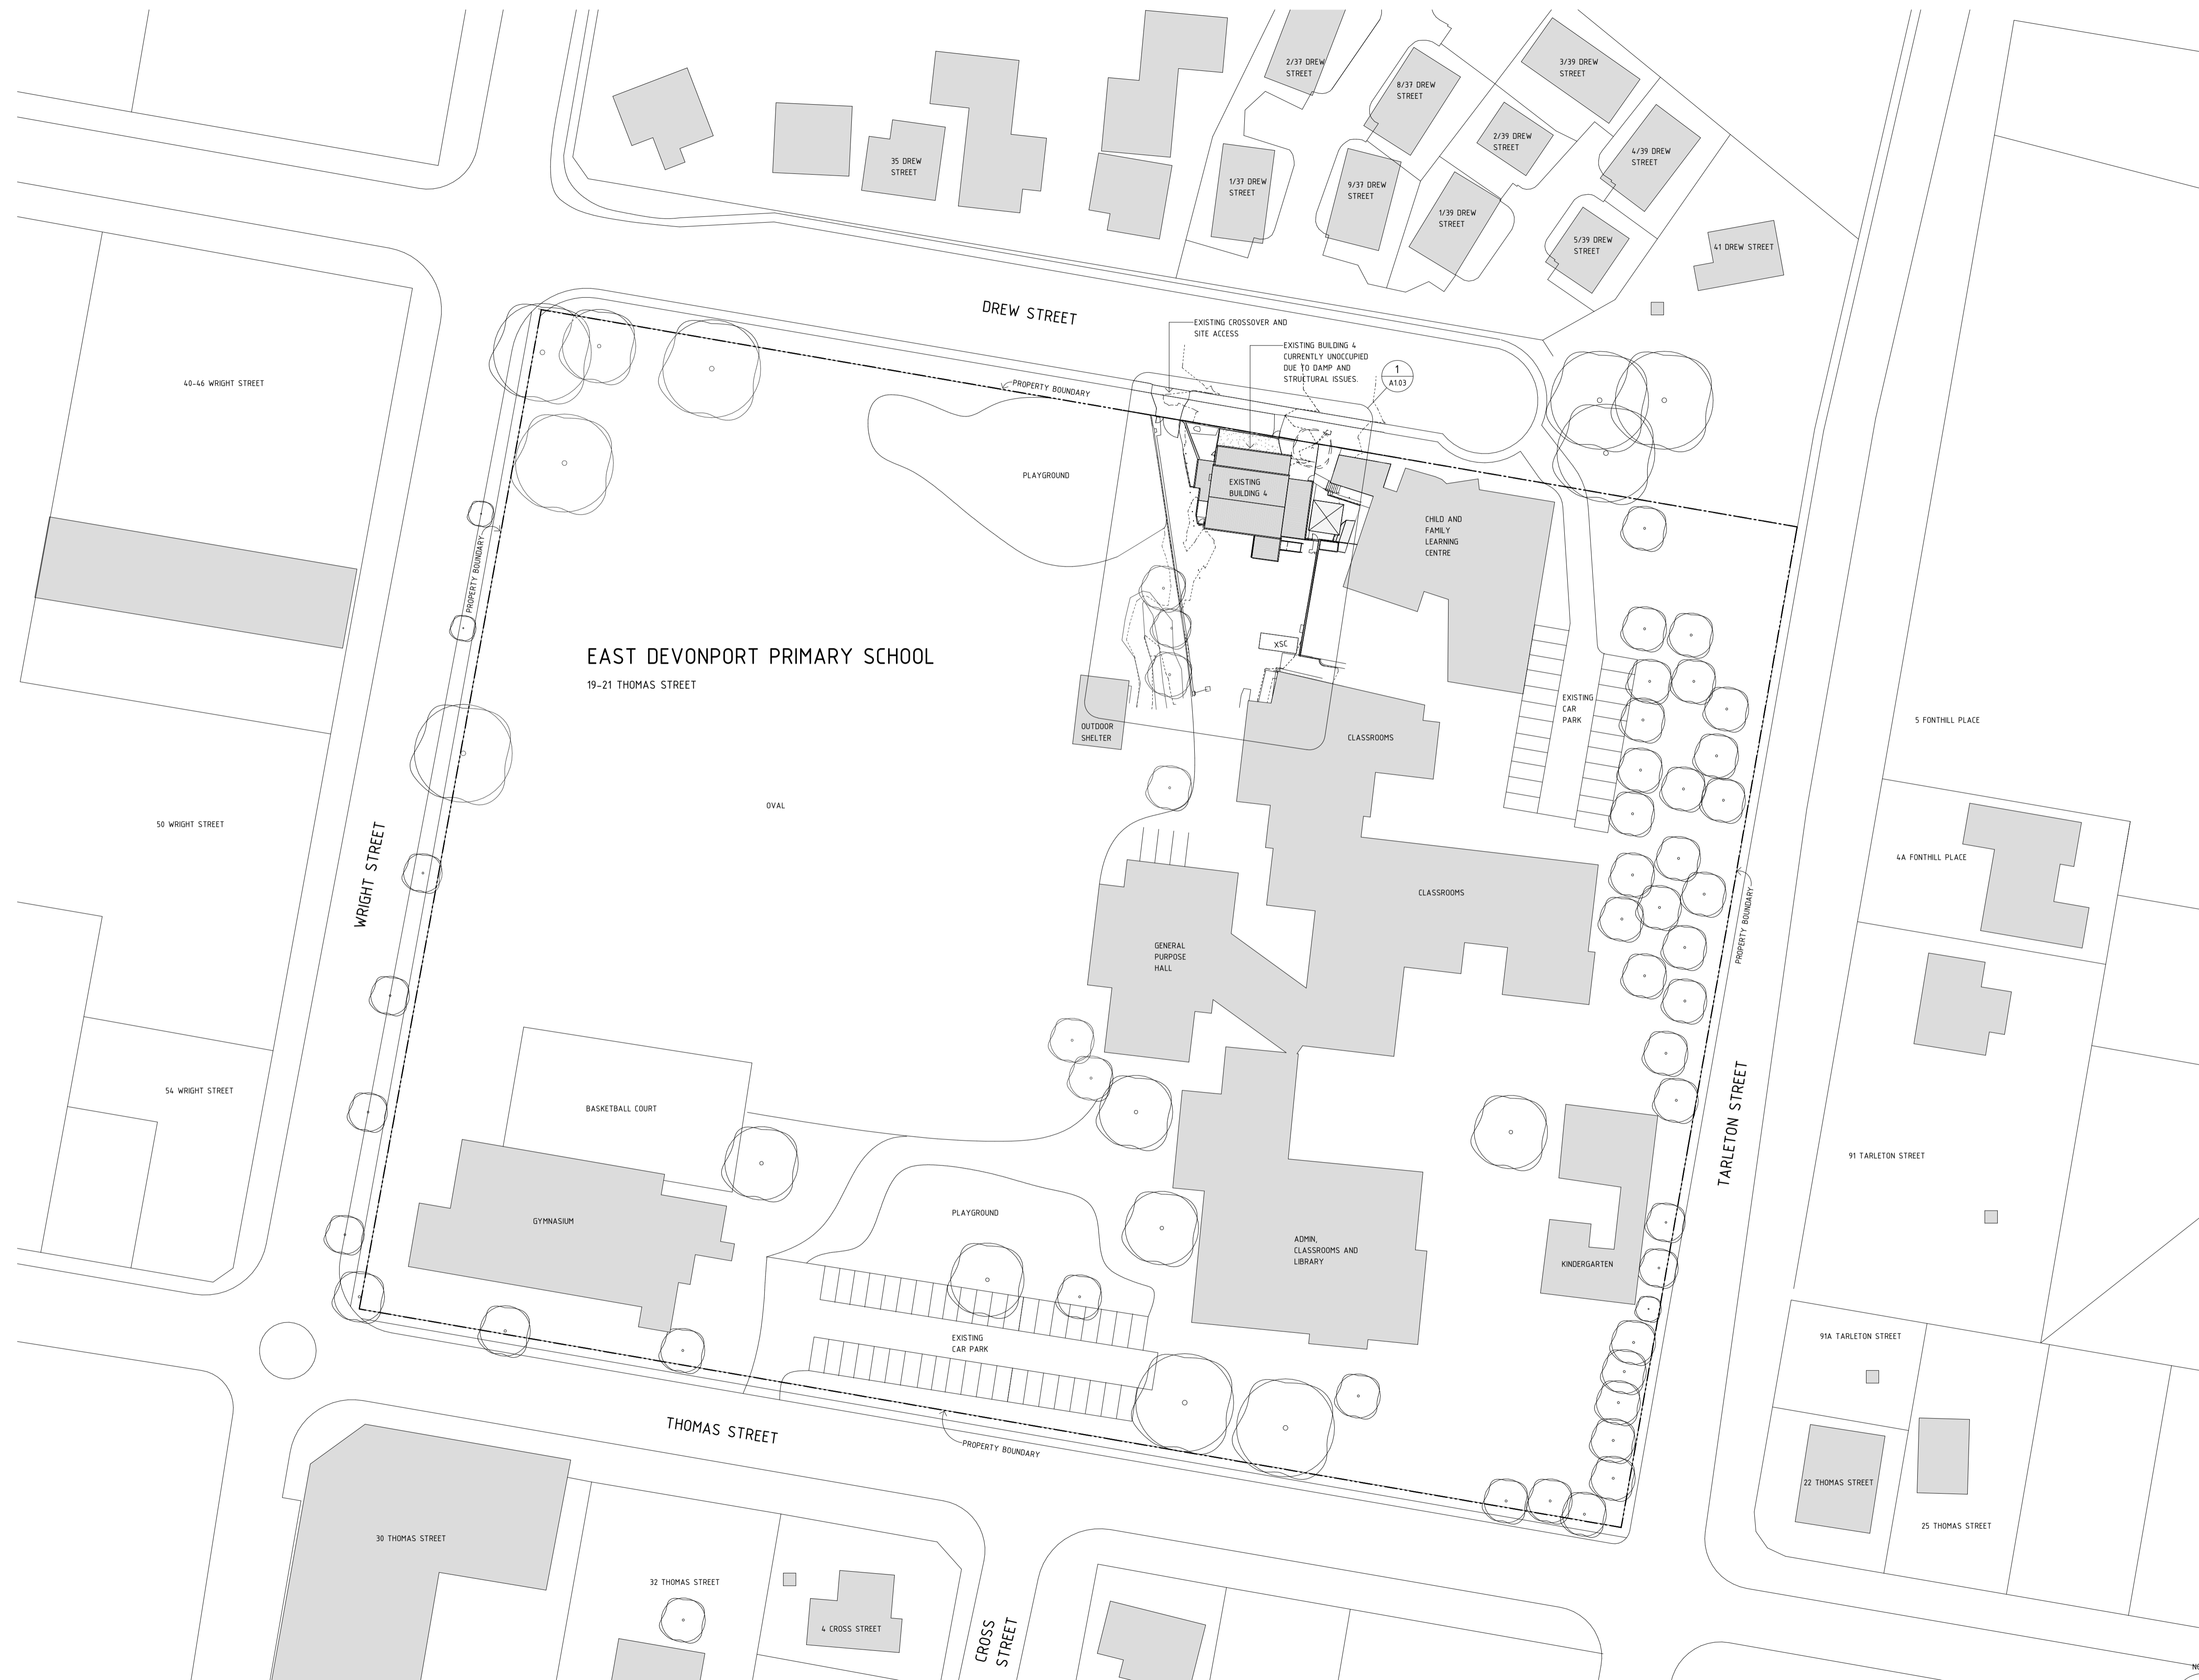
1 EXISTING SITE PLAN
1:500

project DECYP EAST DEVONPORT PRIMARY SCHOOL - EL3 BUILDING
client DEPARTMENT FOR EDUCATION AND YOUNG PEOPLE
address 19-21 THOMAS STREET, EAST DEVONPORT TAS 7310
code 2411
drawing EXISTING SITE PLAN
scale 1:500 @ A1
number
