## PLANNING NOTICE

APPLICANT:	<b>C Everard – PA\25\0102</b>
PROPERTY ADDRESS:	<b>Reiffers Road MEANDER (CT: 211176/45)</b>
DEVELOPMENT:	<b>Level 2 Activity - Extractive Industry (Quarry) Intensification - discretionary use, karst management area</b>

ENVIRONMENTAL EFFECTS REPORT  
**GR and AM Whiteley**

## **Meander Shale Quarry Intensification**

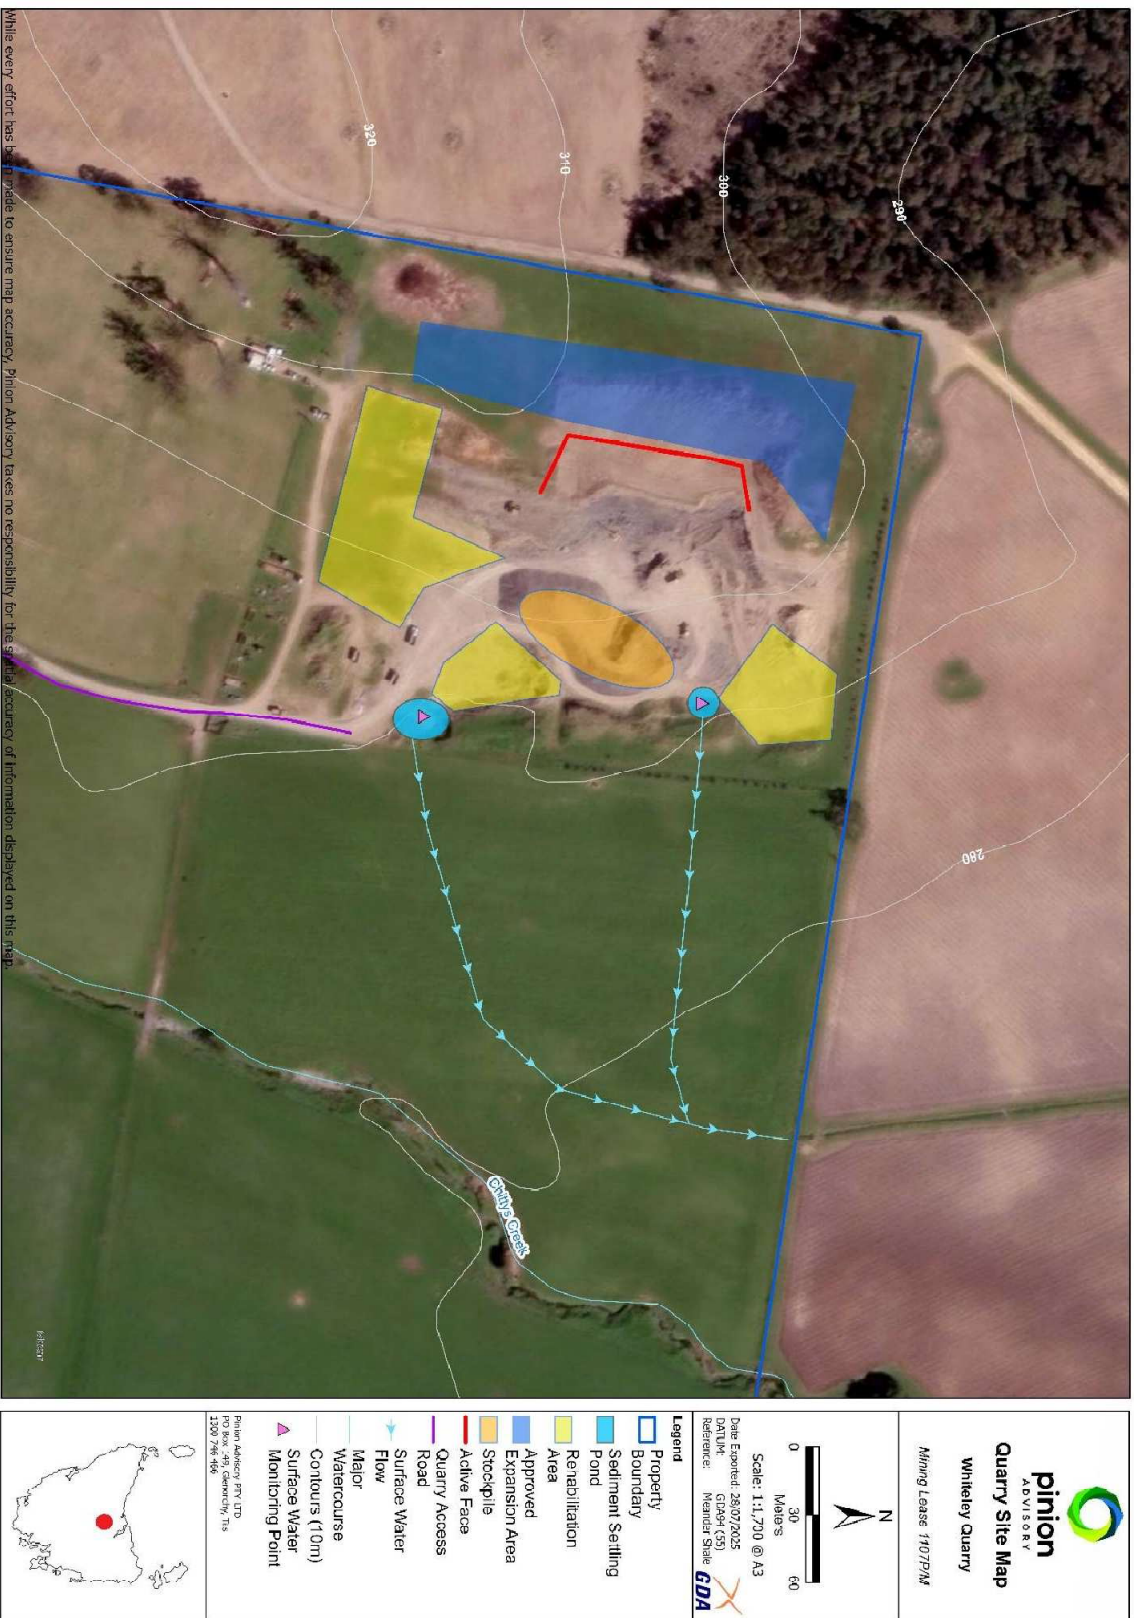
**Figure 4. Site layout plan showing active quarry face in red, approved expansion area in blue and rehabilitated areas in yellow.**  
Aerial Image source: Esri, DigitalGlobe, GeoEye, i-cubed, USDA FSA, USGS, AEX, Getmapping, Aerogrid, IGN, IGP, swisstopo and the GIS User Community (2025).

No threatened native vegetation communities are present within the quarry site or proposed expansion area (Figure 4). One threatened community was identified within one kilometre of the site. The NVA noted some small and isolated patches of the threatened community *Eucalyptus ovata* forest and woodland (DOV), situated approximately 150m – 300m south of the active quarry area (Appendix 1). These were visited during the site visit and found to be isolated trees dominated by other *Eucalyptus* species. The proposed project will not impact these isolated vegetation communities. The NVA also identified some remnant patches of DOV dispersed throughout the landscape (as shown in Appendix 1). These isolated vegetation communities will not be impacted by the project.

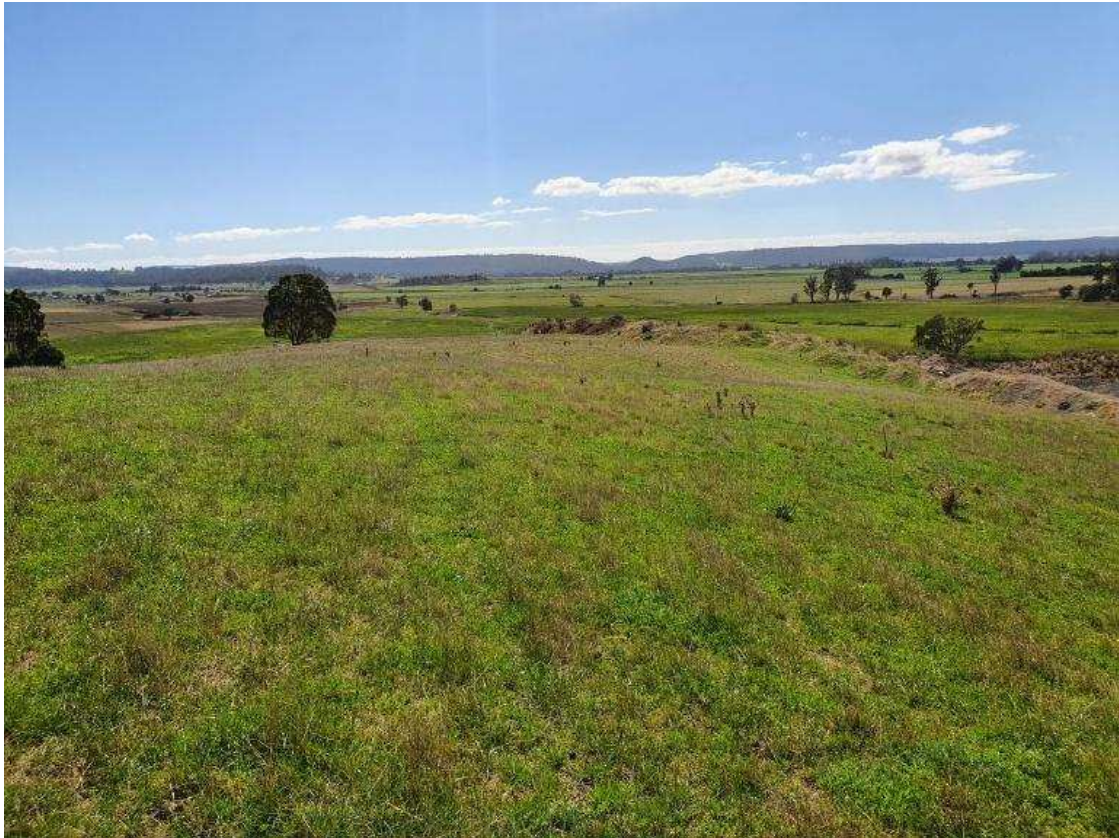
Figure 9. Approved expansion area (facing north), quarry to progress from right (active quarry area) to left.

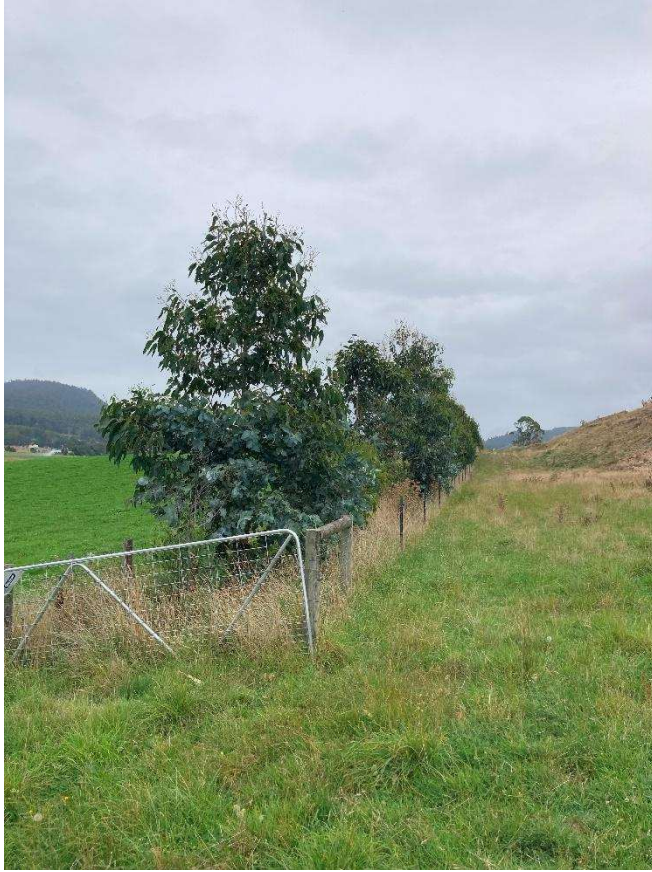
Figure 11. Shelter belt of blue gum and blackwood planted in 2021, located along the northern and eastern boundaries of the quarry

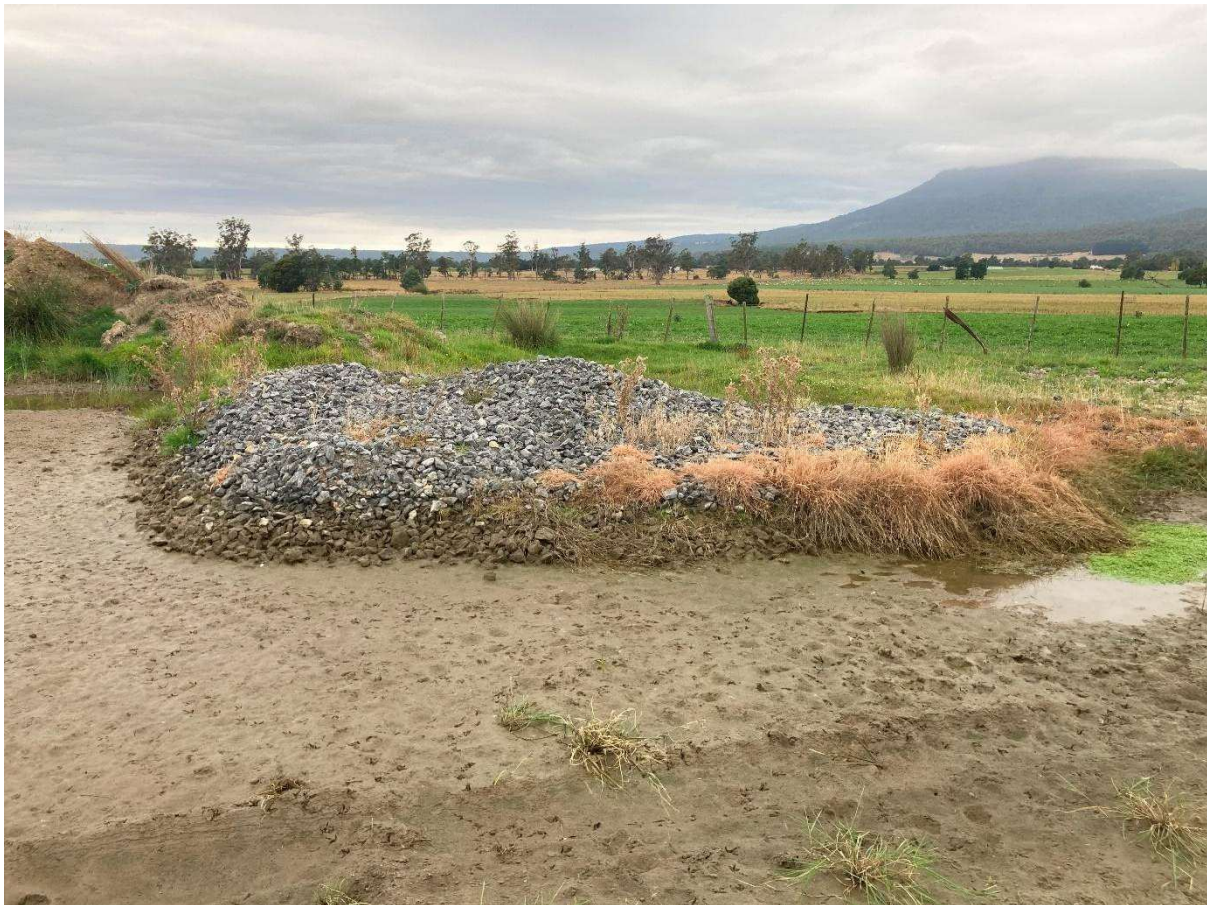
Figure 12. Sediment settling pond with limestone barrier and discharge across pasture paddock in background (March 2025).

The settling ponds are cleaned out on a regular basis (when conditions are dry), to maintain their capacity to settle sediment and ensure maximum retention volume.

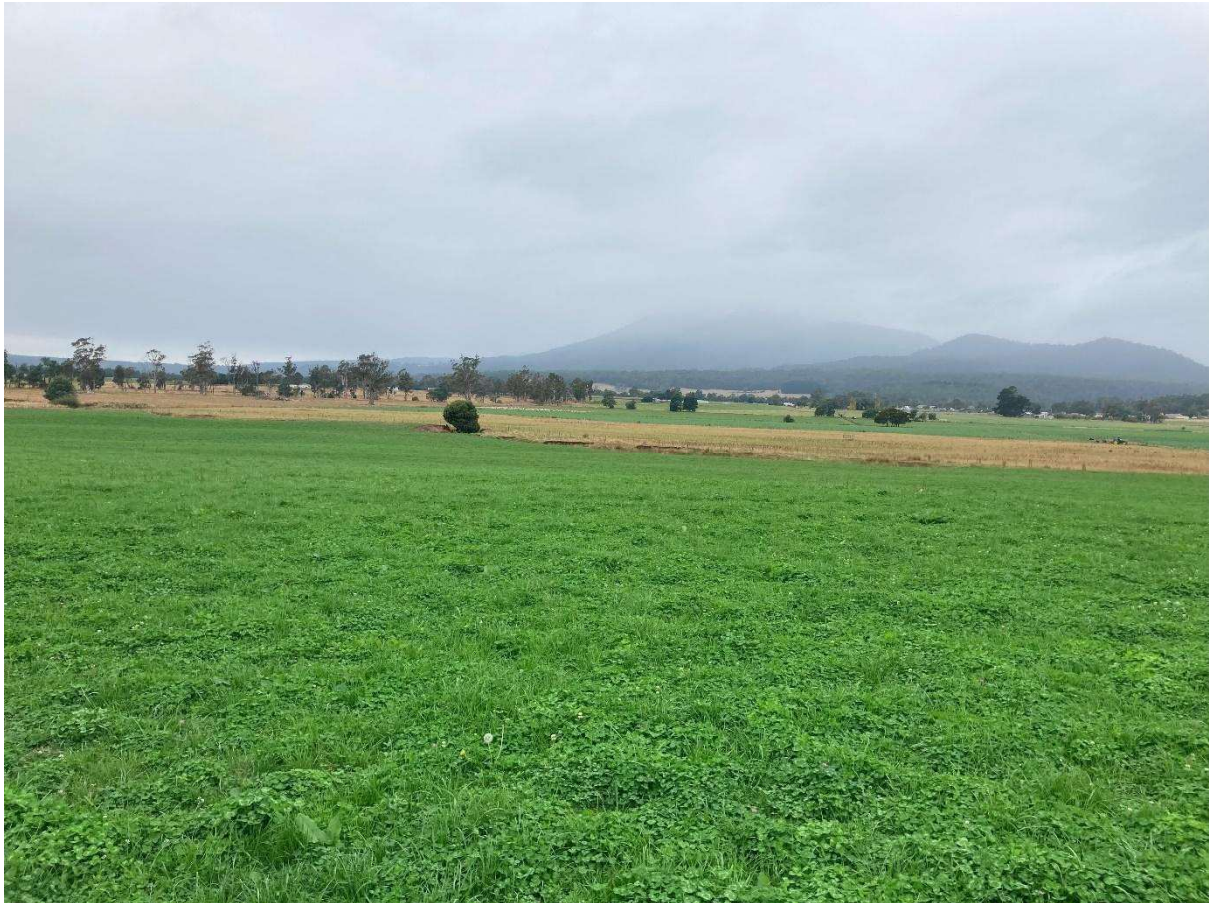
Figure 13. Water distribution area after settling ponds. (March 2025).

The adjacent paddock/infiltration area contains perennial pasture that acts as an additional filter for any turbidity. During the winter period, stocking rates are reduced to minimise risk of soil pugging.

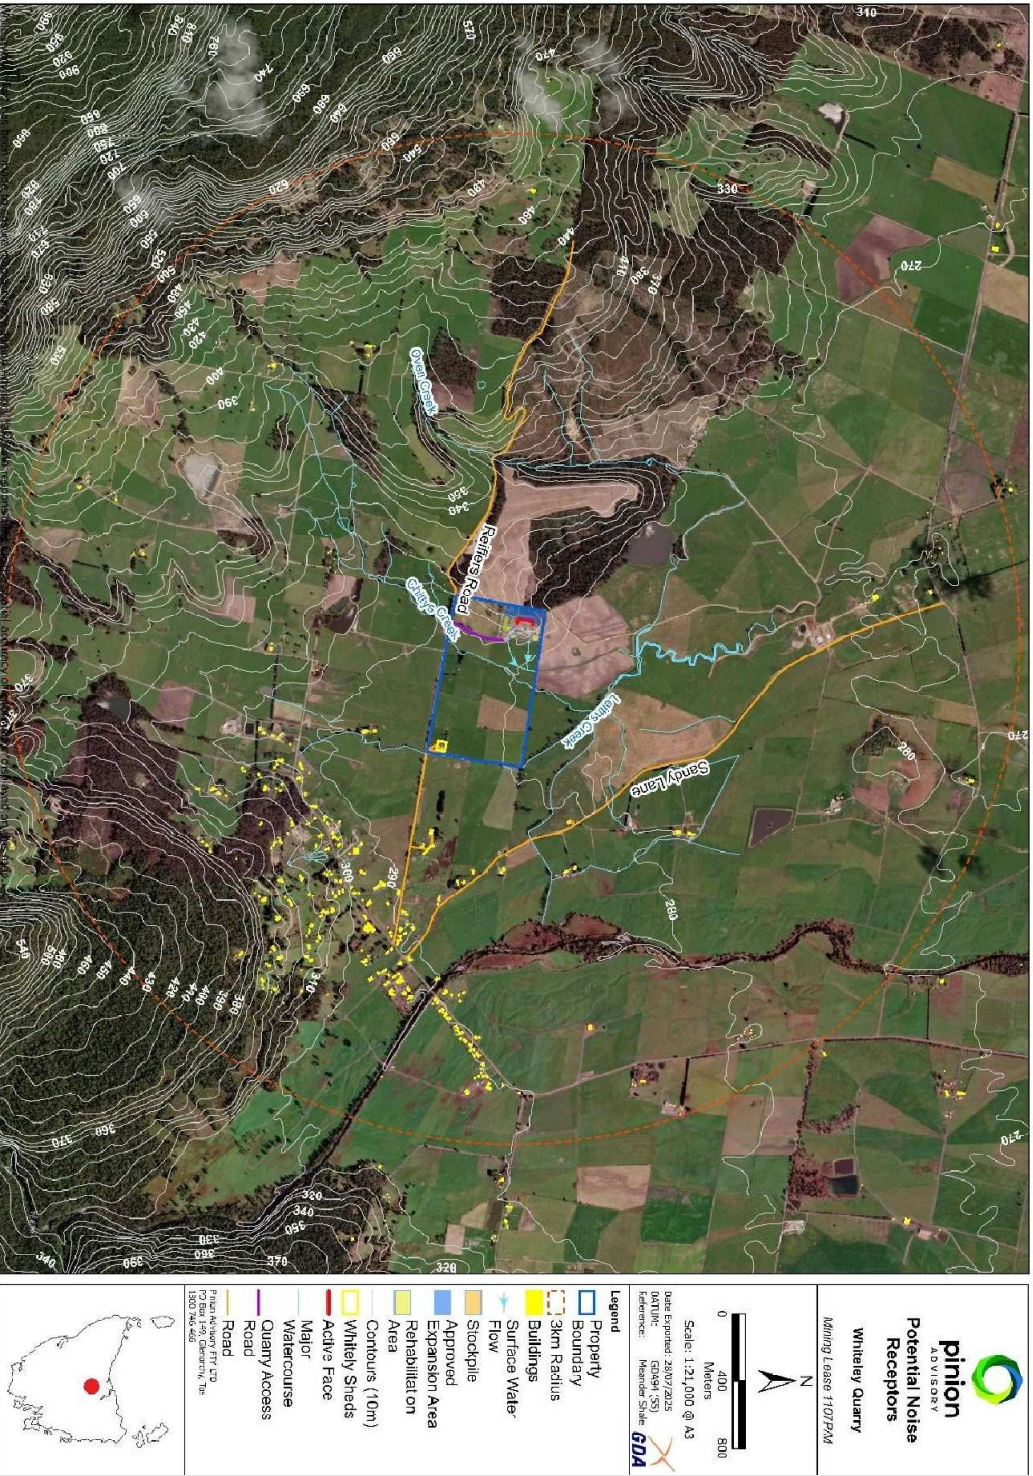
Figure 14. Potential noise receptors within 3km highlighted in yellow. The 3km radius is shown with a dotted red line and includes the entirety of the Meander township, where no noise complaints have been received in the operational lifetime of the quarry.

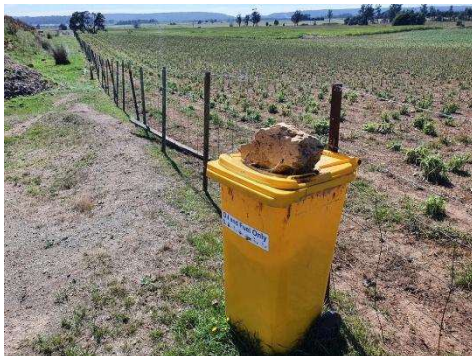
Figure 16. Hydrocarbon spill kit located at the entrance of the quarry.

Mitigation measures to avoid potential impacts include appropriate training for the filling of diesel fuel tanks, spill management and personal protective equipment (PPE). Any spill will be cleaned up immediately and recorded in a site register. A spill kit (located in a large plastic yellow wheelie bin, Figure 16) is situated at the entrance to the quarry to manage hydrocarbon type spills. All site personnel are aware of the location and how to correctly use the spill kit.

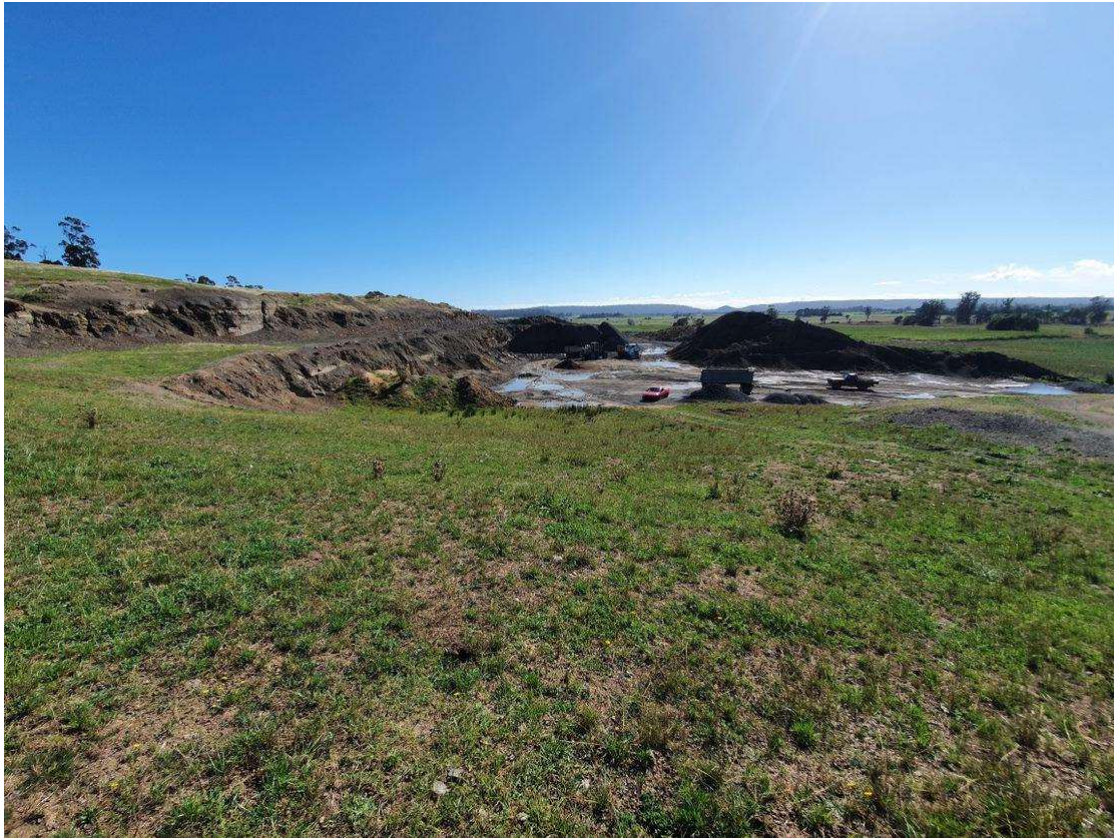
Figure 17. Rehabilitation of previously disturbed area (foreground) and active quarry area (background), facing north.

Areas of the site previously stripped for shale extraction have been rehabilitated where practical. In 2020, disturbed land located south of the active quarry area was recontoured and rehabilitated to grazing grassland using the in-situ over burden (refer to Figure 4 and Figure 17). In 2024, several more areas were rehabilitated.

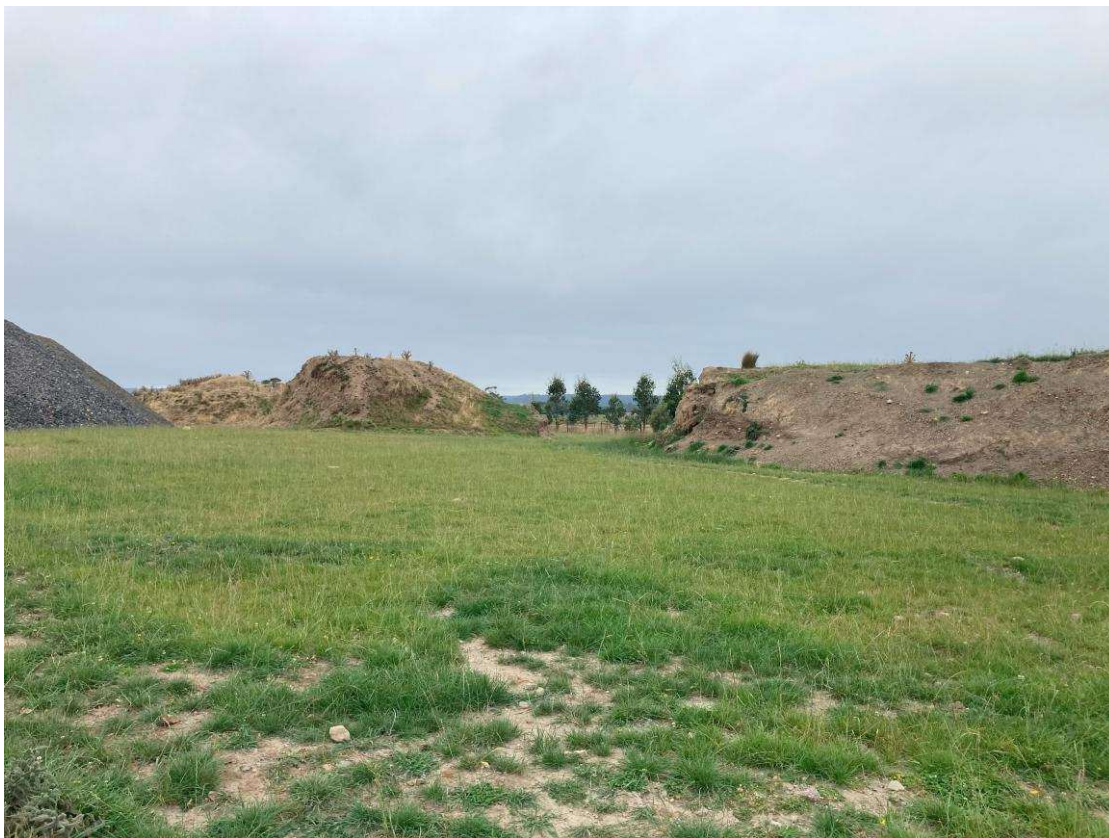
Figure 18. Rehabilitation area on the southeastern boundary (March 2025).

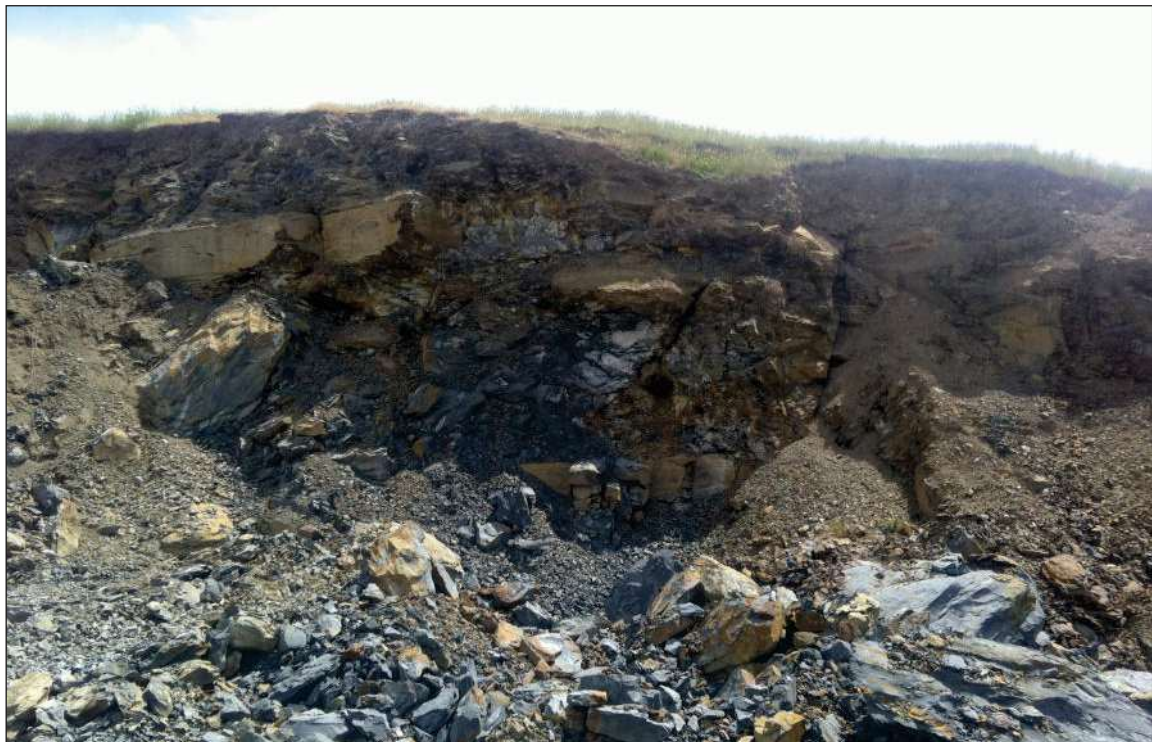
**PLATE 4 - Northern face of the quarry**

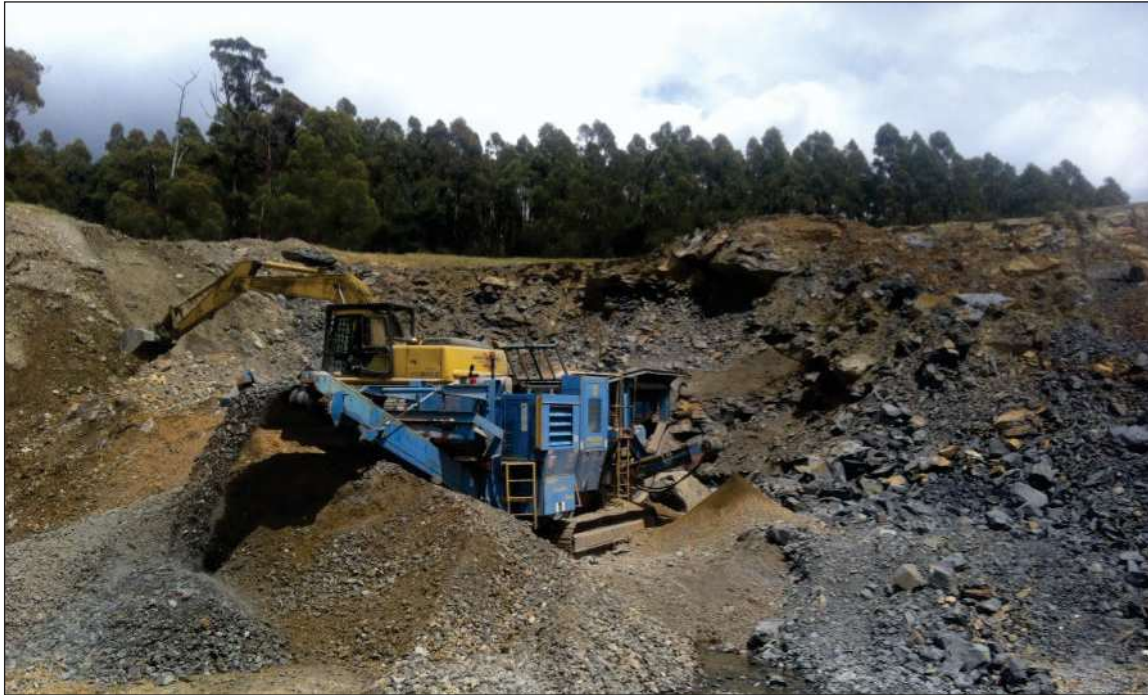
**PLATE 5 - Western face of the quarry**

Minor groundwater seepage has been observed periodically from the western face of the quarry.

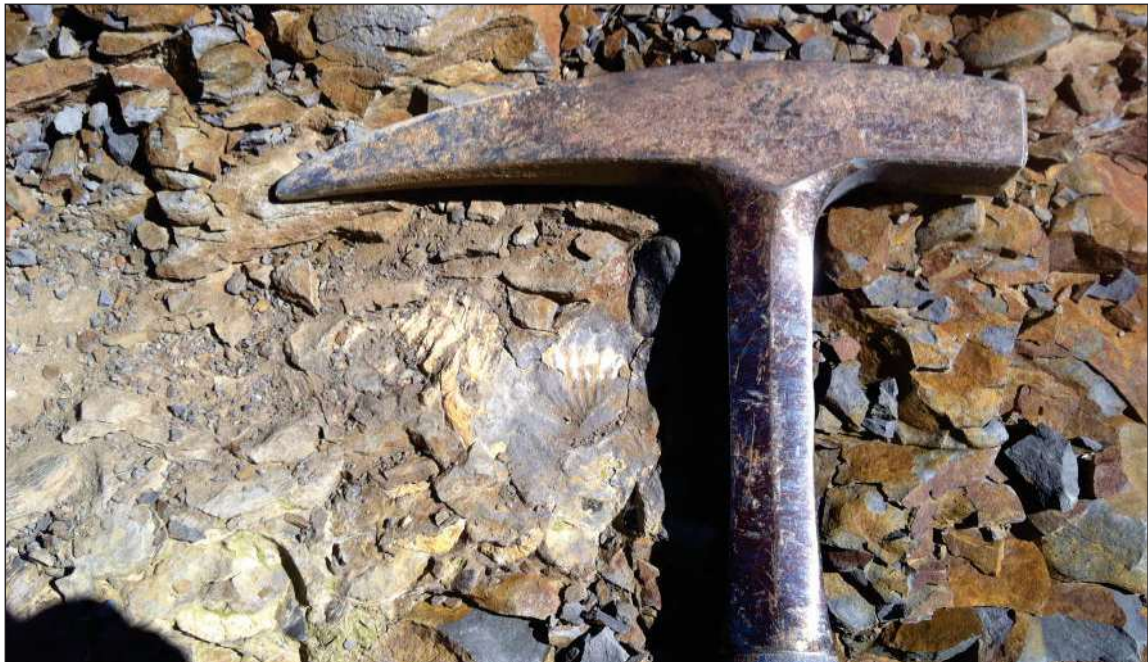
**PLATE 6 - Fossils located near the top of the quarry profile**

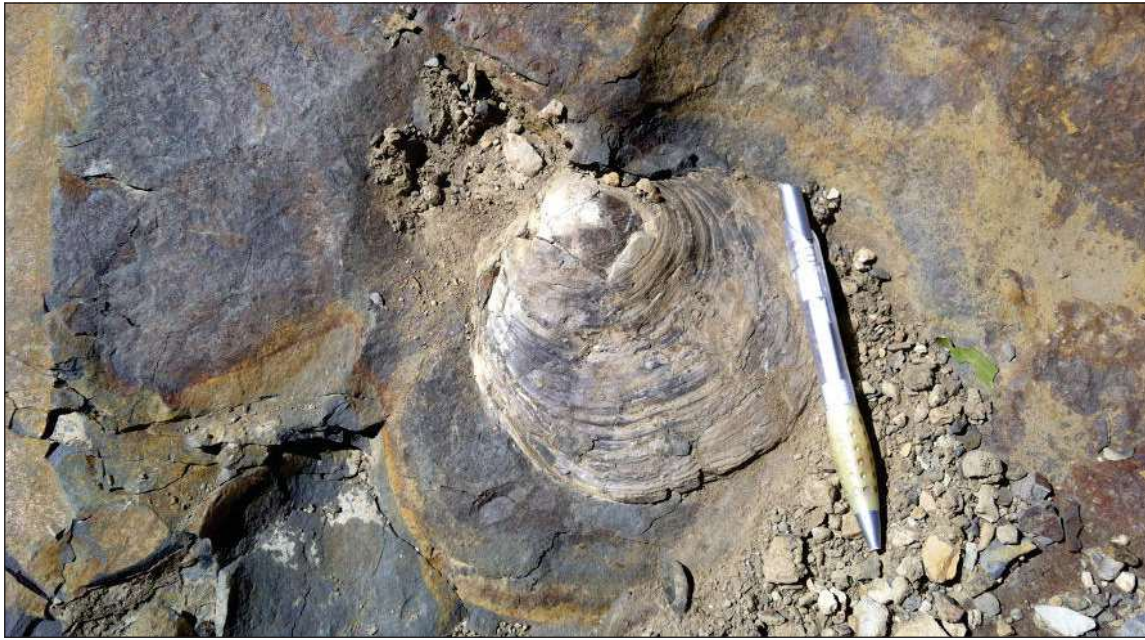
PLATE 7 - Fossil located near the base of the quarry profile

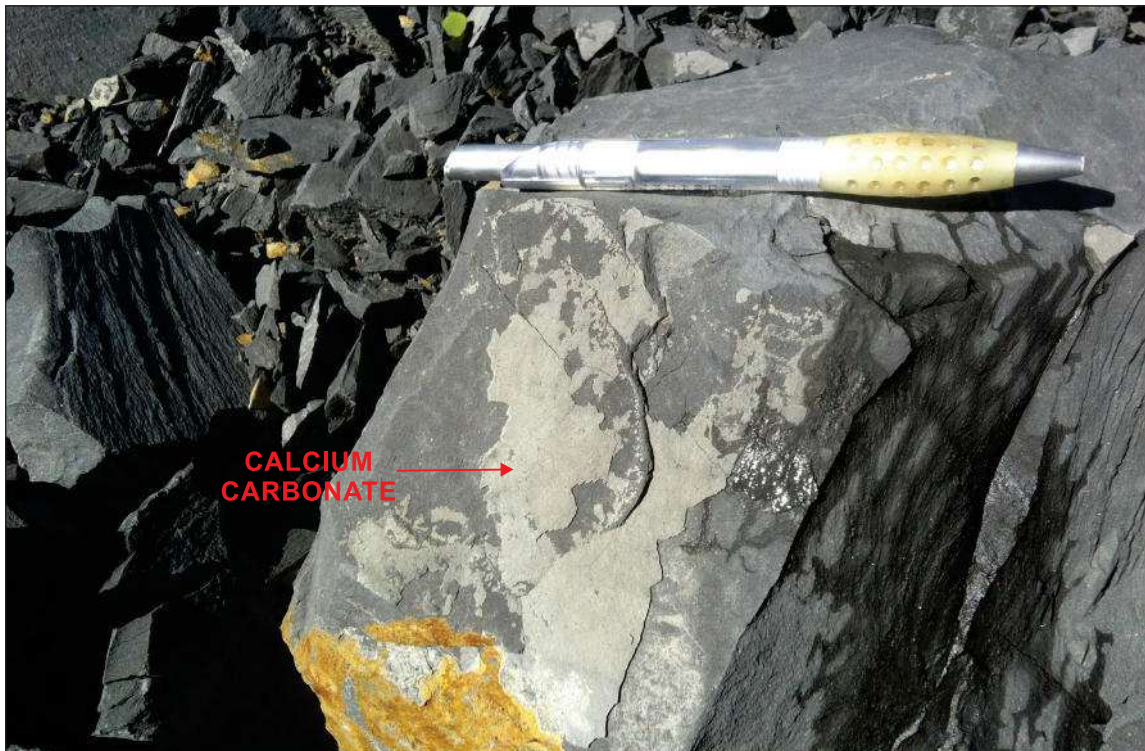
PLATE 8 - Platy calcium carbonate along bedding planes

- The observed geology was fossiliferous with inclusions of acid neutralising calcium carbonate.
- No visual pyrite mineralogy was observed.
- The outflow from the quarry is considered as being minimal as the catchment is very small and only very minor groundwater seepage was encountered.

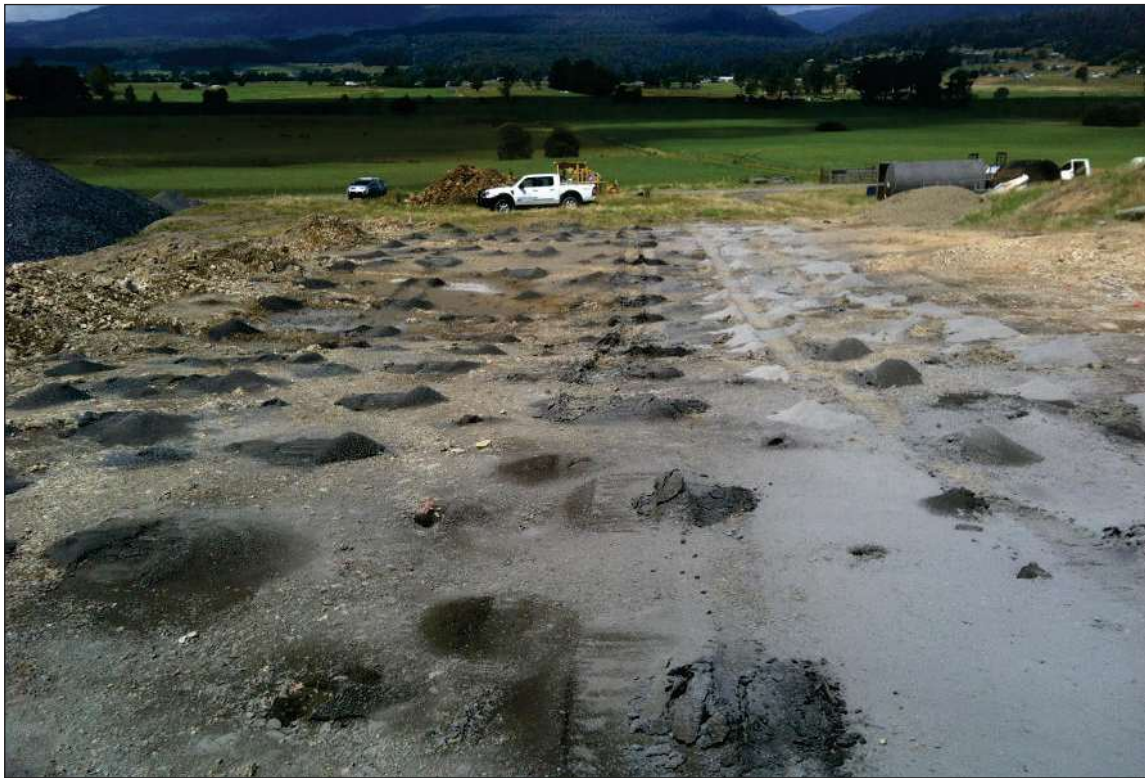
**PLATE 9 - Blast drill pattern to the south of the existing quarry**

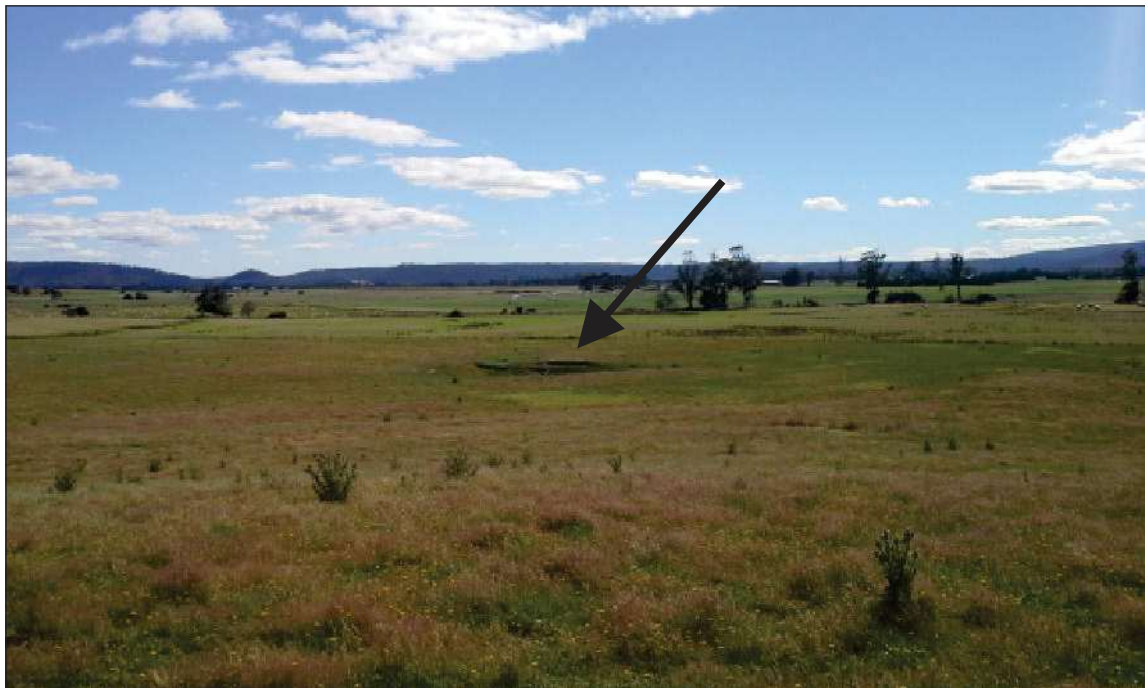
**PLATE 10 - View over slopes to the north of the quarry looking north. Excavated depression indicated by arrow.**

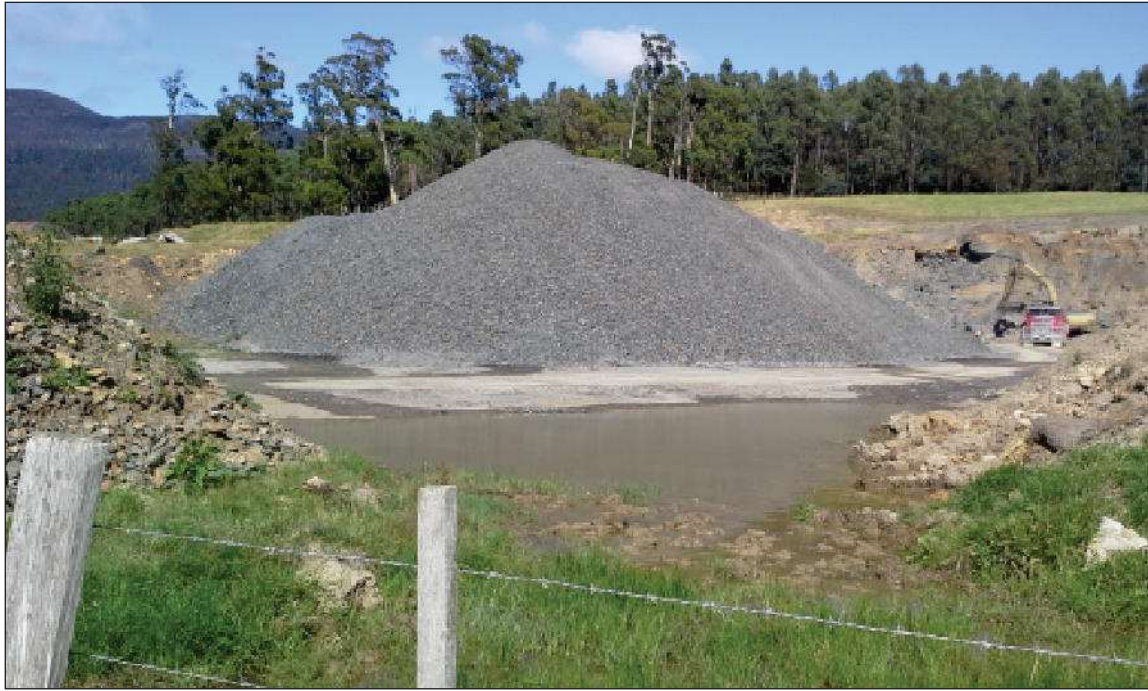
**PLATE 13 - View of sediment basin to the west**
