Application for Planning

Application No.: **DA2025186**

Location: **45 Sice Avenue, Heybridge**

Proposal: **Residential - dwelling extension**

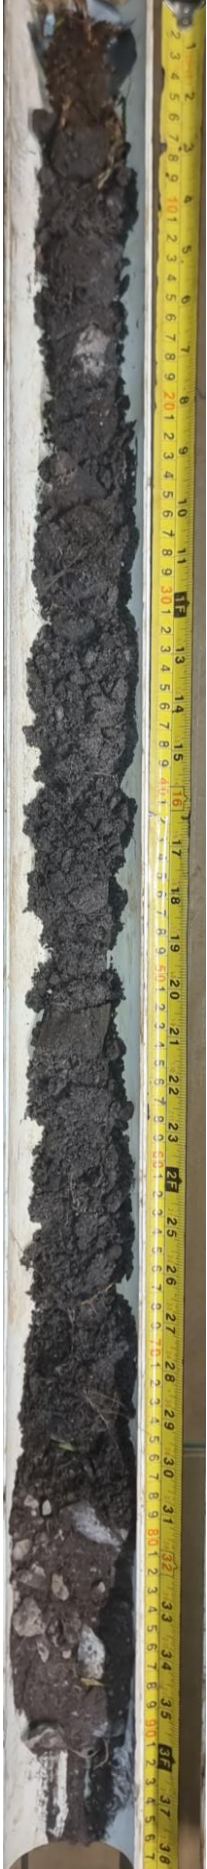
Figure 1. TH1

Figure 2. TH1 lithology transitions at 0.1m from Organic-dominated facies to stabilised aeolian coastal sand atop marine sands. Roots throughout. Transition to B2 layer begins at 70cm. Hard rocks encountered.

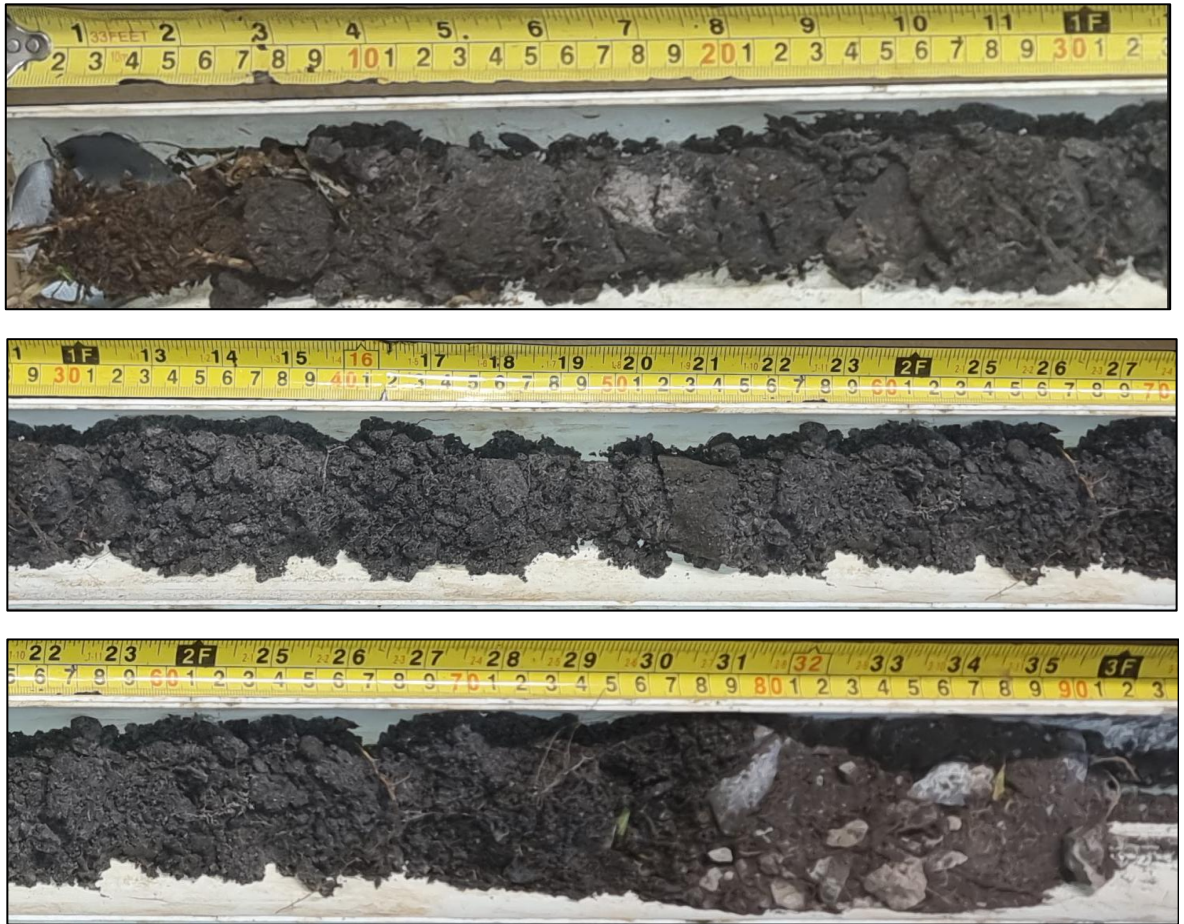
TH1 Depth (m)	Horizon	Description and field texture grade	Observed soil class	Lab-derived USCS Class
0.0 – 0.1m	A	Very Dark Grey 2.5YR 3/1, inorganic silts, silty sands, slightly moist. Fine texture. Roots throughout. Very soft.	SM	CL-ML
0.1 – 0.70m	B	Grey 2.5YR 5/1, inorganic silts, very-fine clayey sands, Dry, loose	SM	ML
0.7 – 0.9m	B2	Brownish Grey 2.5YR 6/2, Friable. Dry, Loose. Decaying sediments. Rocks throughout, Refusal.	SM	ML-CH

Figure 3. TH1 location depicted, along with positions of nearby DCP's.

- DCP #1: 5m south of TH1. Refusal at 0.5m
- DCP #2: 0.2m south of TH1. Refusal at 0.5m
- DCP #3: 0.5m west of TH2. Refusal at 1.8m
- DCP #4: 2m north of TH2. Refusal at 2.6m.
- DCP #5: 3m south of TH6. Refusal at 1.4m

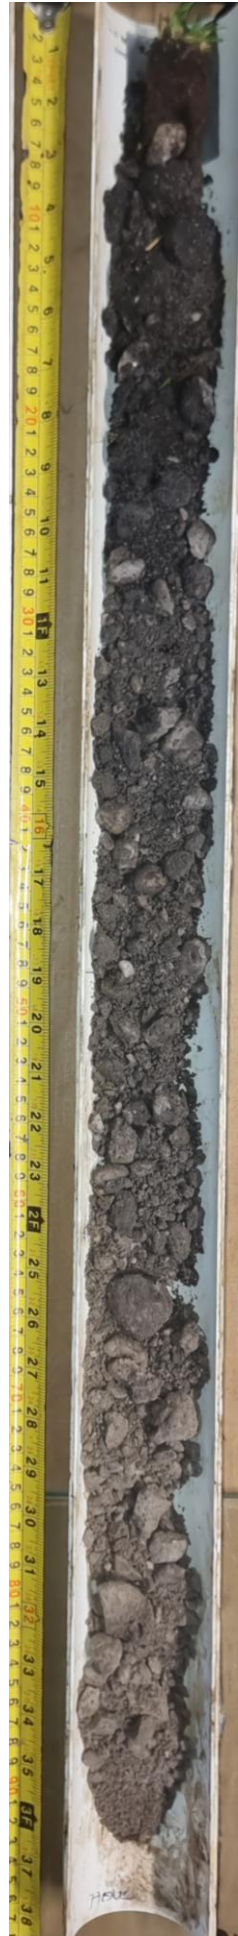
Figure 4. TH2

Figure 5. TH2 lithology transitions at 0.1m, 0.3m, & 0.6m with refusal at 0.95m. Stabilised aeolian coastal sand atop marine sands. Base of core sample dominated by highly weathered rock that features a slight increase in clay alteration.

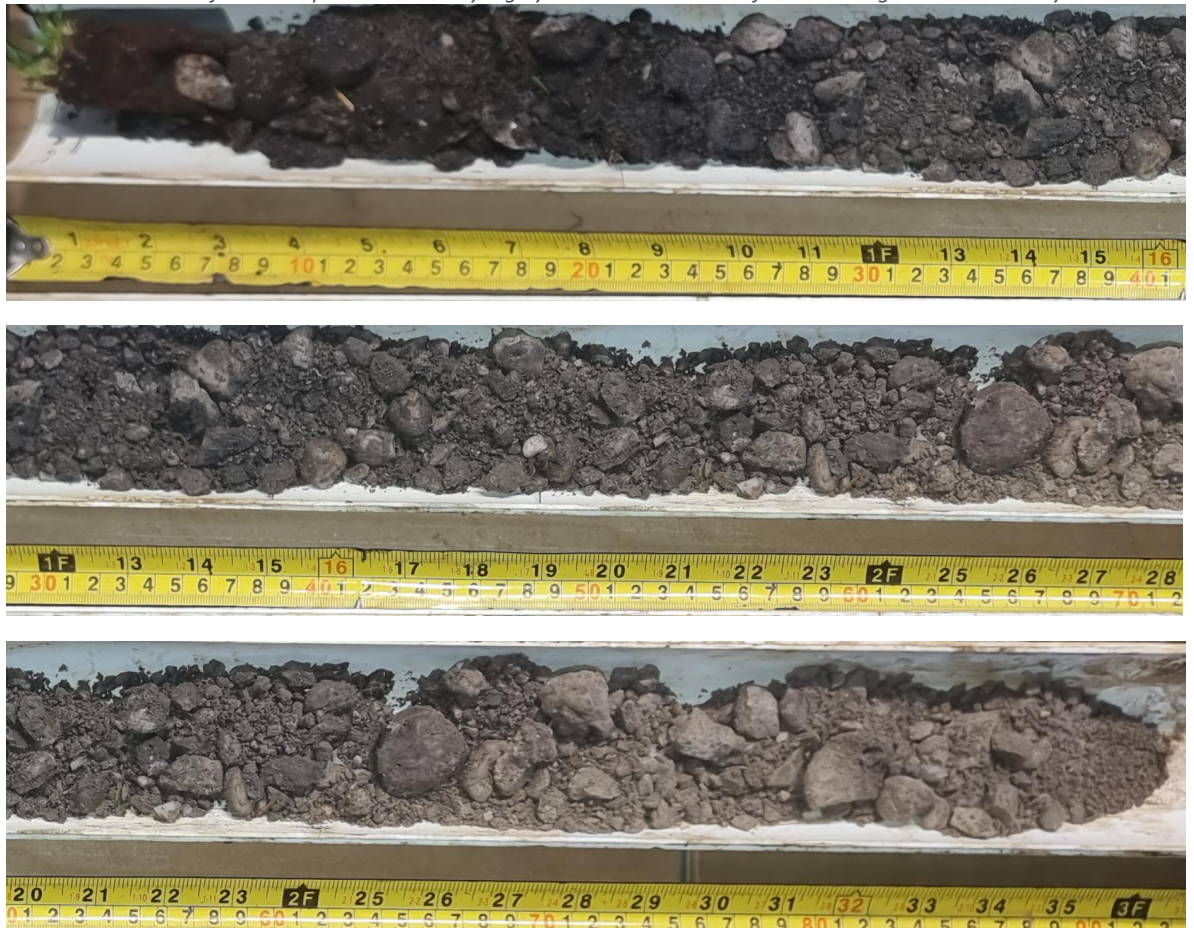
TH2 Depth (m)	Horizon	Description and field texture grade	Observed soil class	Lab derived USCS Class
0.0 – 0.1m	A	Very Dark Grey 2.5YR 3/1, inorganic silts, silty sands, sandy loam & peds, Strong structure, slightly moist. Fine texture. Very Soft. Roots throughout.	SM	CL-ML
0.1 – 0.3m	A2 / B	Grey 2.5YR 5/1, inorganic silts, very-fine clayey sands, Dry, loose	SM	CL-ML
0.3 – 0.6m	B / B2	Light Olive Brown 2.5YR 5/3, inorganic silts / sands, very fine clayey sands, Dry, loose. Hard. Decaying sediments. Gritty / Friable.	SM	ML-CH
0.6 – 0.95m	B2	Light Brown Grey, 2.5YR 8/2, Loamy sand, gritty, low / weak structure, rock throughout, friable. Refusal.	CL	CL-ML

Figure 6. TH2 location depicted along with positions of nearby DCP's.

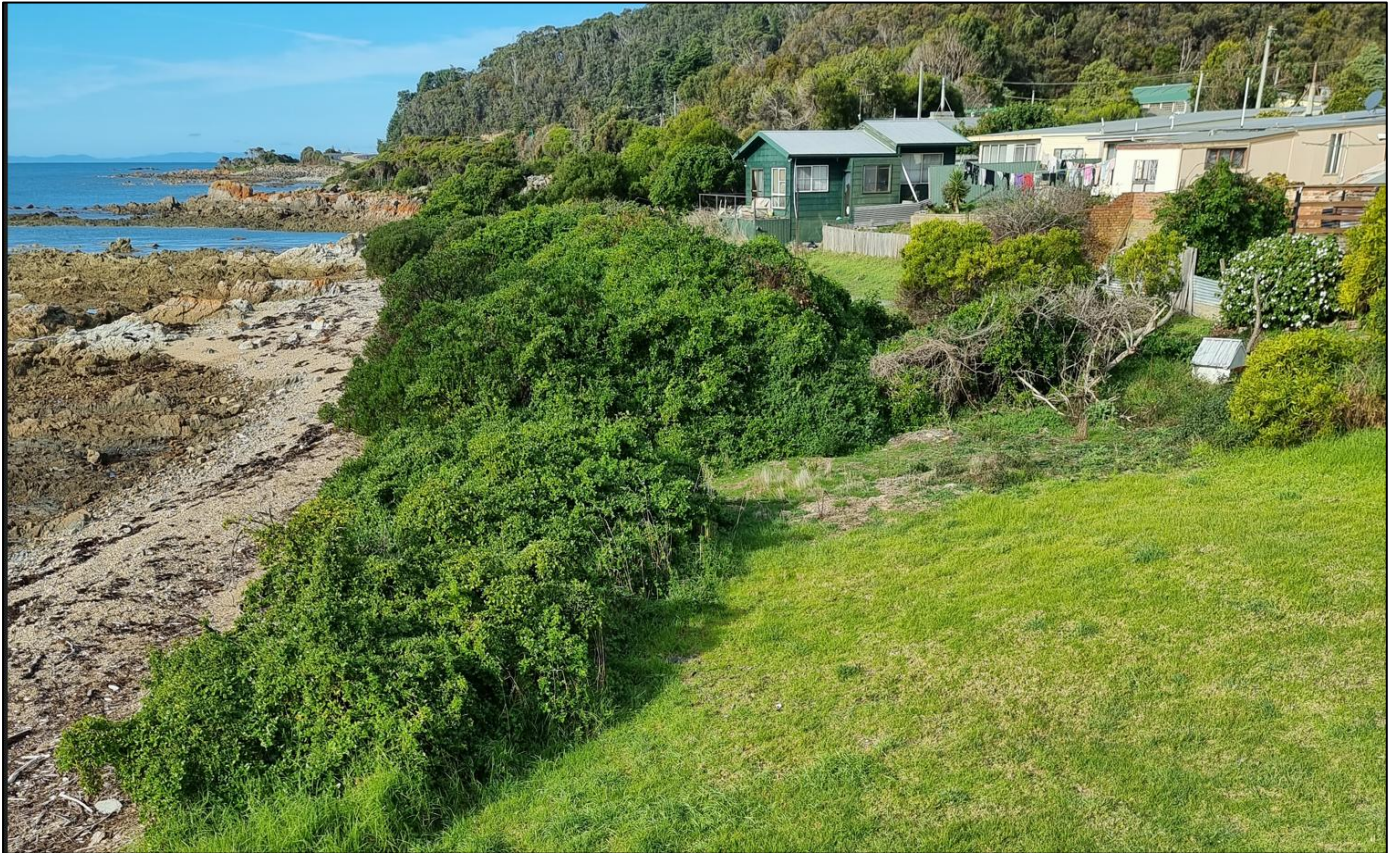
Figure 7. (Below) View from balcony of #45 Sice Avenue looking eastward (2023).

The author of this report completed a similar report in 2023. In the two years between, there has been no degradation of the slope, or removal of biota. Figure .7 depicts a photograph of the area down dip of the property being assessed taken in 2023. Figure .11 depicts the same location nearly 24 months apart.

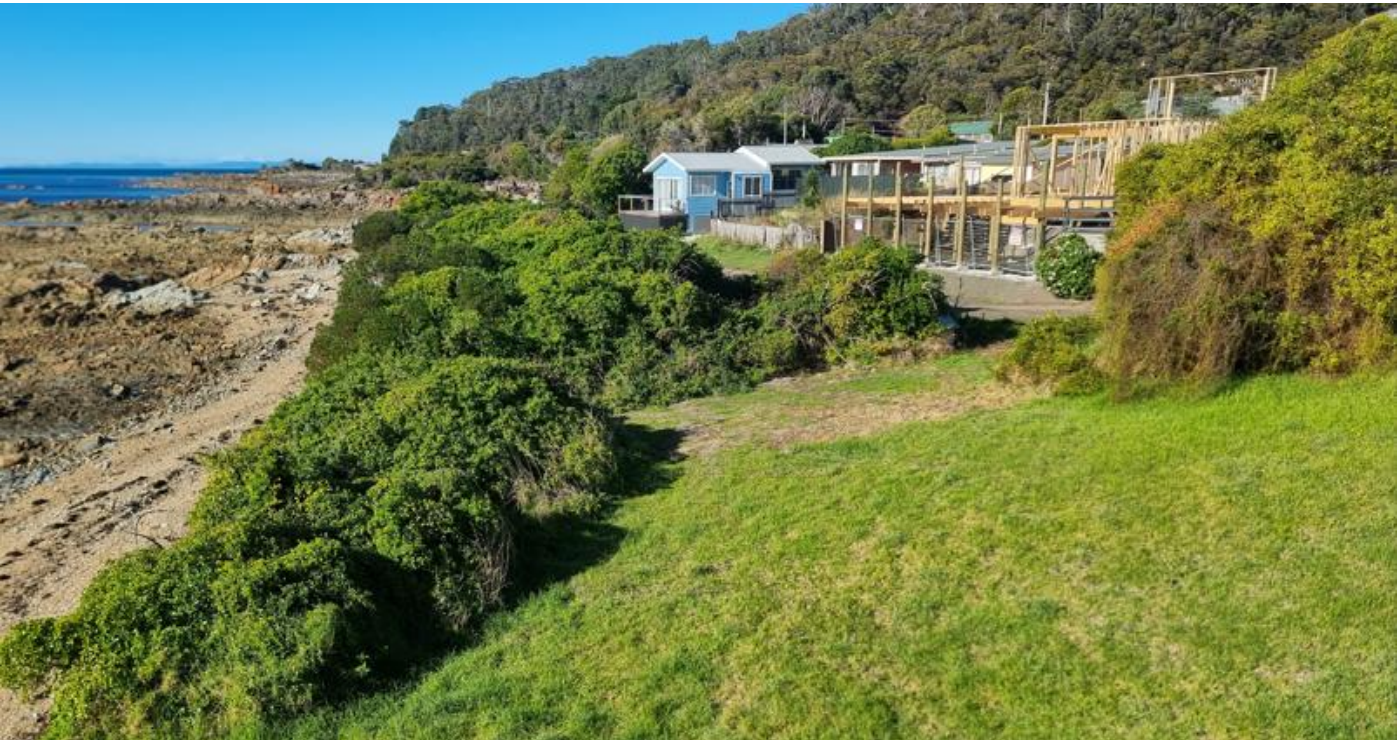
Figure 8. (Below) View from balcony of #45 Sice Avenue looking eastward (2025).

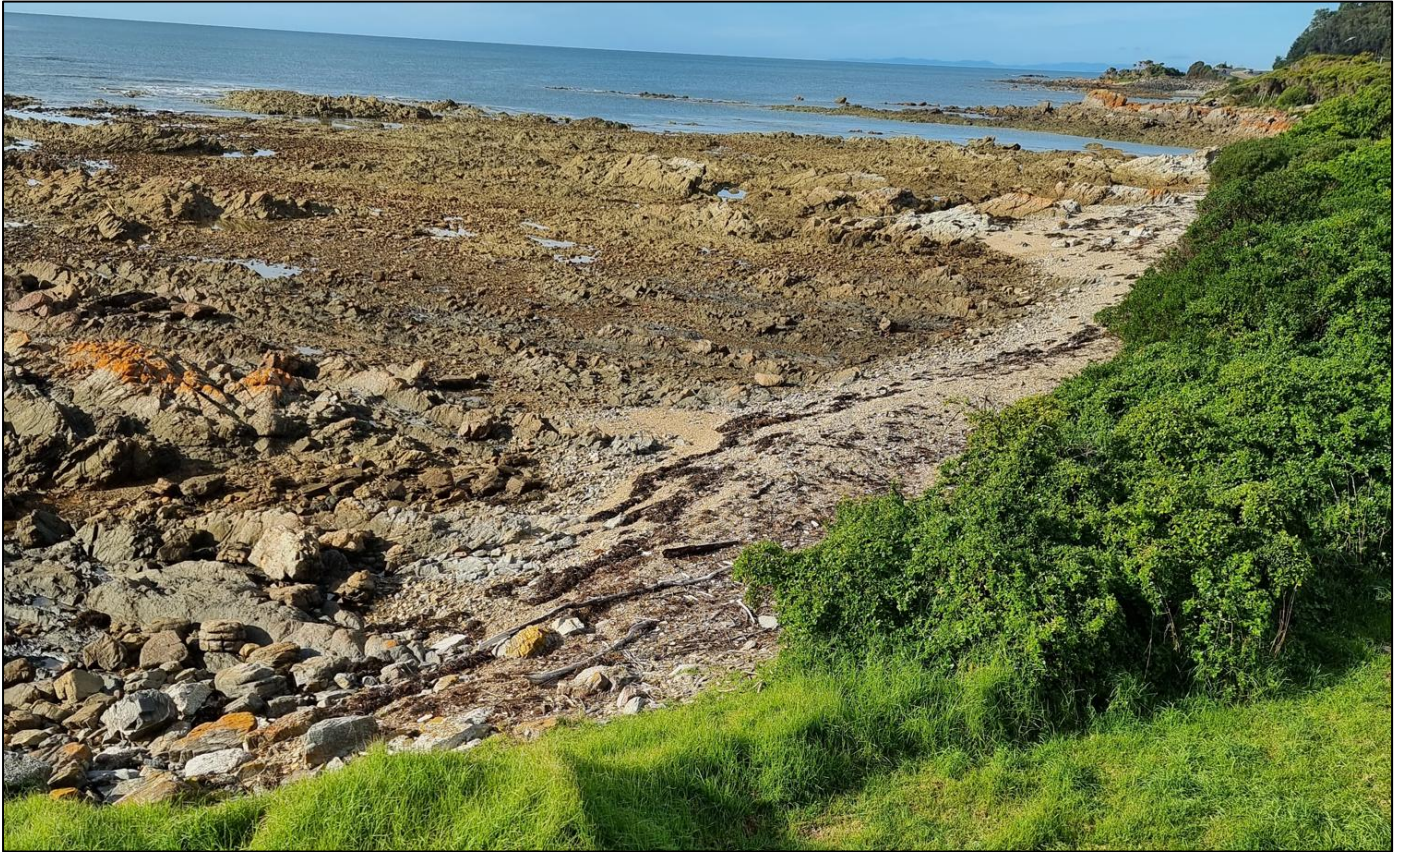
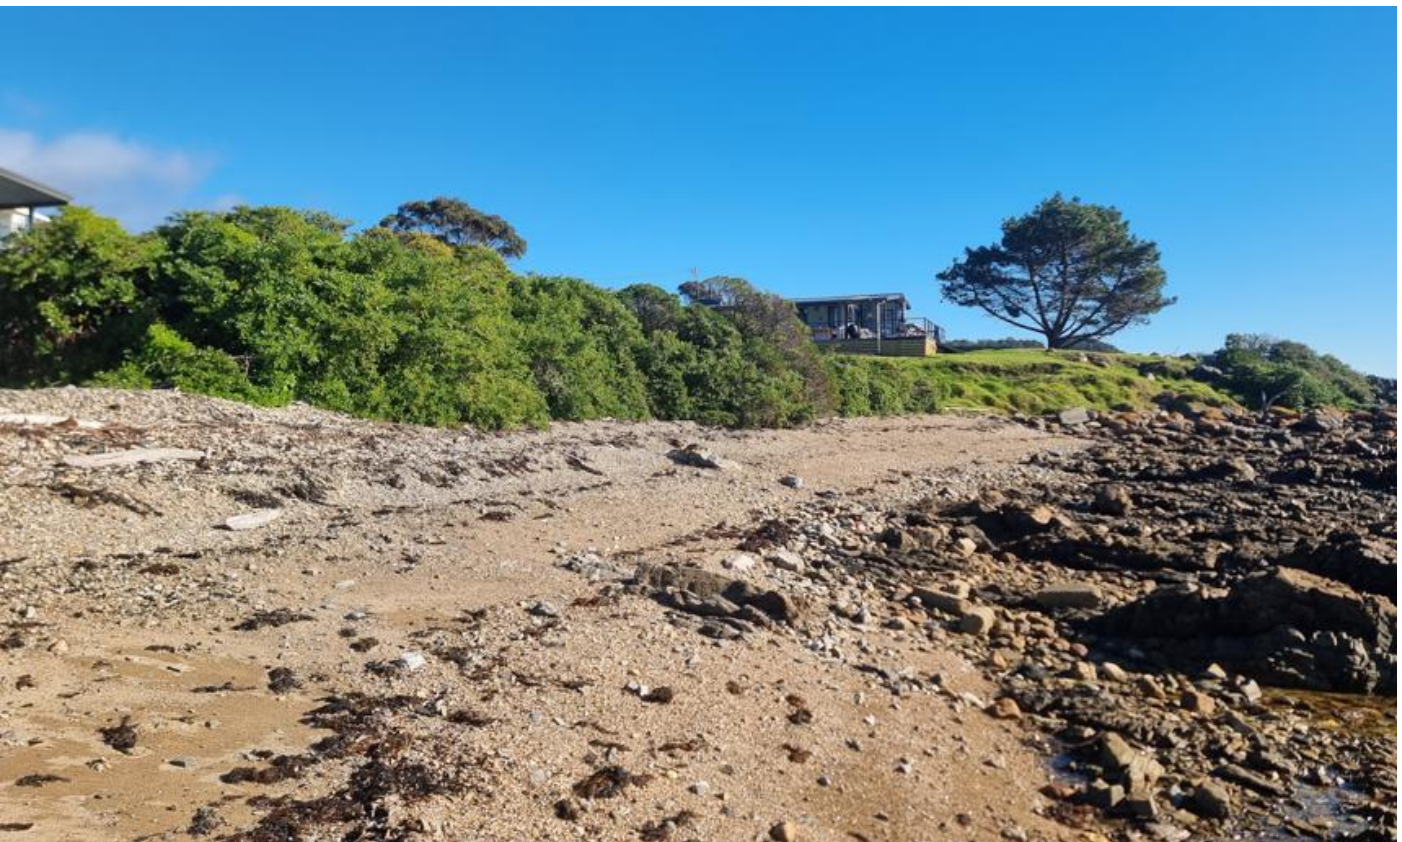
Figure 9. (Below) View from balcony of #45 Sice Avenue looking east, northeast. Resilient wave dampening quartzite, greywacke bedrock. Image at the base of the page depicts the reverse POV, with the balcony of #45 Sice Avenue depicted beneath established trees.

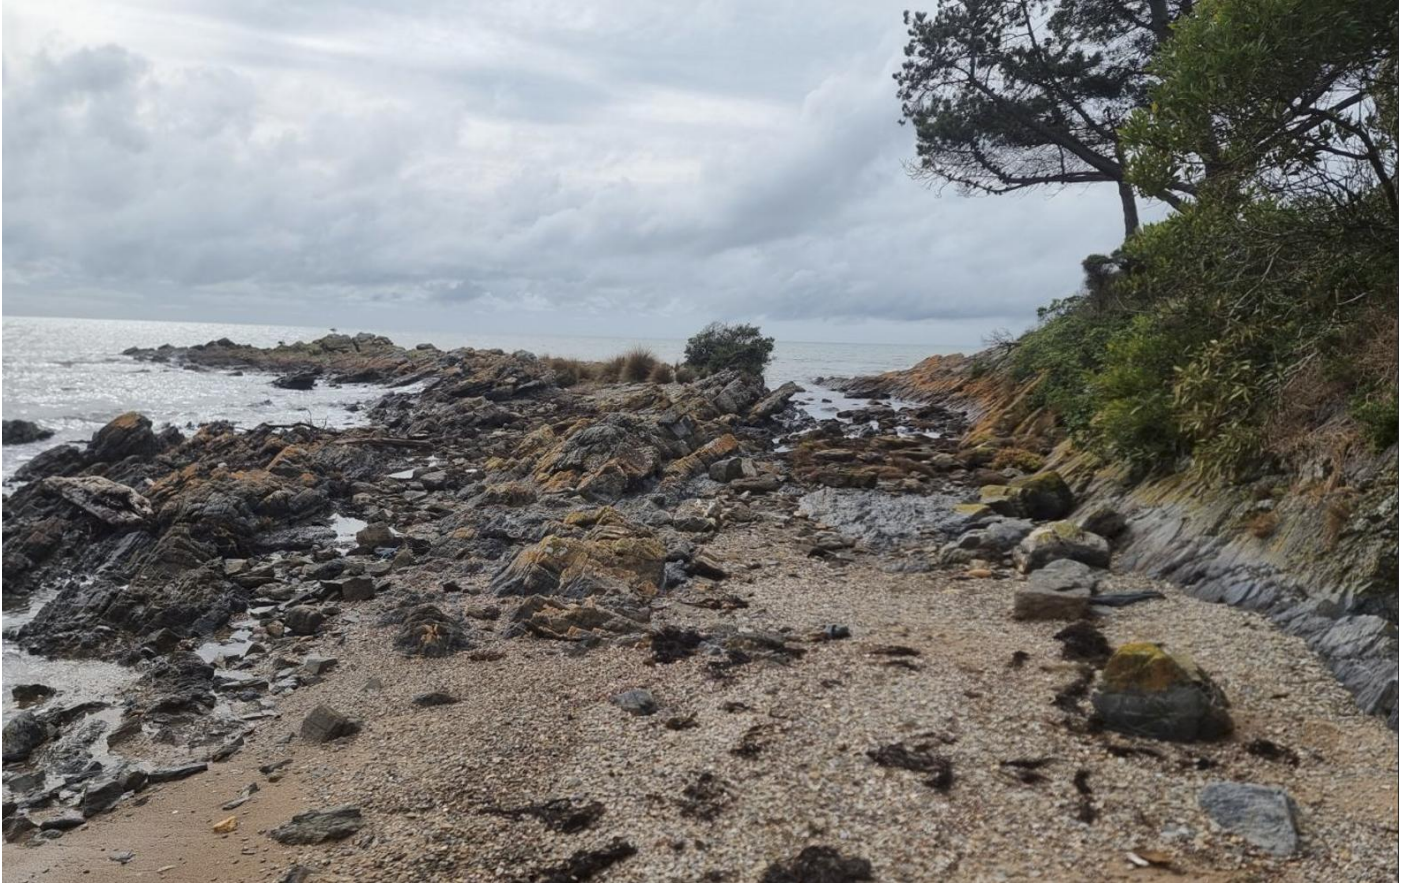
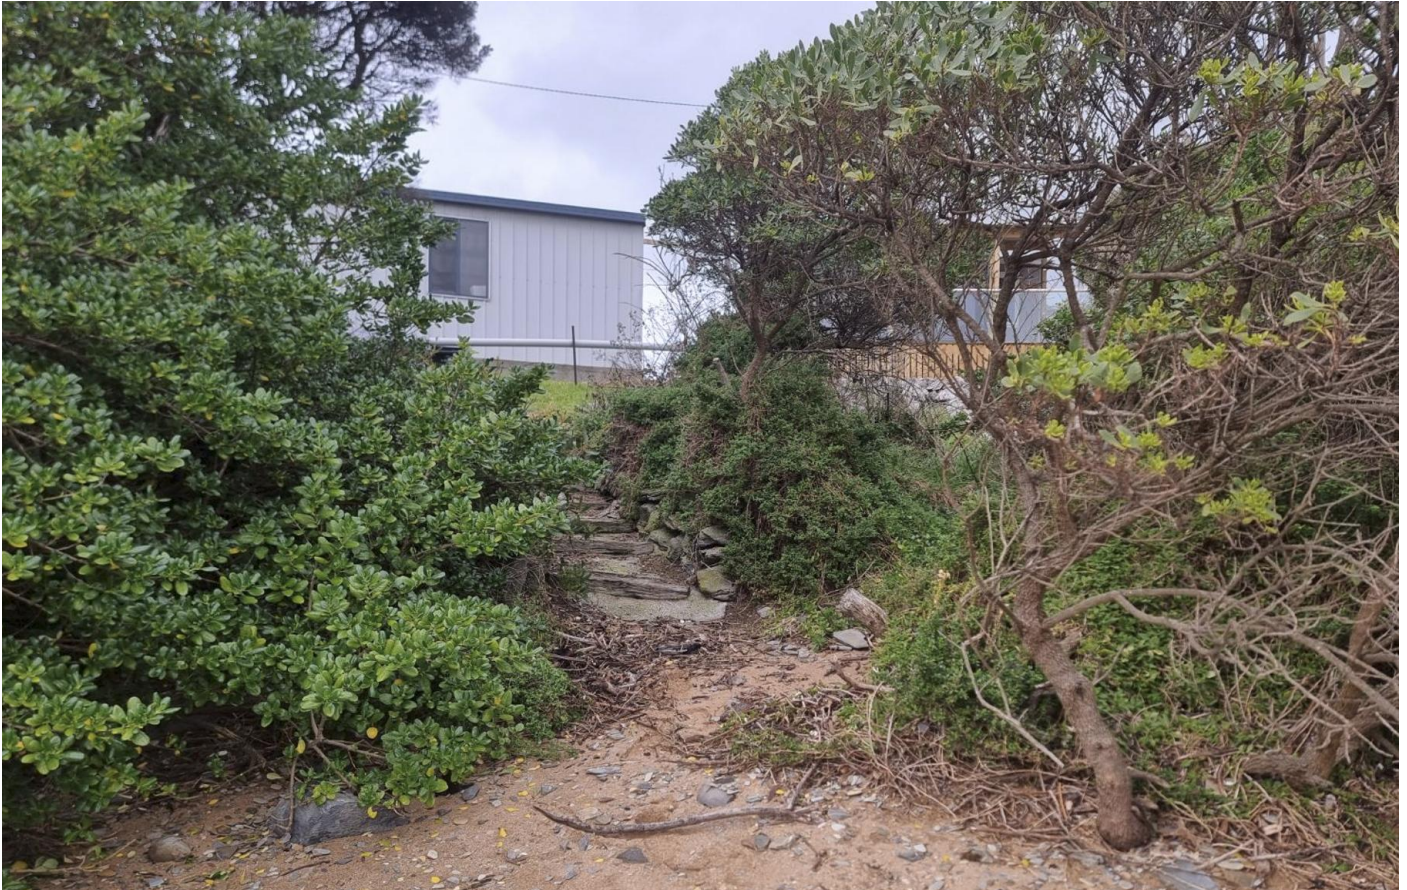
Figure 10. (Below) View from rocky outcrops west of 45 Sice Avenue, looking north. Resilient wave dampening quartzite, greywacke bedrock. Image at the base of the page depicts the POV looking towards #45 Sice Avenue, with the shed depicted surrounded by established plants.

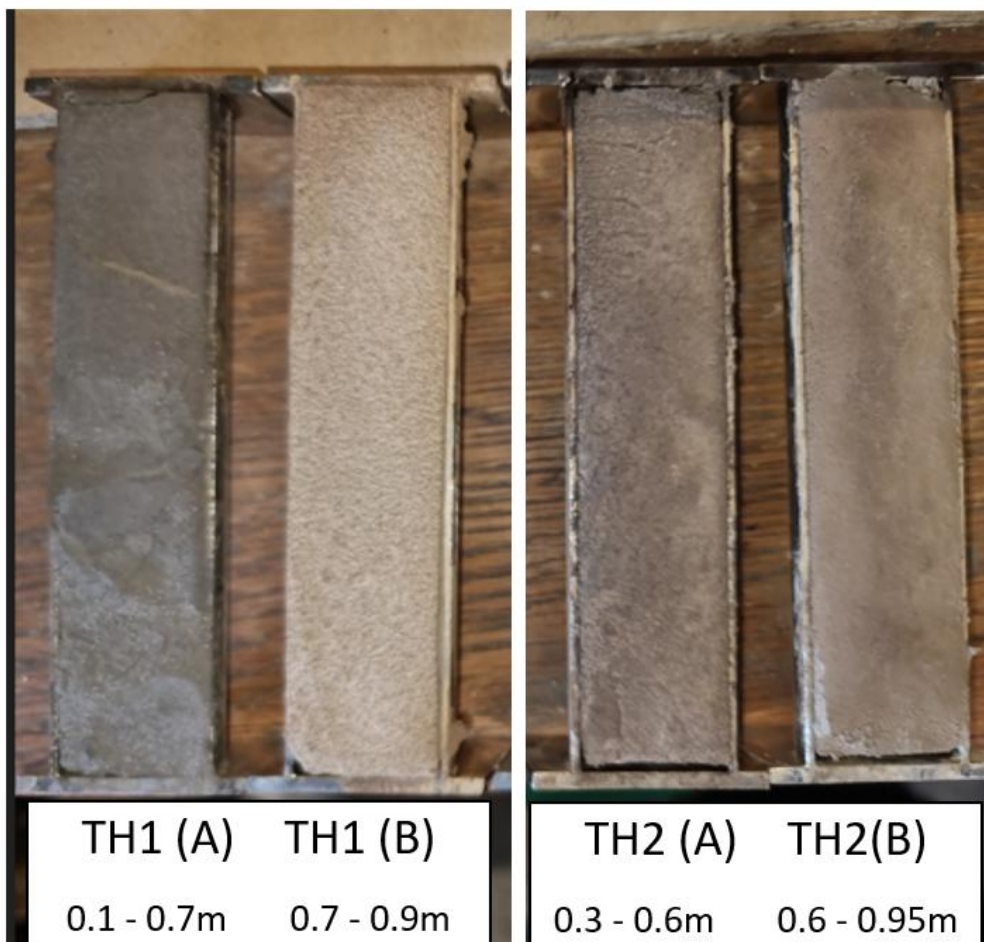
Figure 13. (Below) Linear Shrinkage samples have between 1 and 3mm of shrinkage for a maximum LS of 3%. These values place the category of risk likelihood as “Low” with an Expansive rating of “non-critical”; see figure 13: CSIRO definitions of linear shrinkage.

Samples of all test hole subsoils were tested for reactivity using the linear shrinkage (LS) test. Linear shrinkage provides guidance to soil classification of reactivity of clays for foundations. The tests suggest the soils are uniform in their shrinkage potential with **most results sitting at approximately 2%**. Fig. 12 depicts a contextualisation chart for these values.

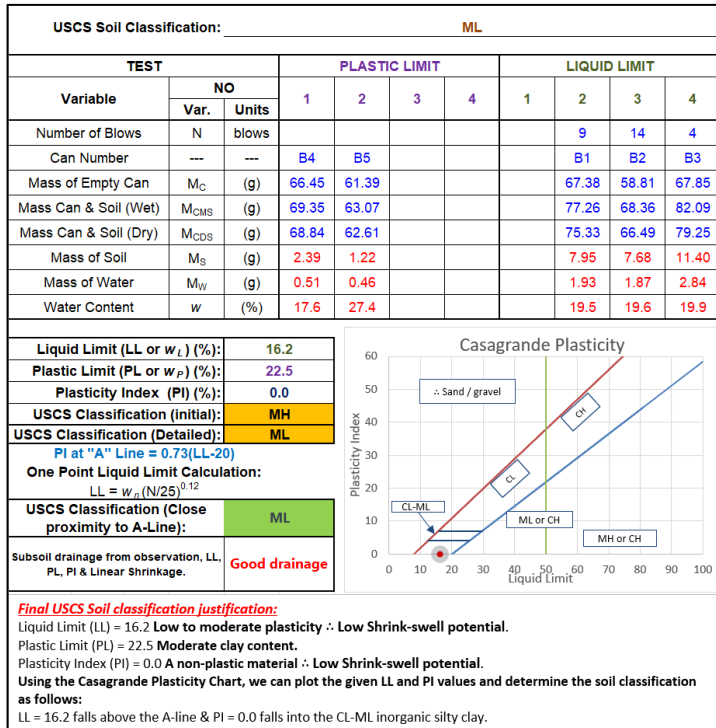
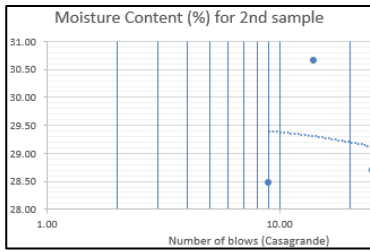
Figure 16. Atterberg limits analysis data TH1 (left: 0.1m-0.7m, right: 0.7m-0.9m).

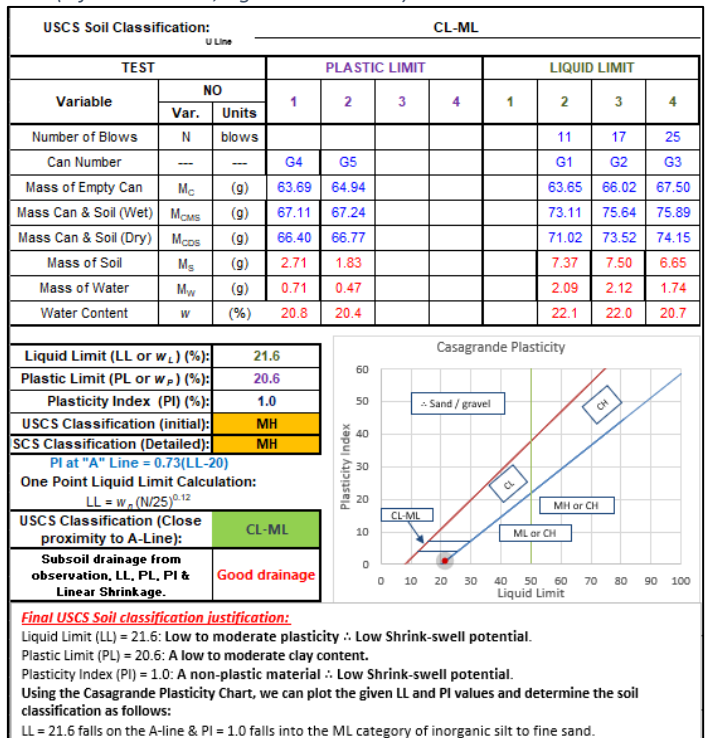
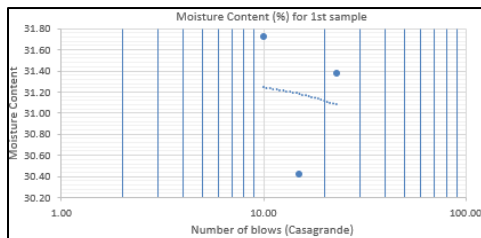
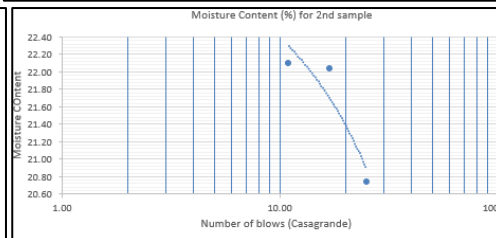
Figure 17. Atterberg limits analysis data TH2 (left: 0.3m-0.6m, right: 0.6m-0.95m).

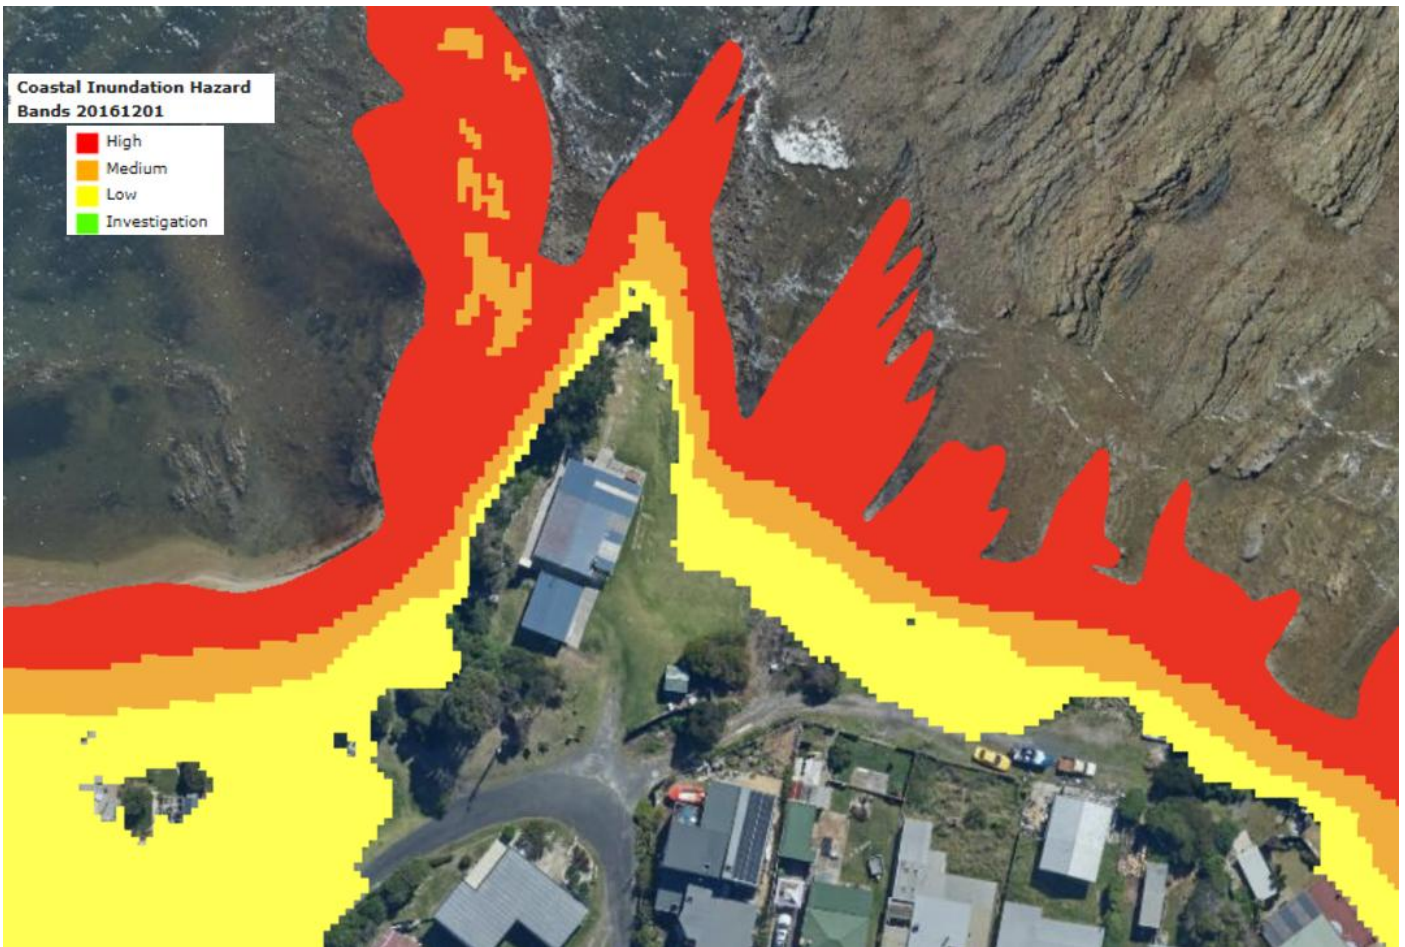
Figure 21. (Below) Coastal Inundation Hazard Bands overlay near site.

The site is proximal to the Coastal Inundation Hazard Bands 20161001 (fig.21), the Coastal Projected Storm Tide 20161201 overlay (fig.22), the Coastal Projected Sea Level Rise 20161201 (fig.23) and is partially located within the Coastal Erosion Component and Hazard Bands 20161201 overlay (fig.24).

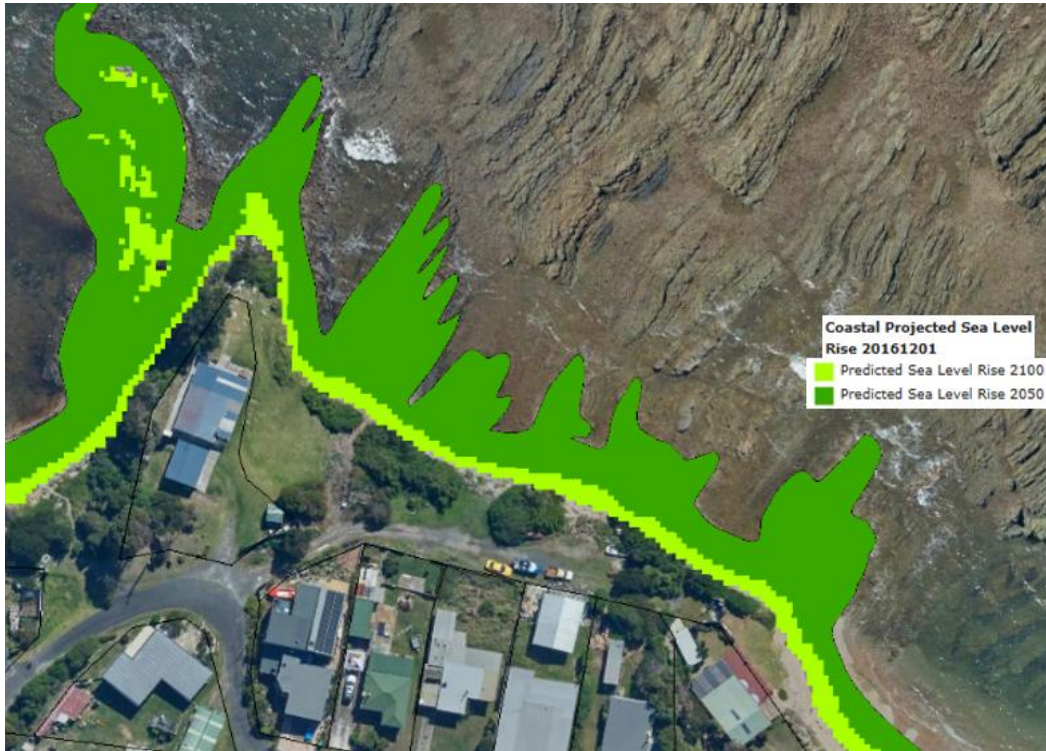
Figure 23. (Below) Coastal projected sea level rise near site.

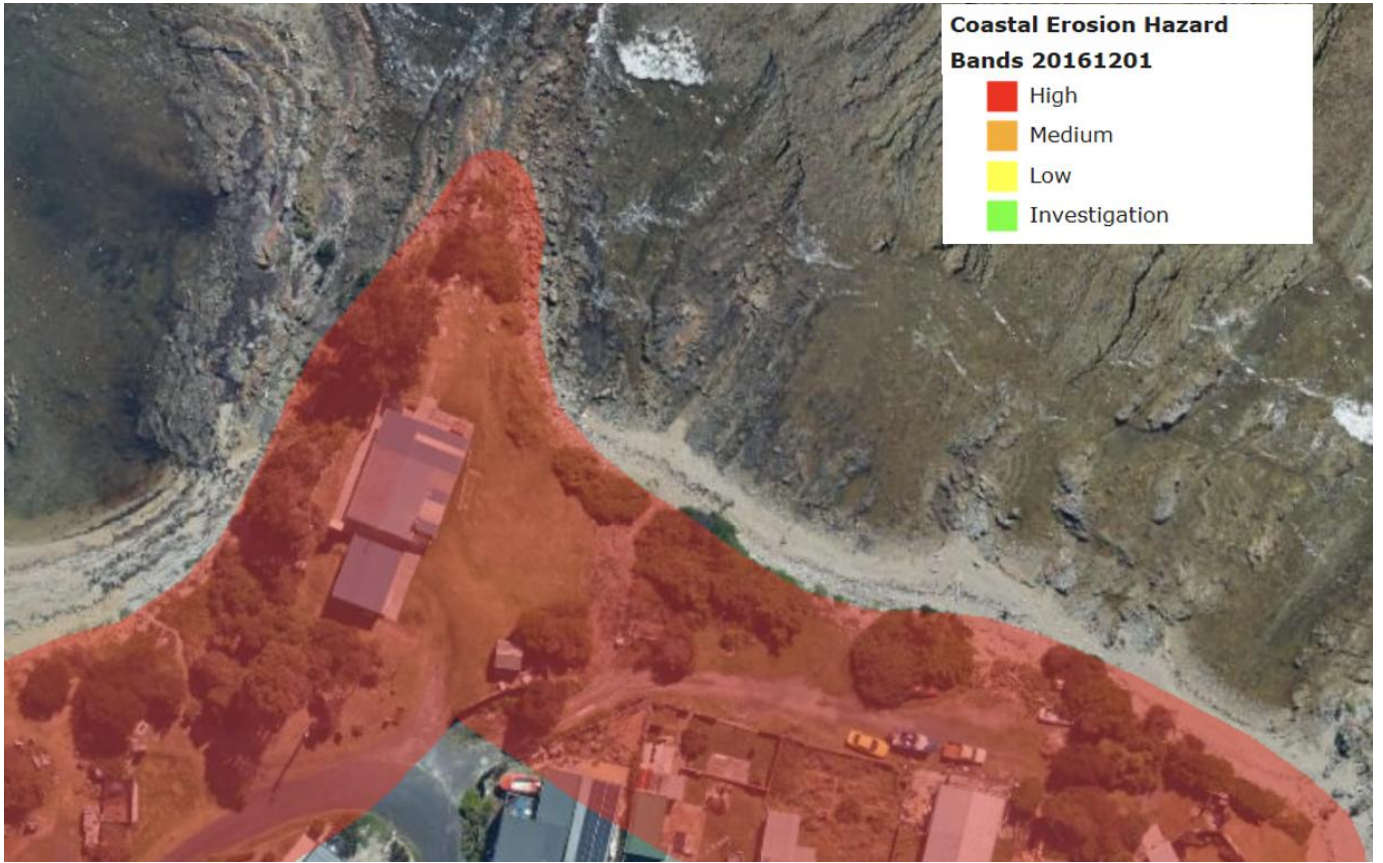
Figure 25. 45 Sice Ave within the CEHC Area (red band below).

In the scenario where any proposed additional developments fall within the Coastal Erosion Hazard Code (CEHC) Area (fig.25), and there are **no acceptable solutions** for buildings and works in a CEHC Area, **C10.1** and **C11.1** performance criteria must be met (fig.26).

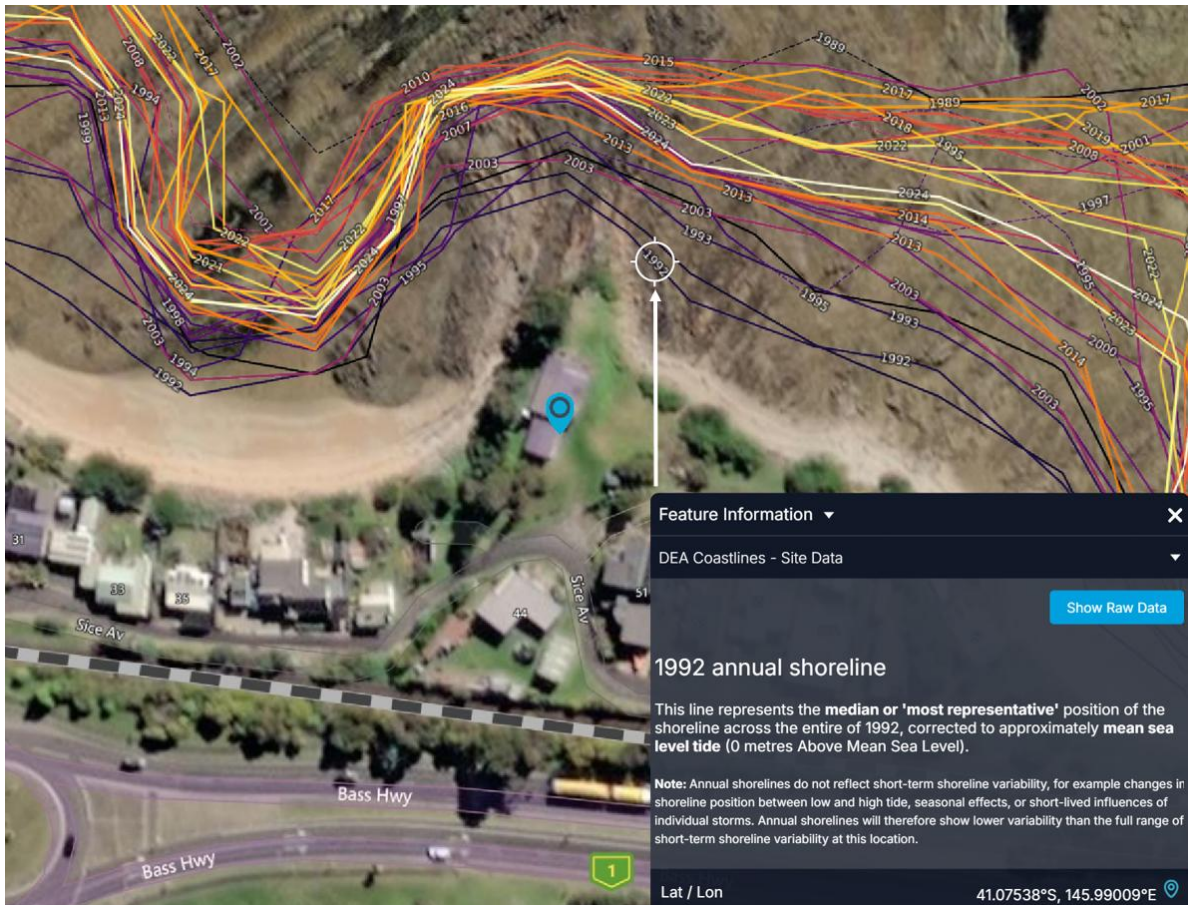
Figure 25a. 45 Sice Ave and the Digital Earth Australia (DEA) recorded annual shoreline recordings between 1980 and 2024 indicate a peak of sea level occurring in 1992, and in the 30 years since, the annual shoreline recordings have been receding, not encroaching closer to land.

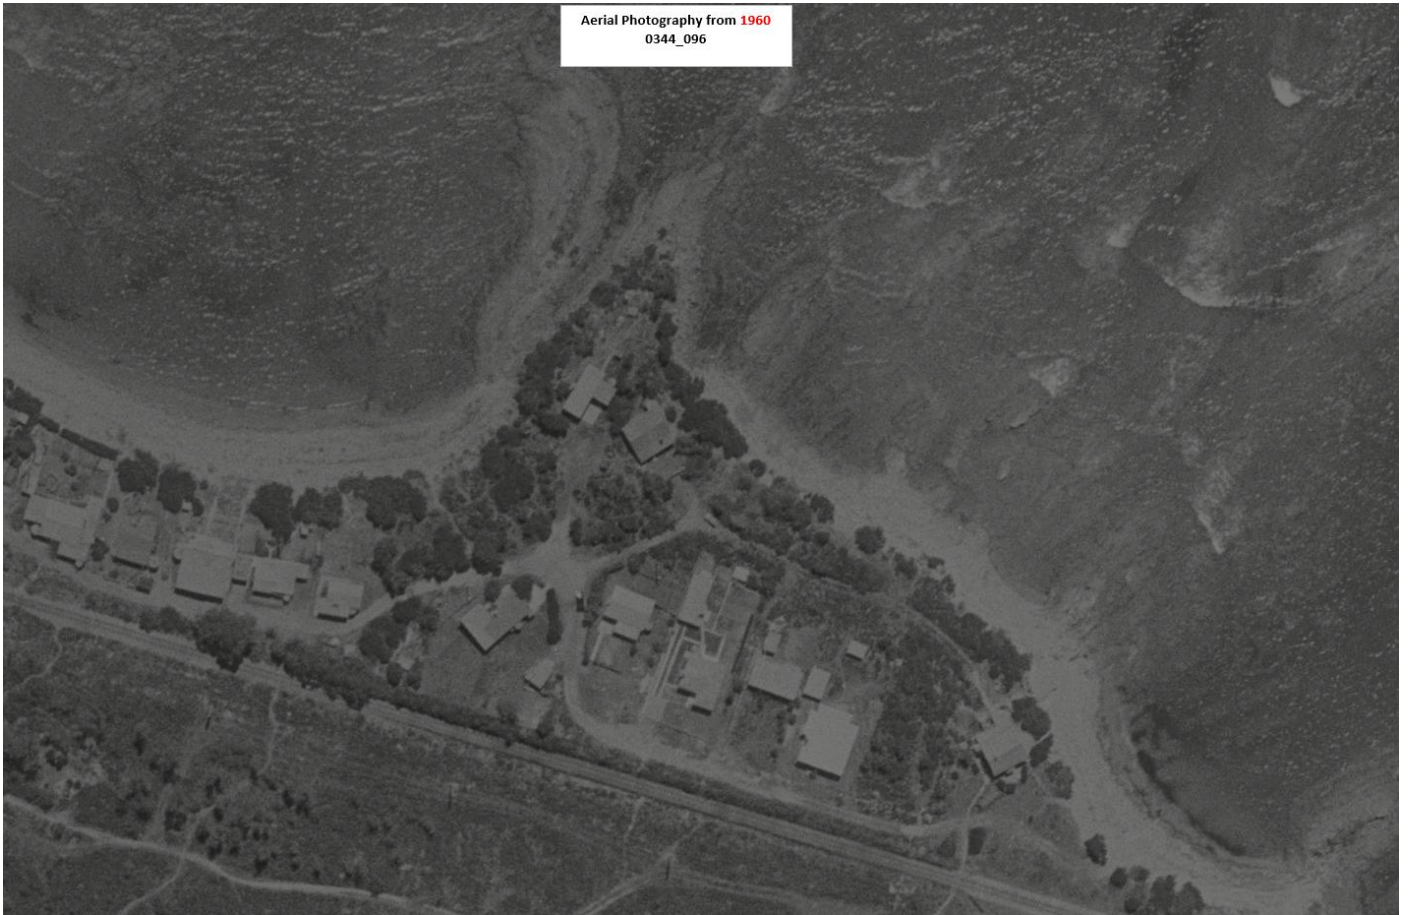
Figure 25b. 45 Sice Ave. 1960 Sourced from "Tasmanian Government Land Tasmania (2025). Aerial Photo Viewer

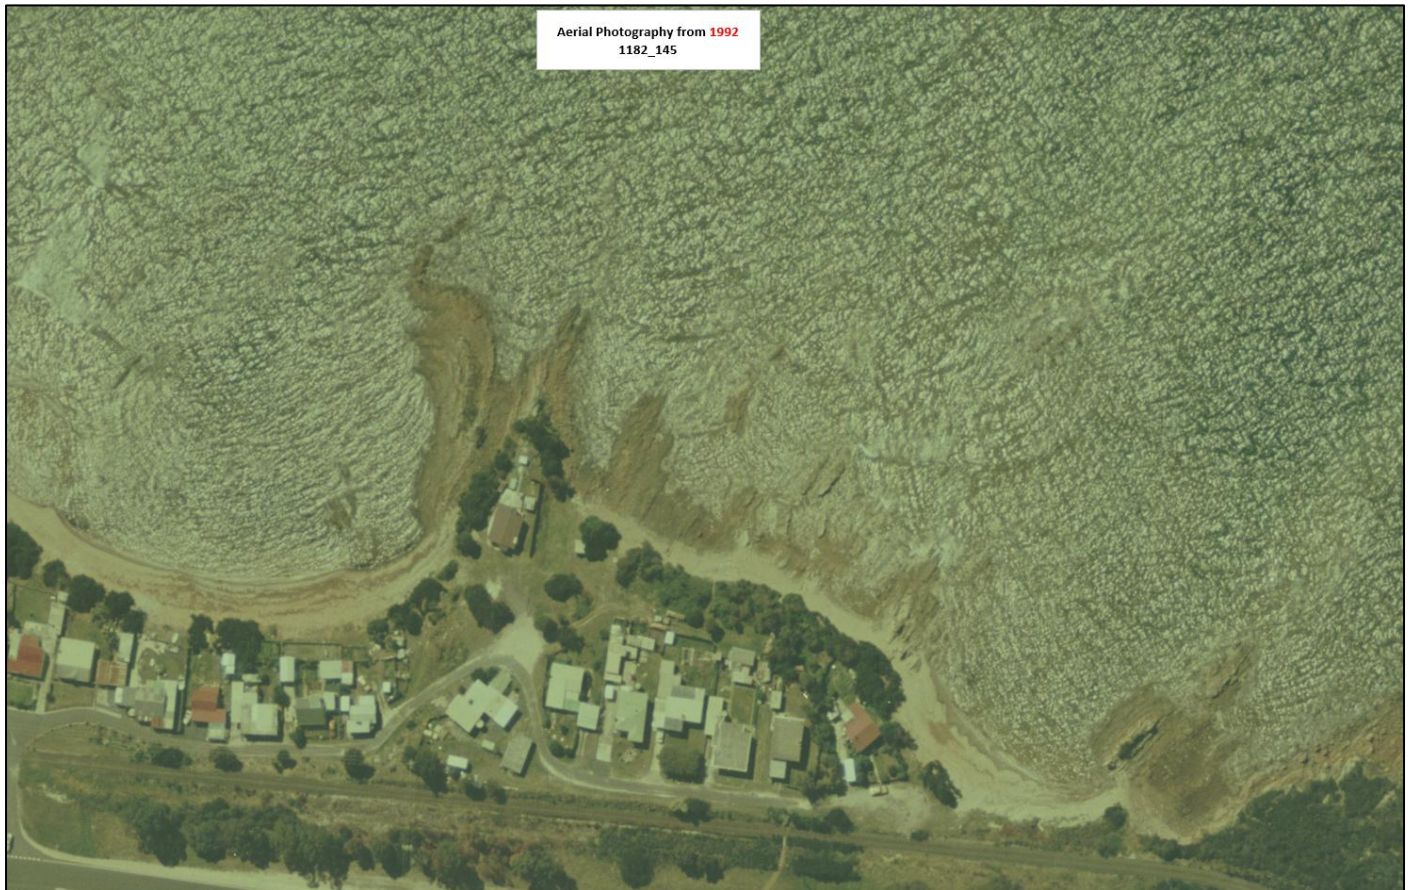
Figure 25c. 45 Sice Ave. 1992 Sourced from "Tasmanian Government Land Tasmania (2025). Aerial Photo Viewer

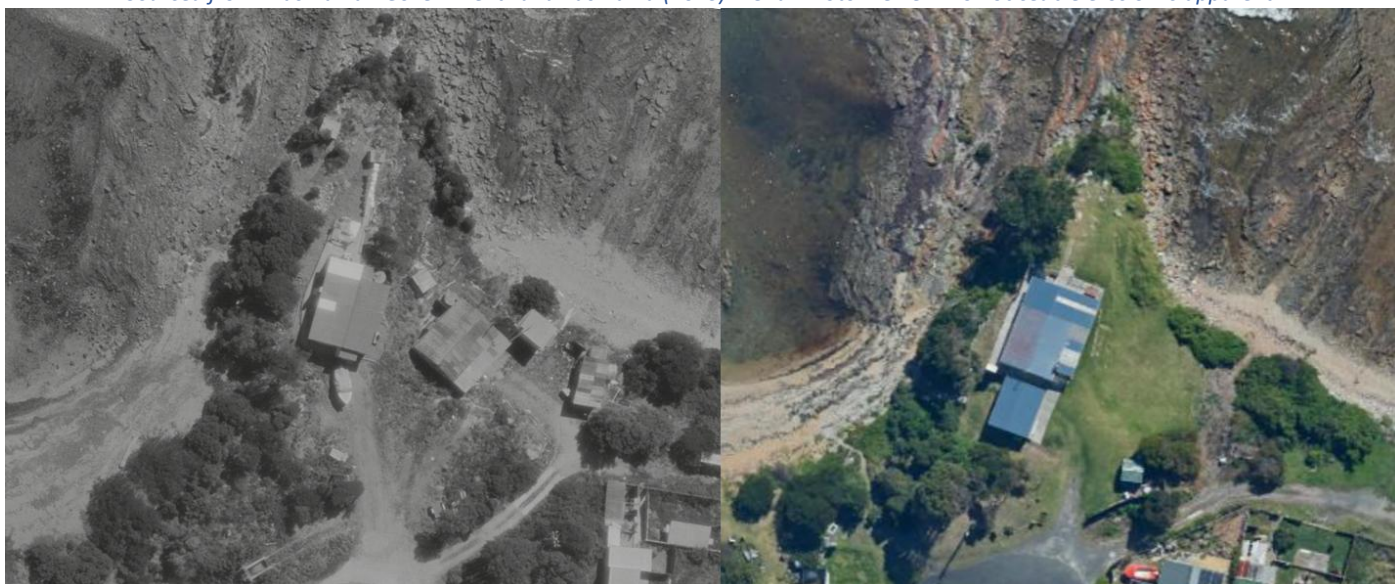
Figure 25j. 45 Sice Ave. Side-by-side images in similar orientations depicting aerial coastal comparison of the site in 1975 (L) and 2025 (R). Sourced from "Tasmanian Government Land Tasmania (2025). Aerial Photo Viewer" No noticeable erosion is apparent.

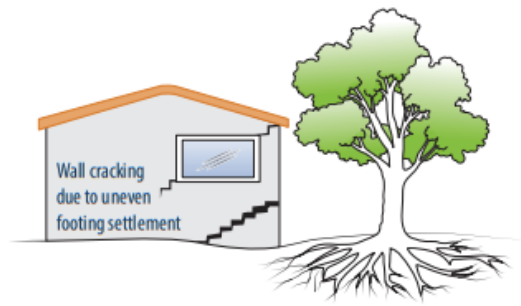
FIGURE 1 Trees can cause shrinkage and damage.

- ▶ Roots in the vicinity of footings will absorb much of the moisture in the foundation soil, causing shrinkage or subsidence.
