Application No.: **DA2025302**

Location: **15 Adaihi Street, Ulverstone**

Proposal: **Residential - Rehabilitation centre -  
alterations and additions**

# Alterations & Additions

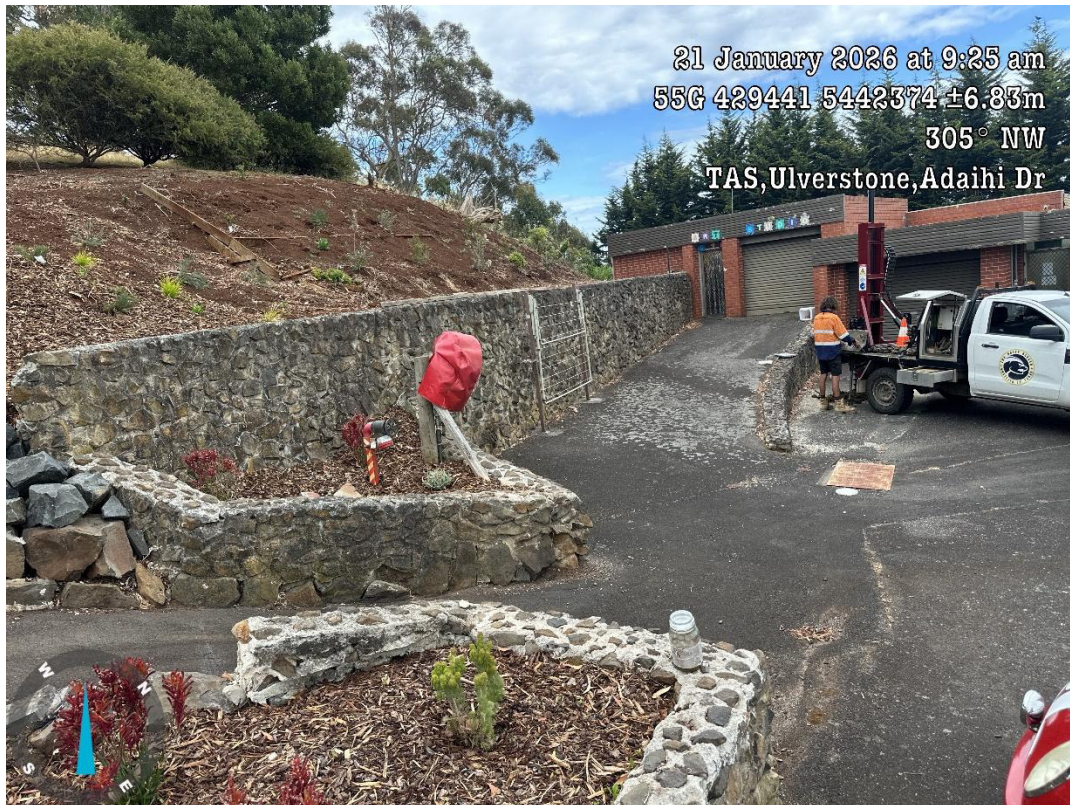
**Plate 1 – View of the proposed extension area and existing retaining walls, 21.01.2026**

Two retaining walls, with heights ranging from approximately 0.3 m to 2.0 m, are located along the western boundary of the proposed extension area.

The slopes within the site are typically subdued smooth uniform slopes and do not show any obvious signs of any recent landslide activity. Furthermore, the buildings and retaining walls did not display any damage related to landslide activity.

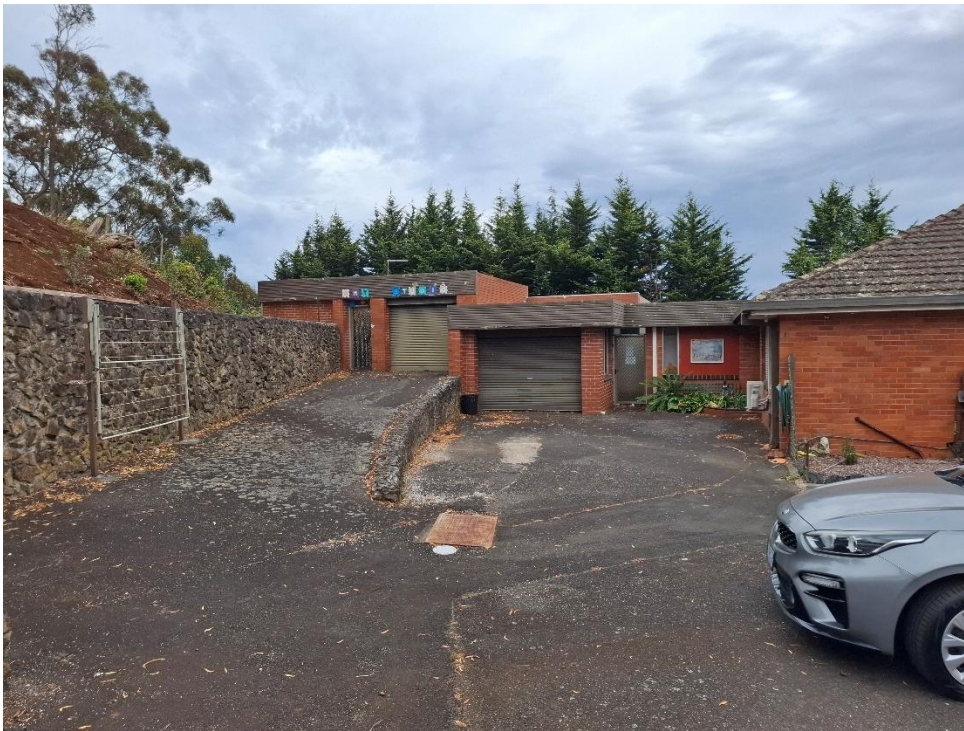
The extension consists of brick, colourbond steel and cement sheeting. The location of the extension is shown on figure 3.1 below.

Figure 3.1 – Area of proposed entrance and foyer

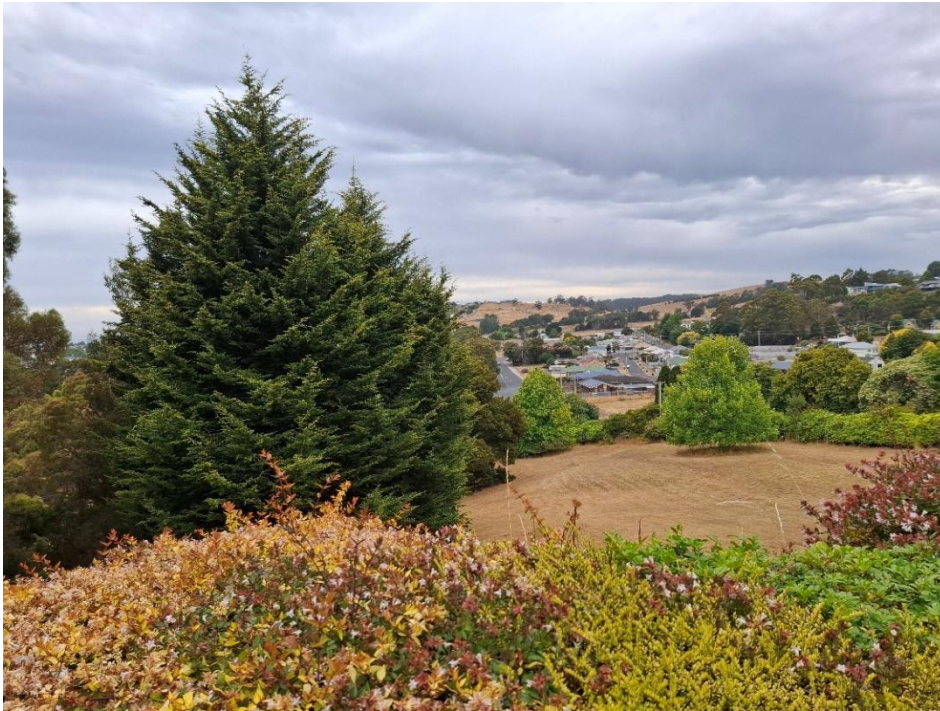
Image 4.1.1- East/Northeast – low threat gardens and roadways

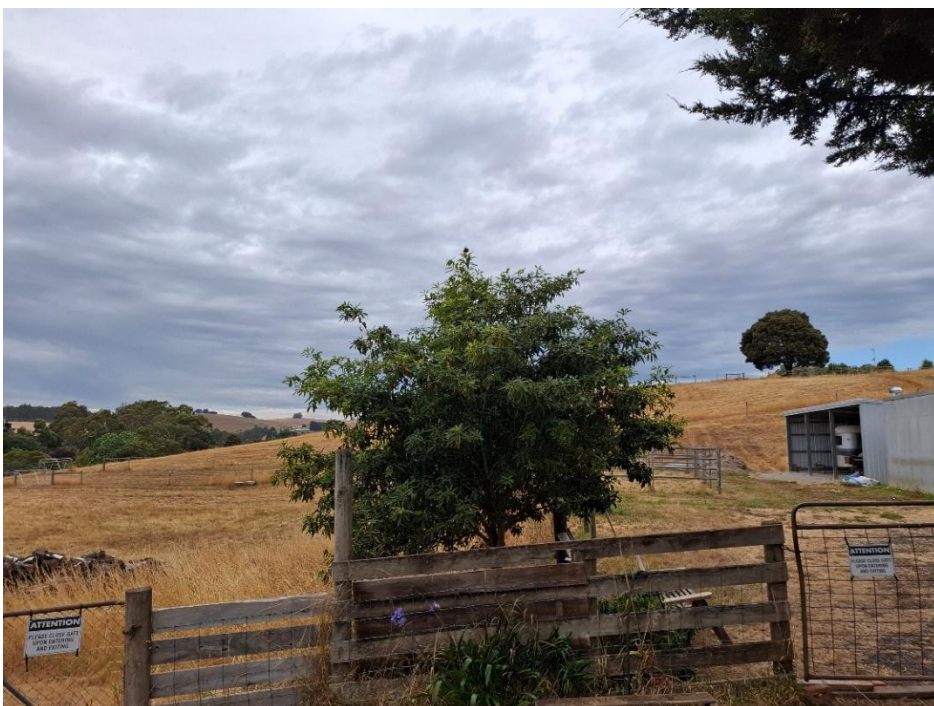
Image 4.1.2 – South - Grassland on adjacent property

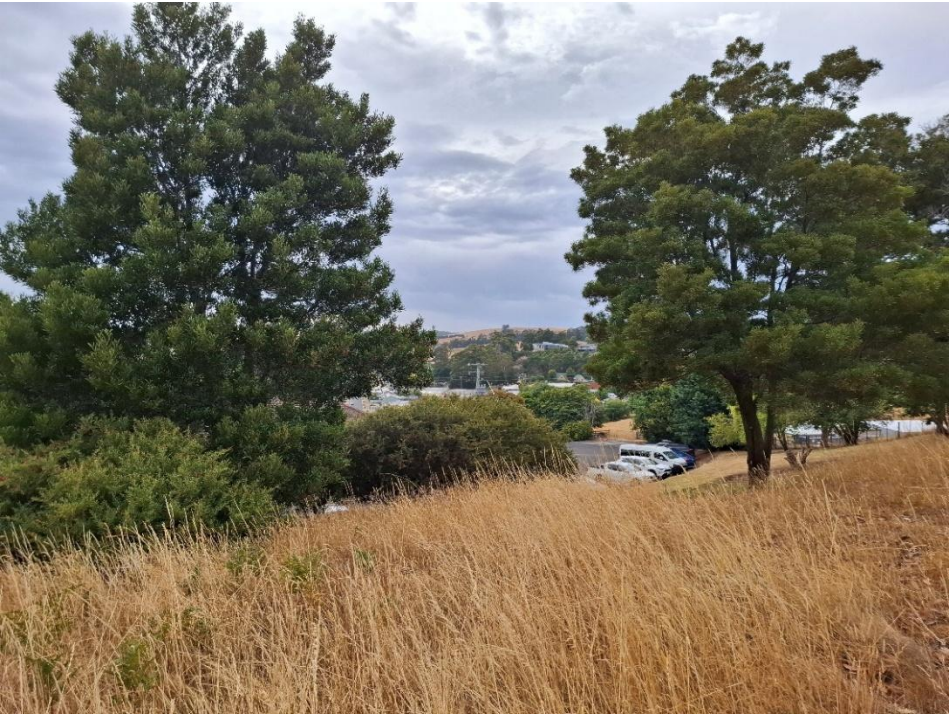
Image 4.1.3 – West – up slope above building low threat gardens with woodland behind

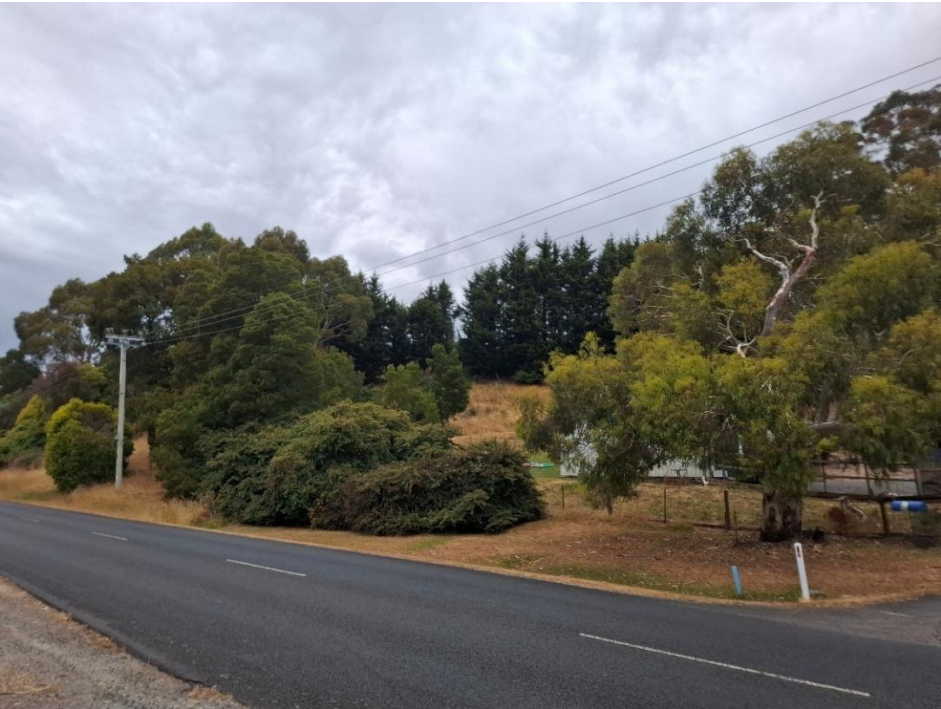
Image 4.1.4 – North – view from Adaihi Street looking back to grassland, windbreak and residential

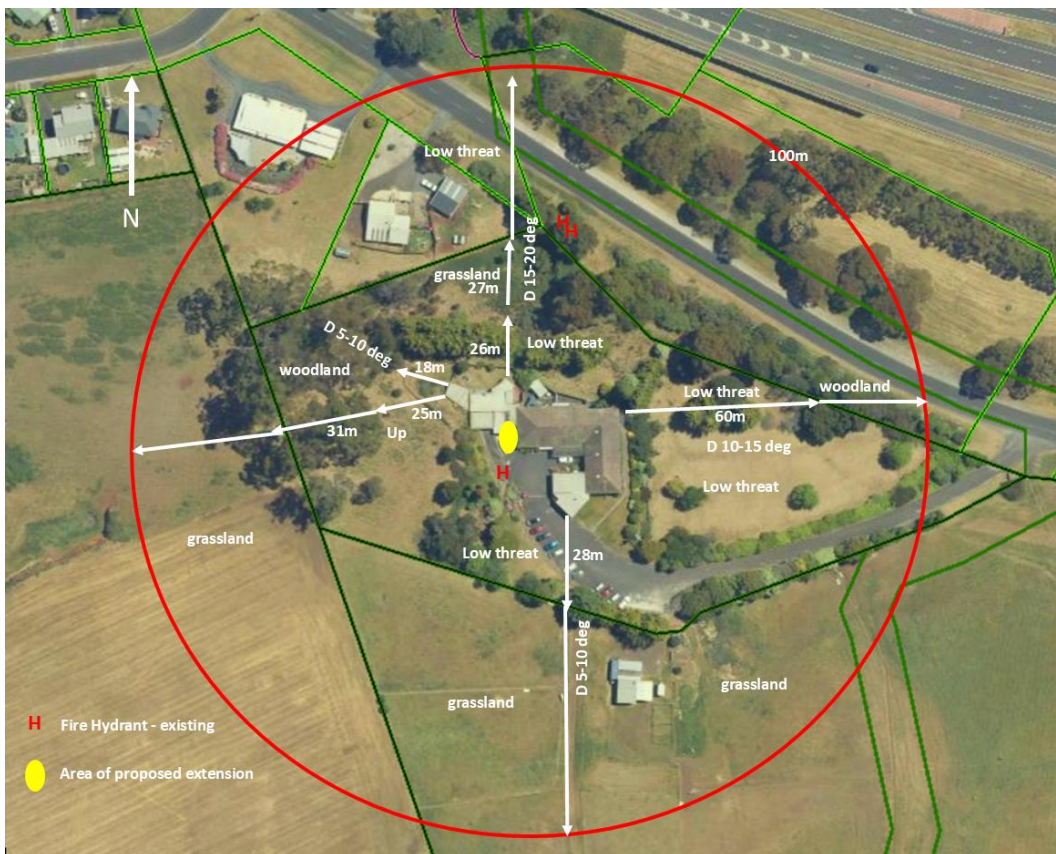
Image 4.1.5 – Site analysis

Distances are illustrated on Image 4.1.5 - Site Analysis.

North – grassland at 32m	BAL 12.5
South – grassland at 43m	BAL 12.5
East – grassland at 63-100m	BAL low
West and northwest – woodland at 40m	BAL 12.5

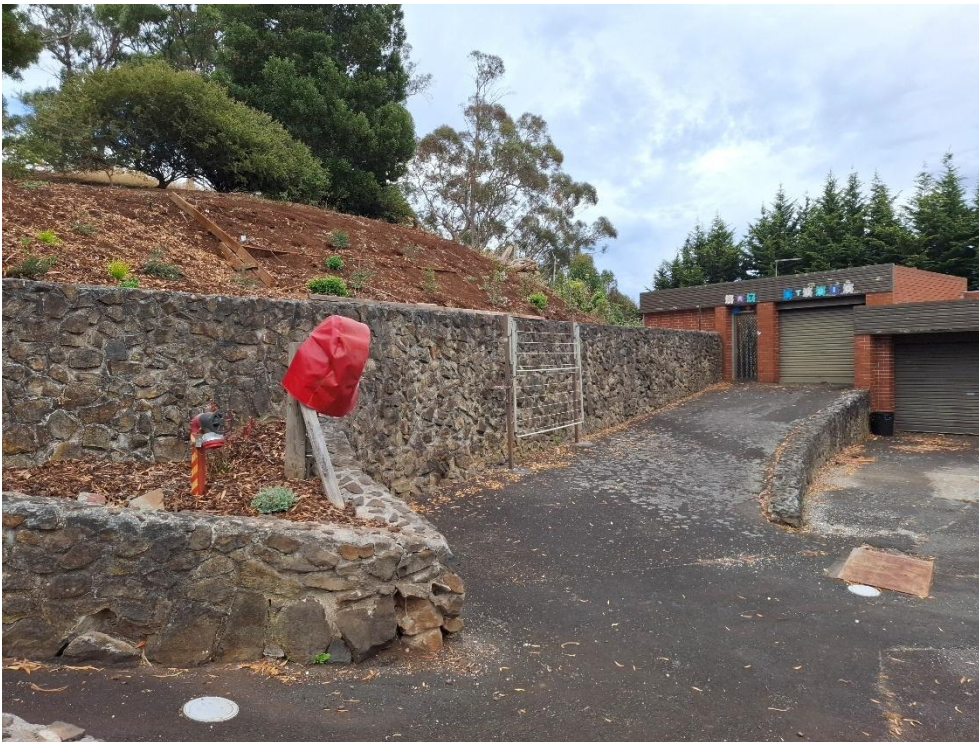
Image 5.1.1- Existing internal hydrant

- The lot has an existing compliant sealed access with adequate turning areas for emergency vehicles measuring 40m x 10m and 11m x 10m.
- Access is less than 200m to the existing hydrant and passing bays are not required.
- There is an existing reticulated water supply for firefighting within a 120m hose lay of the furthest portion of the building and there are no specific design and construction requirements.
- There is an existing internal fire hydrant located south of the existing building and greater than 6m from the proposed extension. The existing hydrant is within a 120m hose lay of the furthest portion of the existing building and proposed extension being protected.
- Existing access and water supply comply with the requirements of Code C13 Tables C13.2 and C13.4
