Application for Planning Approval

SECONDARY DWELLING & ROOFED VERANDAH

New Ancillary Dwelling and New Veranda Roof

Class 1a&10
SNH25-033

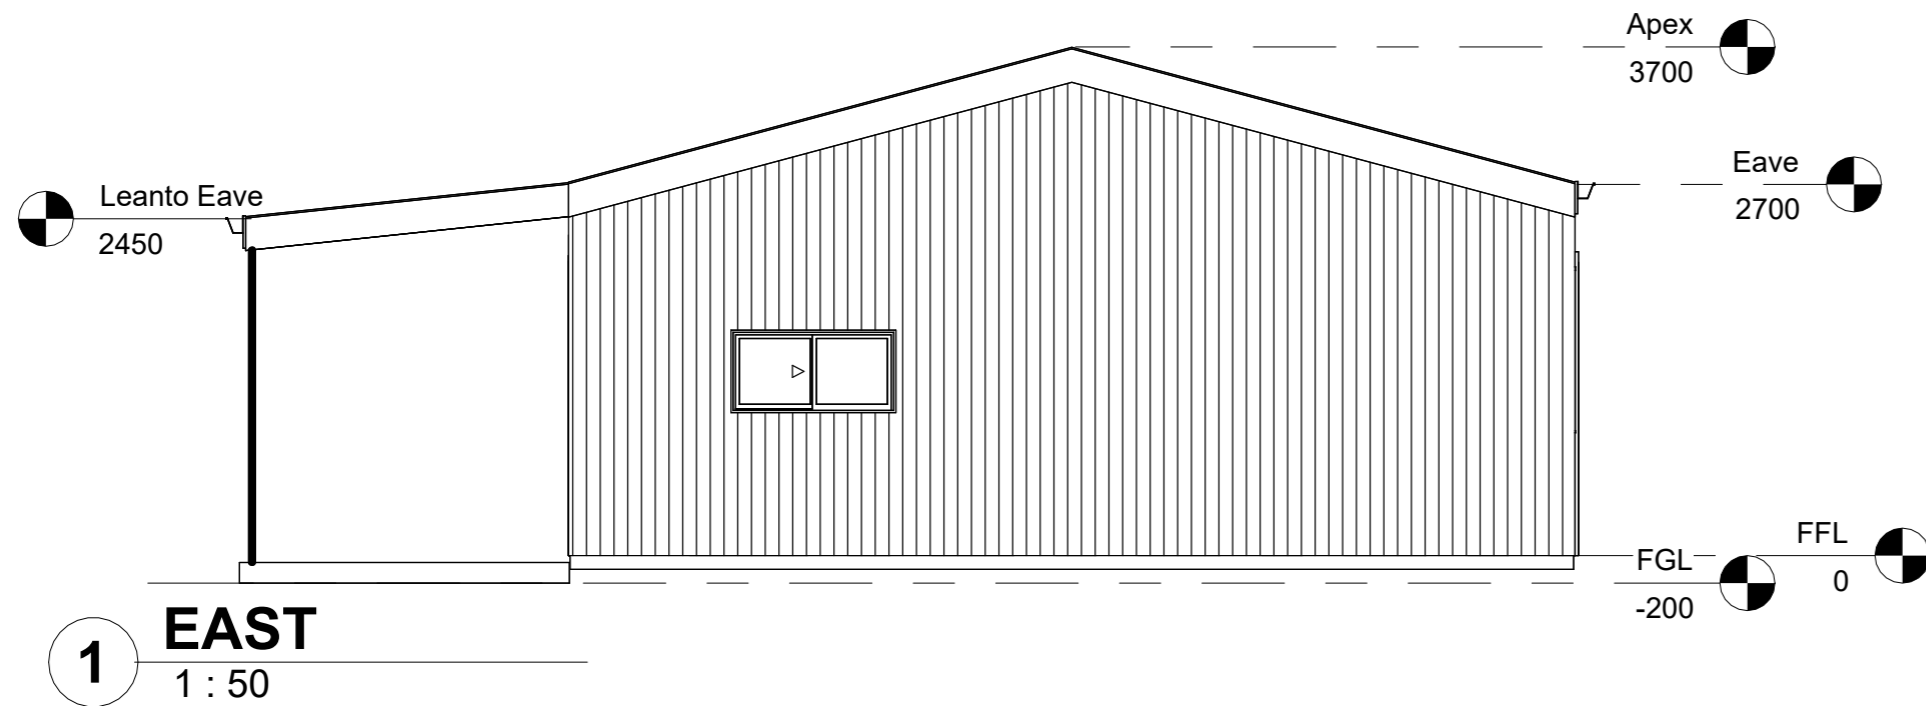
Colorbond Roof Cladding
 Corodek
 Colour: Pale Eucalypt
 SRI: 44

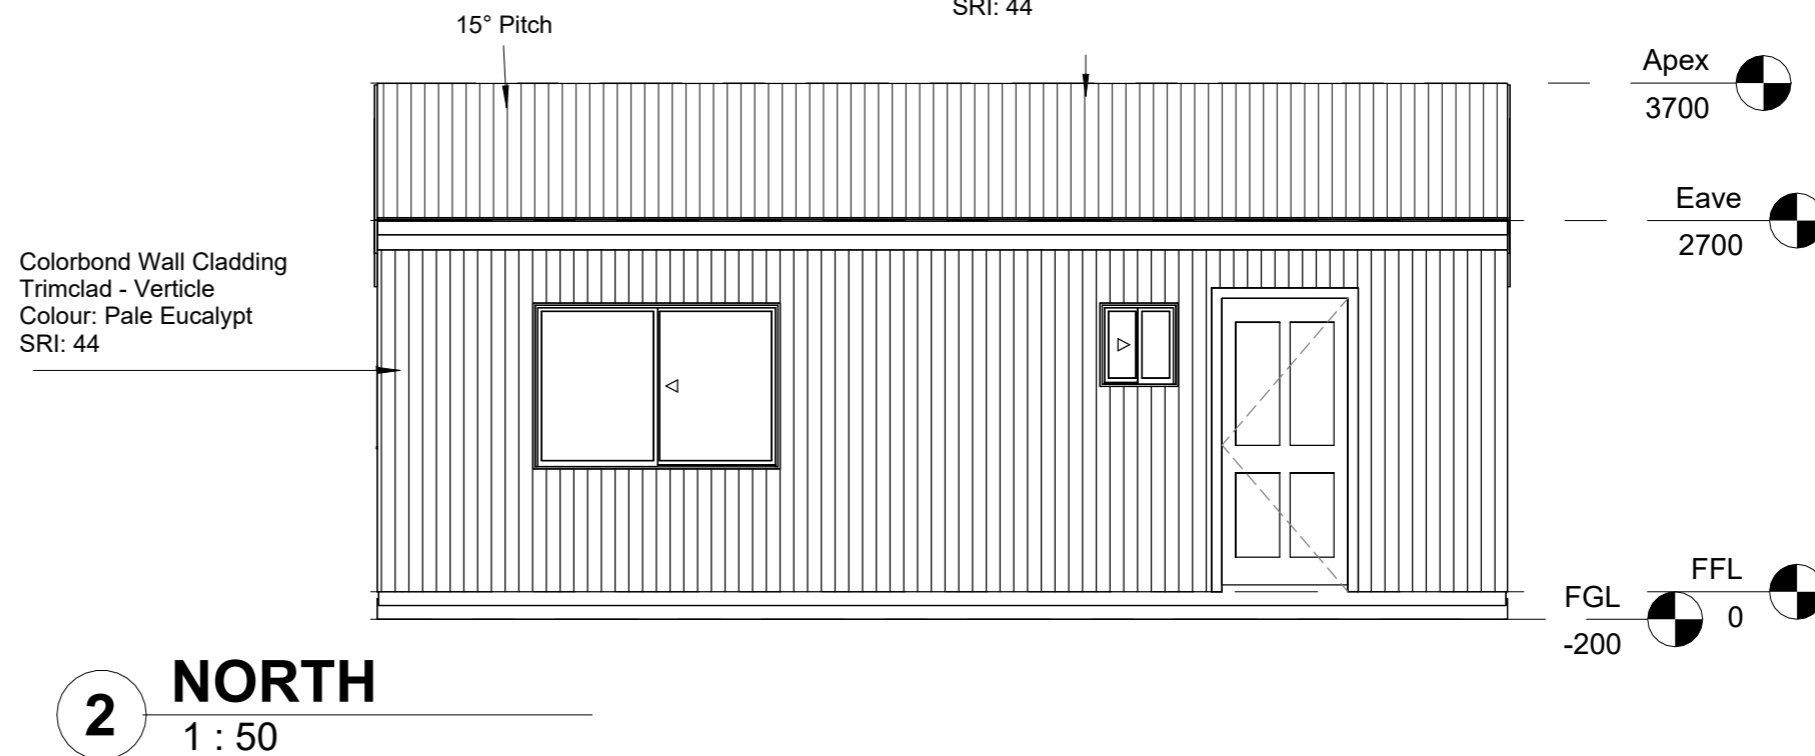
Colorbond Wall Cladding
 Trimclad - Vertical
 Colour: Pale Eucalypt
 SRI: 44

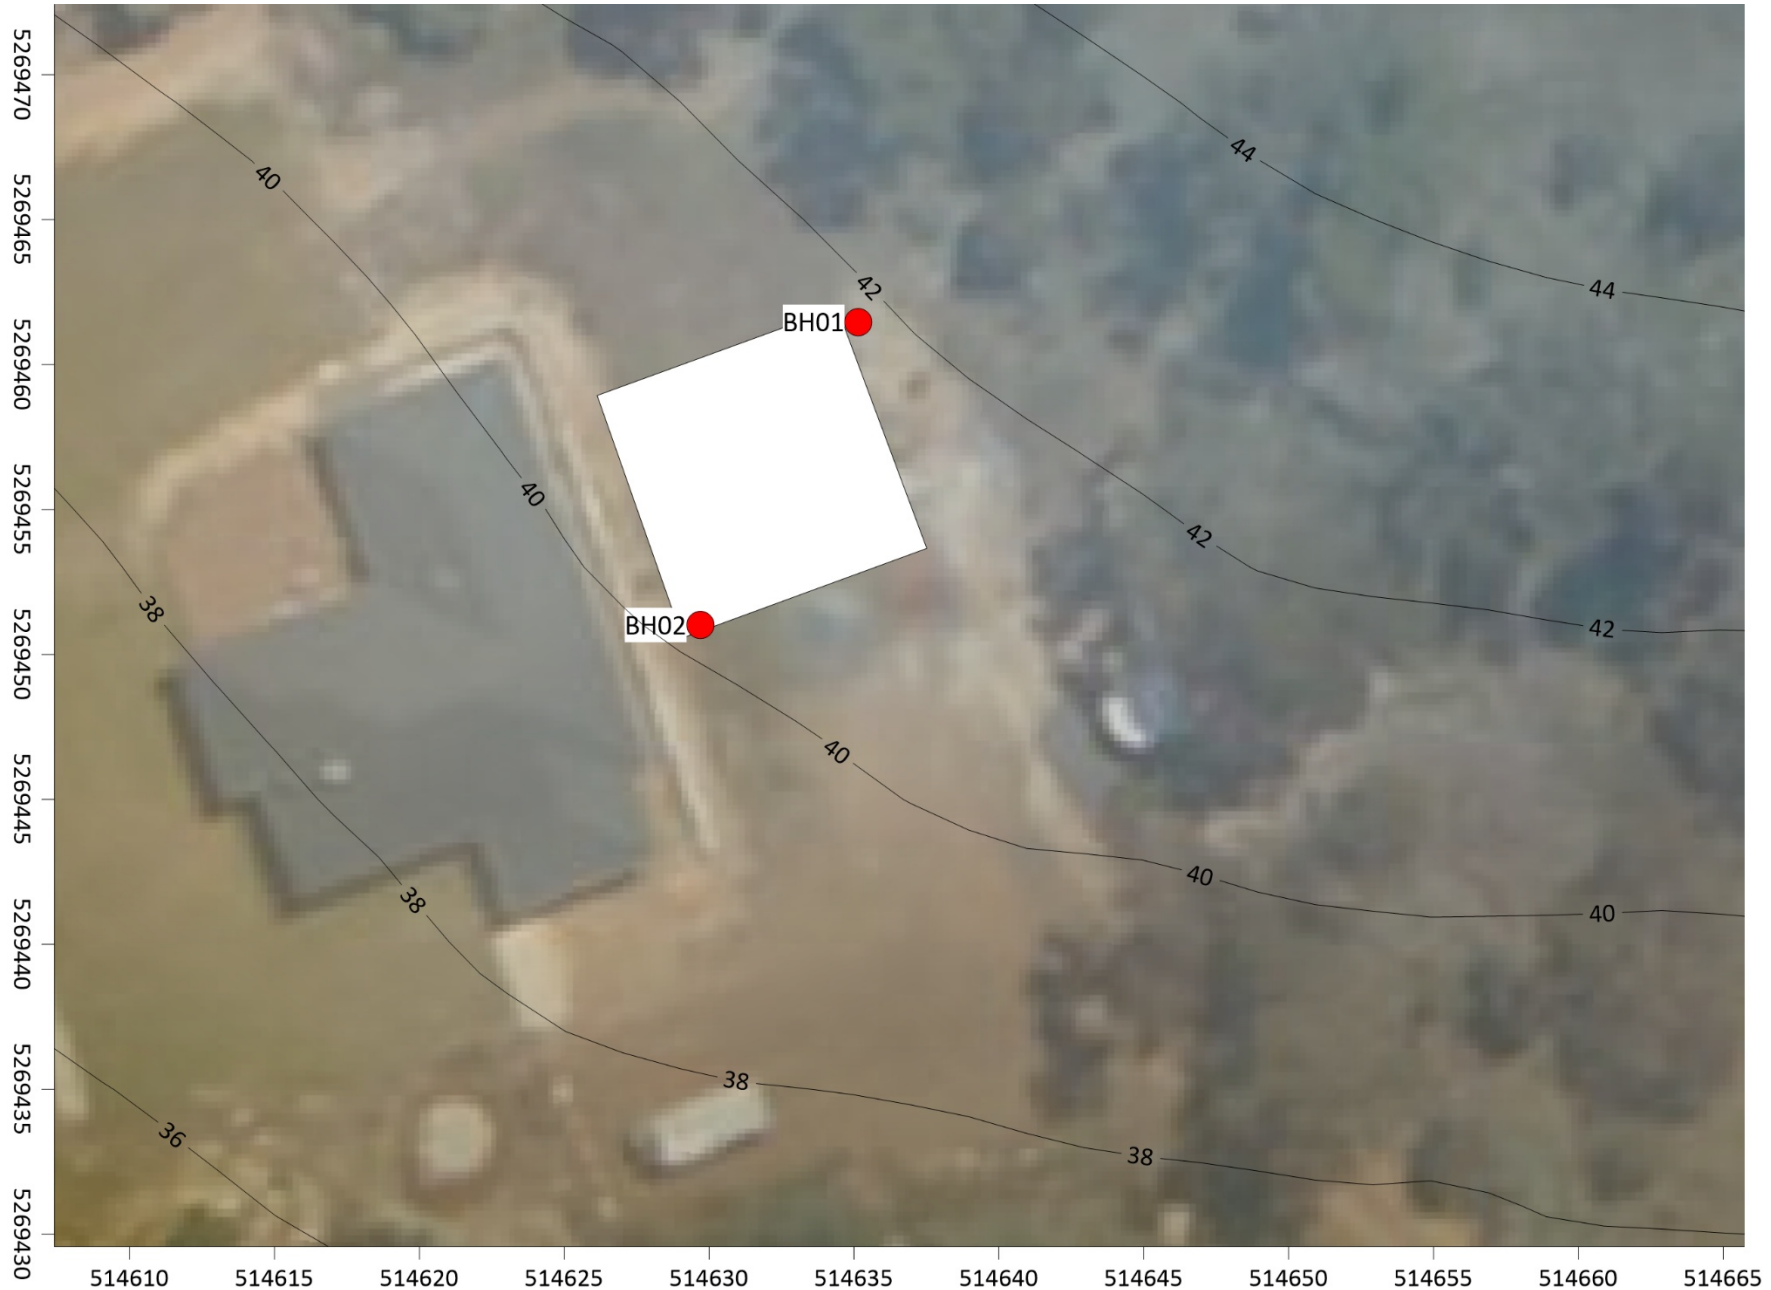
Figure 1 Site Borehole Locations

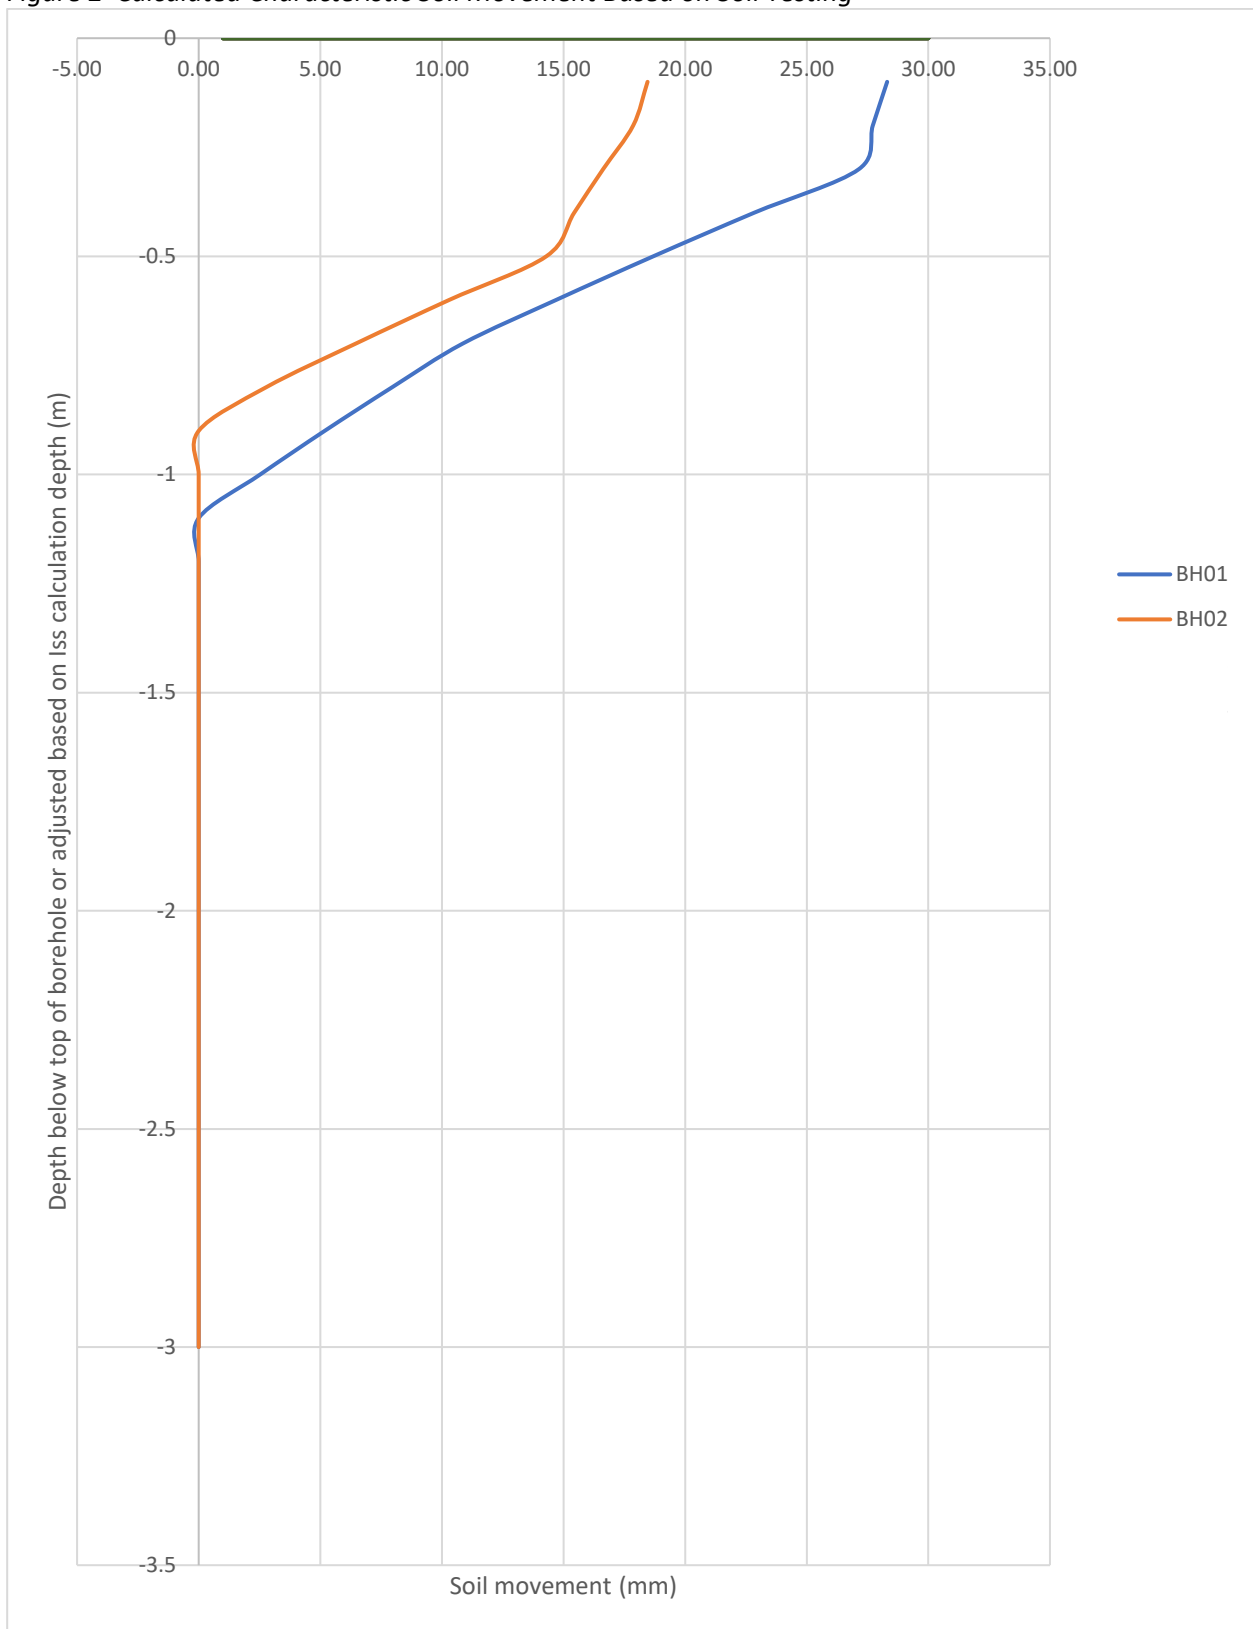
Figure 2 Calculated Characteristic Soil Movement Based on Soil Testing

According to AS 2870 Section 2.3, calculations consider the depth of groundwater and bedrock. Soil characteristic movements based on lab testing are presented in Figure 2.

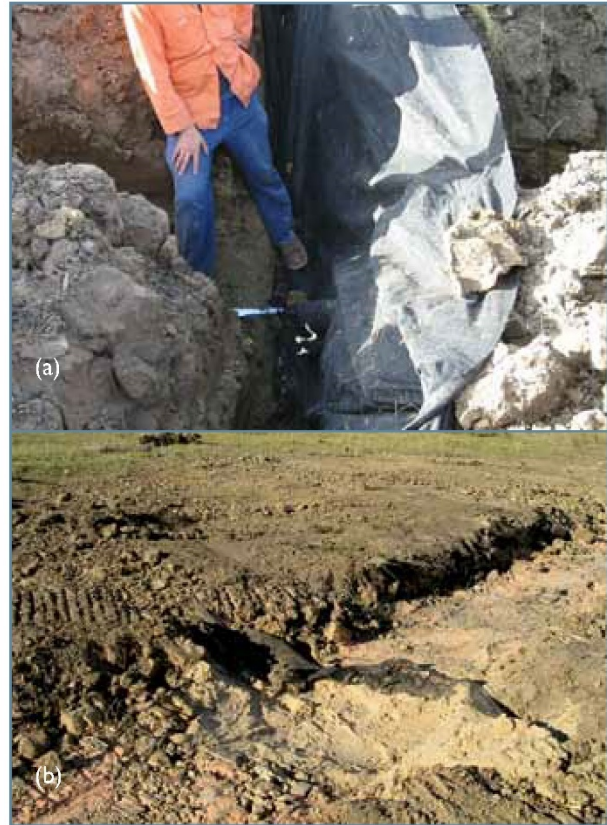
Figure 15. (a) Installation of sandblock perpendicular to a service trench. Note securing of geotextile to the optical fibre cable to prevent water flowing past the sand block. (b) Sandblock before final topsoiling.

Sand filters were first developed to prevent piping in earth dams. Sand filters prevent dam failure by trapping entrained sand and silt, blocking the exit of the tunnel and preventing further tunnel development (Sherard *et al.* 1977). Following the work of Sherard *et al.* (1977), Richley (1992 and 2000) developed the use of sand blocks to prevent tunnel erosion during installation of an optical fibre cable in highly dispersive soils near Campania, Tasmania. The sand blocks work slightly differently to the sand filters in that they allow the free water to rise to the surface through the sand. The use of sand blocks has recently been modified by Hardie *et al.*, (2007) to prevent re-initiation of tunnel erosion along an optical fibre cable near Dunalley. Modifications to the original technique developed by Richley (1992 and 2000) include (Figure 14 & 15);

- » Upslope curved extremities to prevent the structure from being by-passed.
- » Geotextile on the downslope wall to prevent collapse or removal of sand following settlement or erosion.
- » Application of gypsum (around 5% by weight) to ensure infiltrating water contains sufficiently electrolyte to prevent further dispersion.
- » Earth mound upslope of the structure to prevent run-on entering the sand blocks.

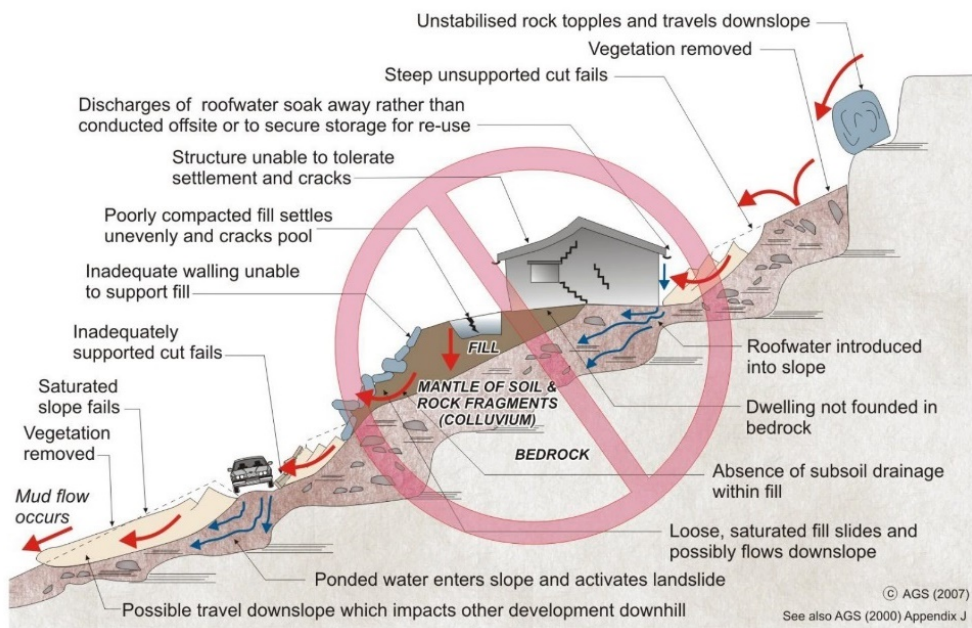
EXAMPLES OF **POOR** HILLSIDE CONSTRUCTION PRACTICE

Roadways and parking areas - are unsurfaced and lack proper table drains (gutters) causing surface water to pond and soak into the ground.

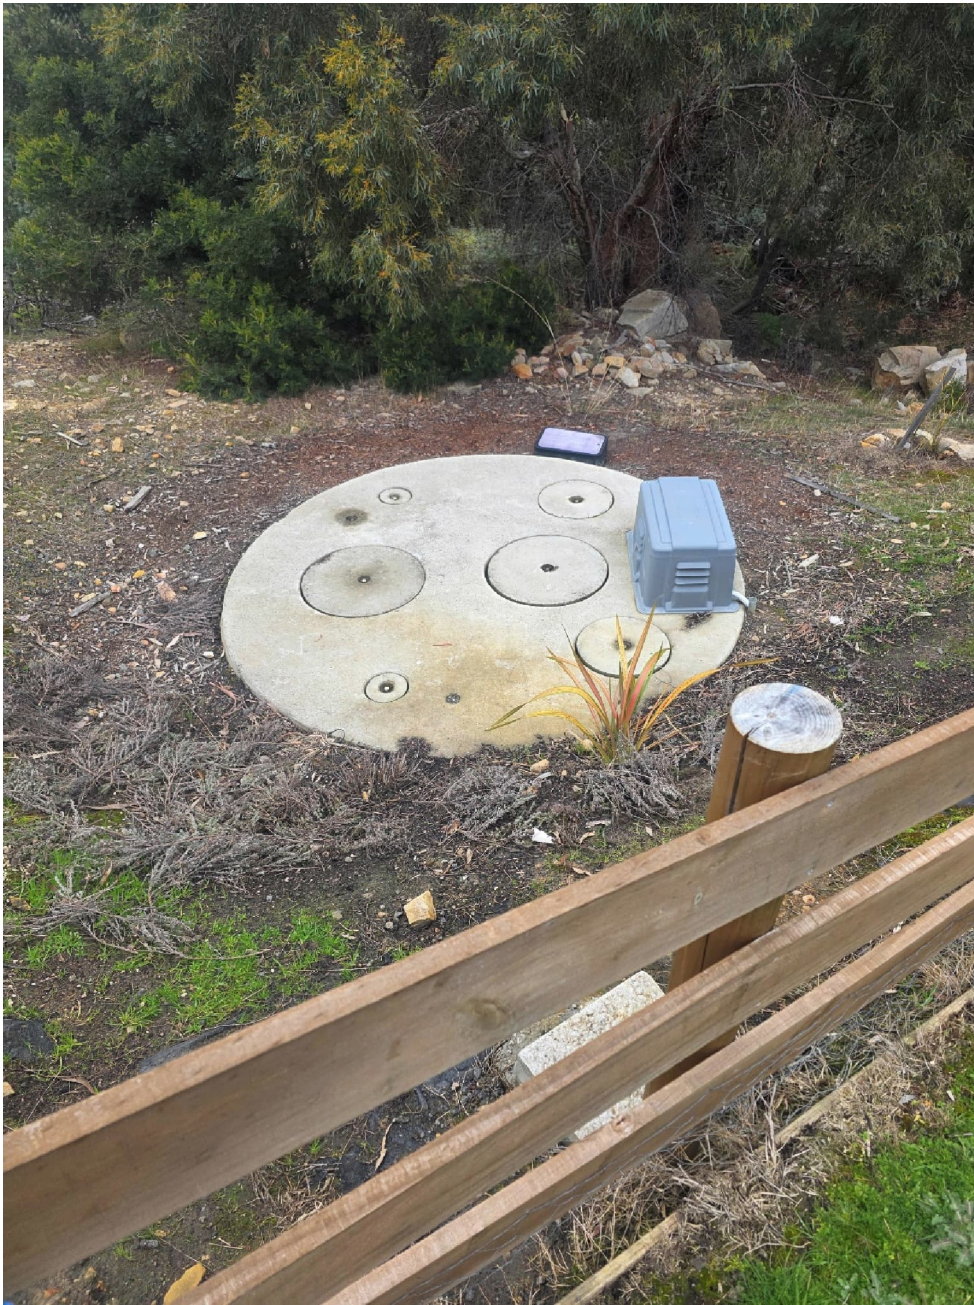
Figure 3: Existing 7000L Econocycle ENC10-1 system

A site inspection was performed to inspect the existing concrete Econocycle 7000L ENC10-1 AWTS currently being used by the existing dwelling located at the property

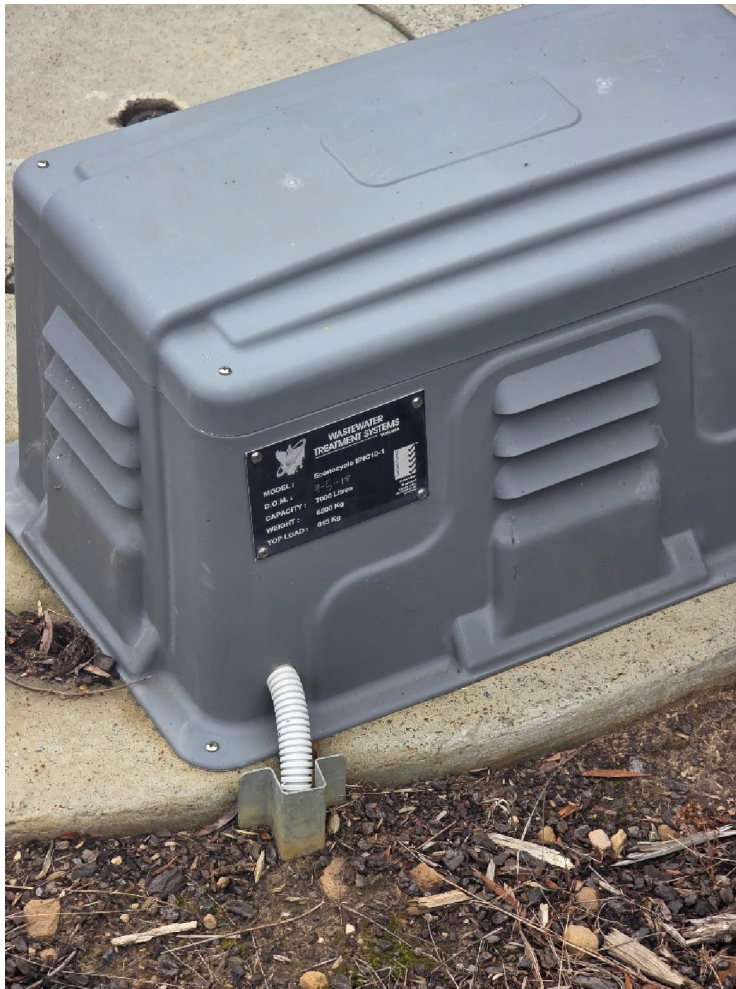
Figure 4: Existing 7000L Econocycle ENC10-1 system

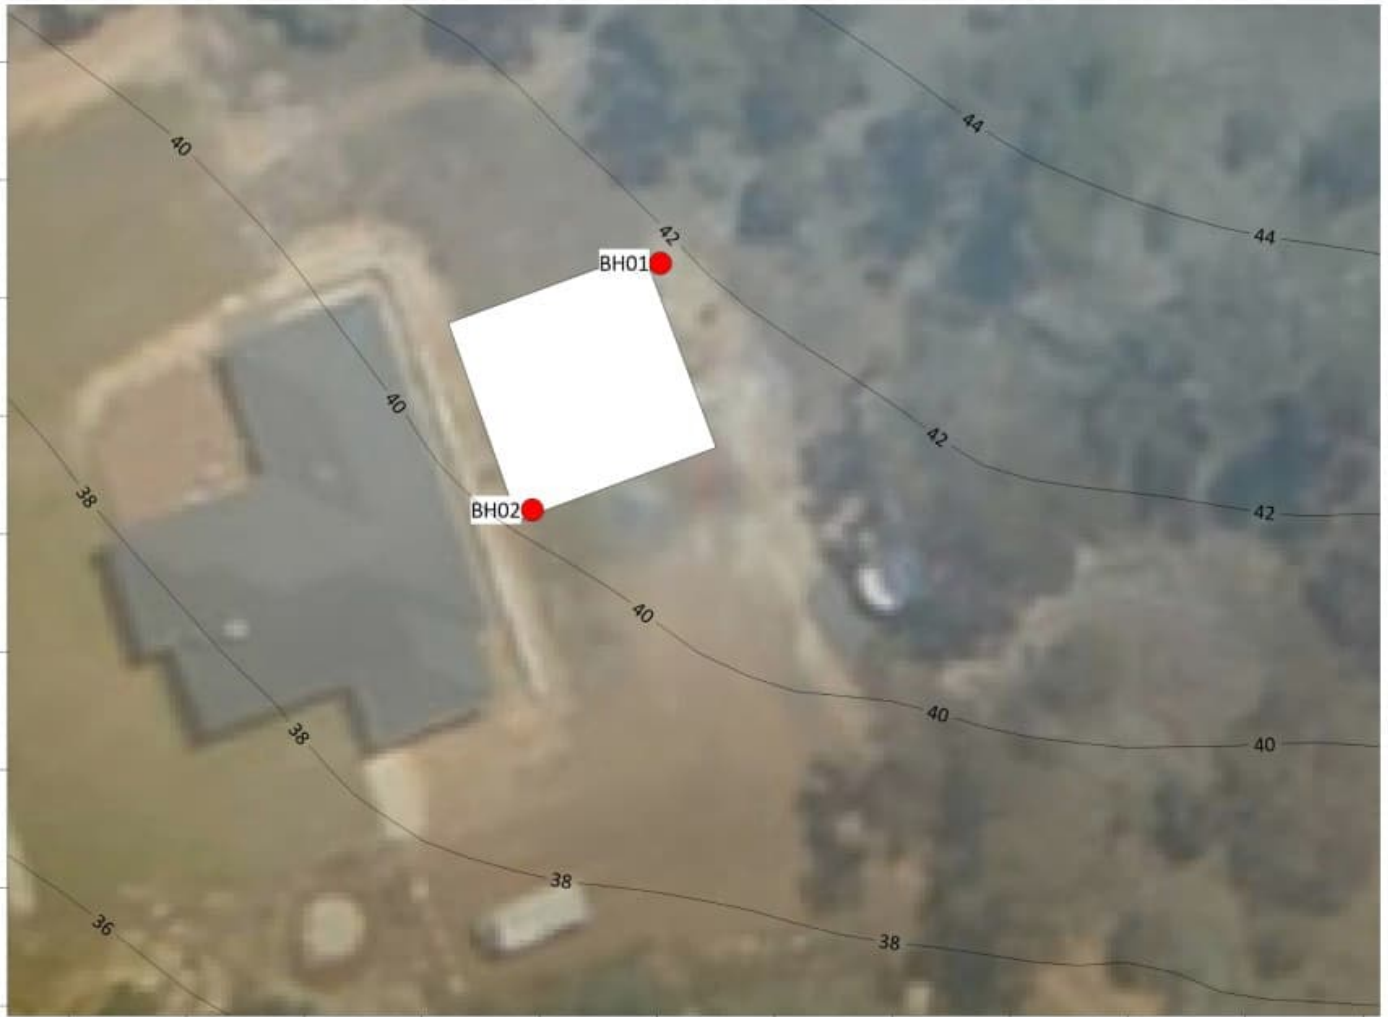
Figure 7: Test Hole Locations

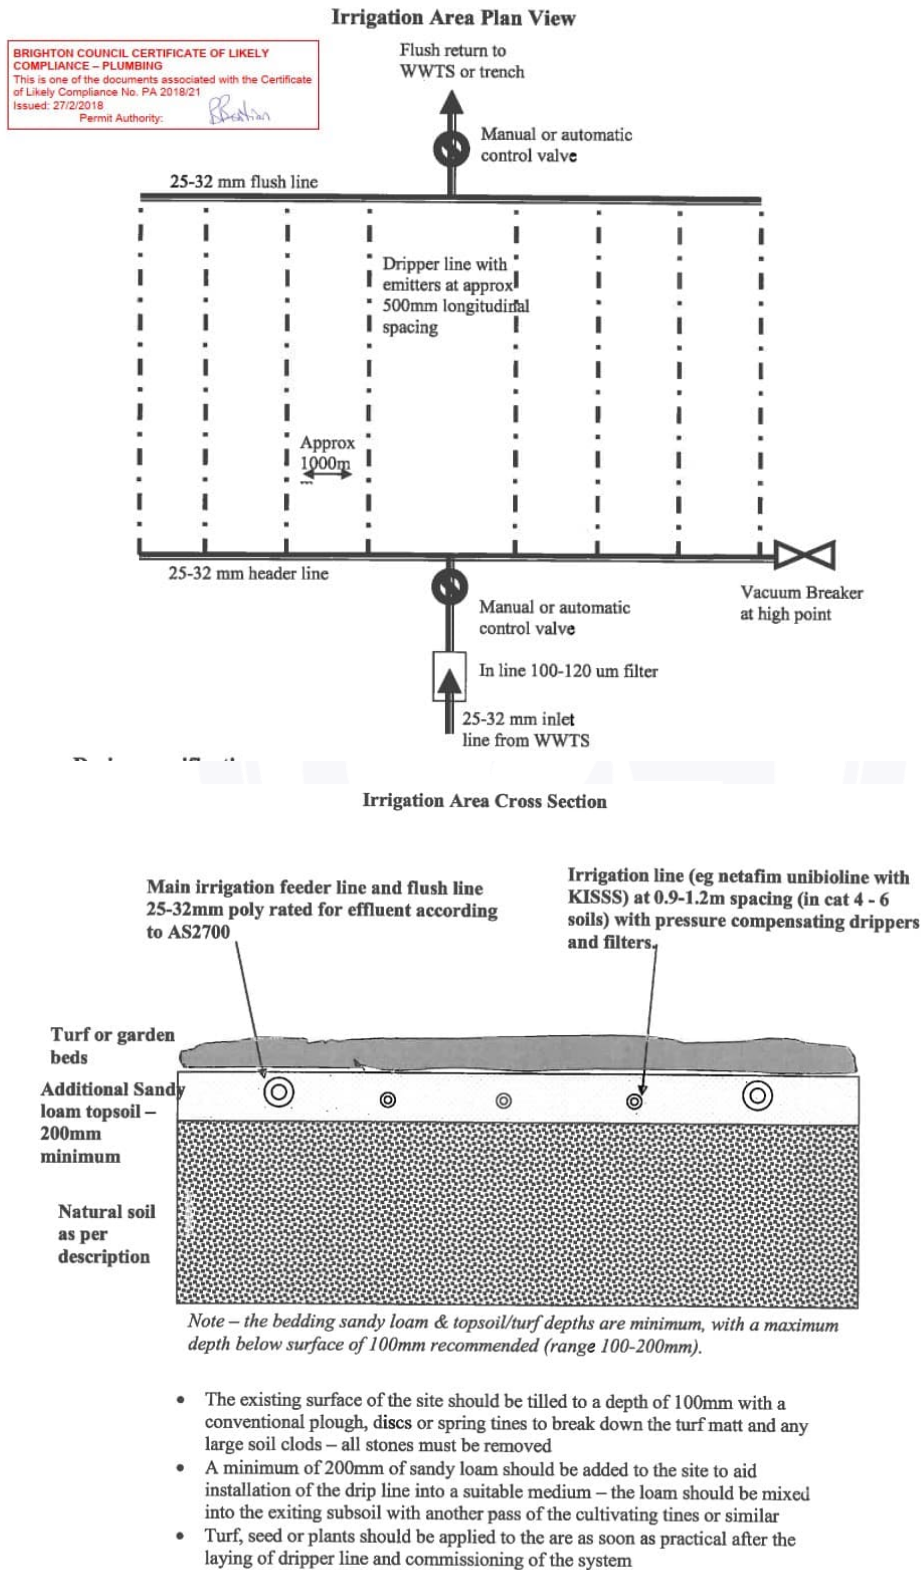
Figure 11: INSTALLED IRRIGATION DETAILS
